SEISMIC REINFORCEMENT OF EARTHEN CONSTRUCTIONS

M. Blondet⁽¹⁾, J. Vargas-Neumann⁽²⁾, N. Tarque⁽³⁾, J. Soto⁽⁴⁾, C. Sosa⁽⁵⁾, J. Sarmiento⁽⁶⁾

It is known that unreinforced earthen buildings are highly vulnerable to seismic activity and thus millions of people living in earthen dwellings are at risk. This article presents preliminary results from an ongoing project undertaken at the Pontifical Catholic University of Peru (PUCP), whose main objective is the development of reinforcement techniques for earthen constructions located in seismic areas.

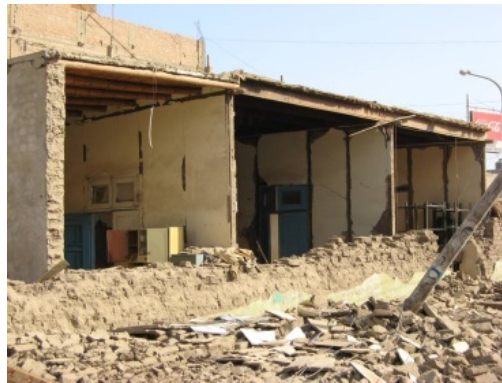
Fig. 1 - Damage of adobe houses during the Pisco (Peru) earthquake of 2007

Collapse of earthen constructions is triggered by the progressive formation of cracks in the walls. The most common types of cracks are x-shaped cracks due to shear, and vertical cracks at the corners. Vertical cracking at the corners may be followed by overturning of exterior walls (Fig.1), which may in turn pull the roof with them if they support the roof joists. On the other hand, if the joists are supported by walls perpendicular to the façade, the roof may not collapse. The high seismic damage on adobe buildings is mainly due to the lack of appropriate structural reinforcement of their walls.

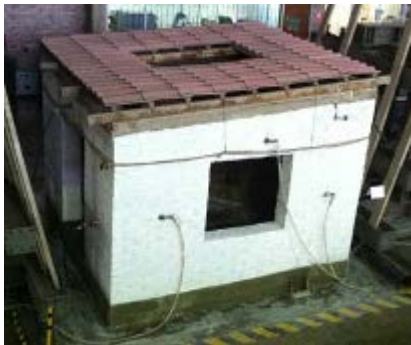
Fig. 2 - Adobe model on the shaking table, prior to testing

A full-scale adobe house model was built at the PUCP's Structures Laboratory to be tested on the unidirectional shaking table [3]. The purpose of the test was to evaluate the efficacy of the mesh reinforcement retrofit system, which would complement the mud injection repair procedure. The model consisted of four adobe walls (3.00 m long and 0.25 m wide, with different heights). Adobe blocks measuring 250 x 250 x 90 mm were made using soil, straw and coarse sand (5:1:1 in volume). The adobe blocks were joined with 20 mm thick mud mortar also made with soil, straw and coarse sand (3:1:1 in volume).

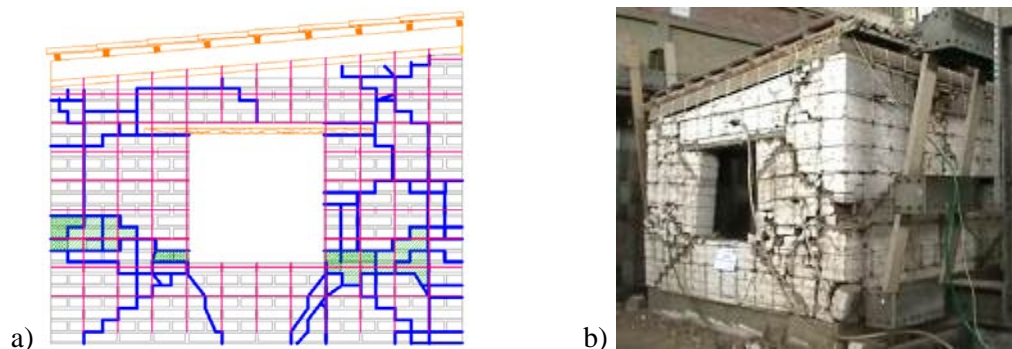
Fig. 5 - Retrofitted adobe model after the test.
(a) Cracking pattern of the right wall. (b) Snapshot of the adobe model during the test

The retrofitted adobe model was tested again on the shaking table. This time the model was subjected to successive testing phases with 0.30 g, 0.71 g, 1.08 g and 1.53g horizontal acceleration. During the first phases all the repaired cracks opened and new cracks appeared in all the walls (Fig.5a). In the last phase the mesh was able to keep together the large pieces in which the walls had been broken (Fig.5b). Even though the crown beam got detached due to the damage at the top of the back wall, the reinforcement mesh and the crown beam worked well together in keeping the integrity of the structure. It was noticed that the horizontal ropes placed near the base of the window started to cut into the mud mortar.

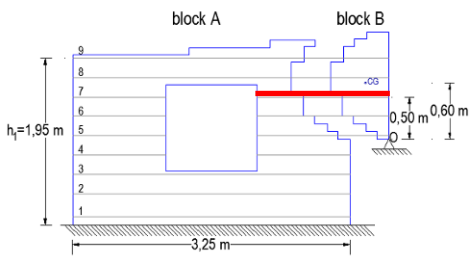
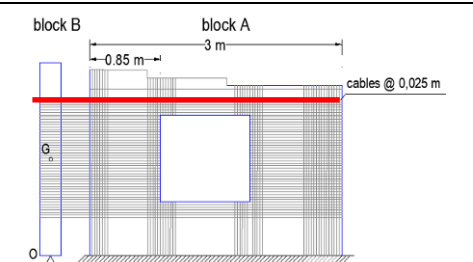
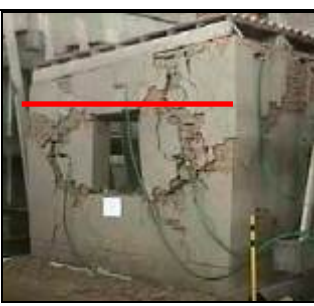
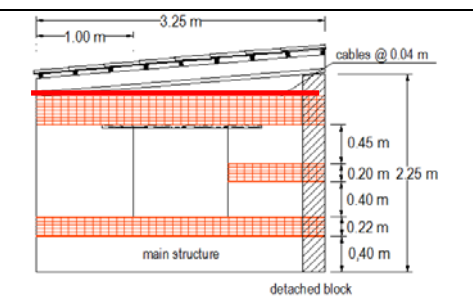
a) $I_o = 320 \text{ kg-m}^2$ b) $k_i = 3,00 \text{ kN/m}$ c) $T_n = 2,42 \text{ s}$. d) $f_{max} = 0,83 \text{ kN}$. e) $f_{max} < f_w = 1,0 \text{ kN}$.
2

a) $I_o = 2590 \text{ kg-m}^2$ b) $k_i = 1,80 \text{ kN/m}$. c) $T_n = 0,33 \text{ s}$. d) $f_{max} = 0,44 \text{ kN}$. e) $f_{max} < f_w = 6,0 \text{ kN}$.
3

a) $I_o = 2590 \text{ kg-m}^2$ b) $k_i = 0,12 \text{ kN/m}$. c) $T_n = 4,75 \text{ s}$. d) $f_{max} = 0,10 \text{ kN}$. e) $f_{max} > f_w = 0.035 \text{ kN}$

Fig. 8 – Evaluation of maximum forces according to design procedure

Fig.8 shows the values of the peak load on the most stressed string and the corresponding working load ($f_w = f_u/2$, where f_u is the ultimate load of a single string) calculated for three types of reinforcement mesh: 1) nylon rope mesh; 2) biaxial geogrid mesh; and 3) plastic safety mesh. These calculations predicted correctly the observations in the laboratory: the forces in the nylon string mesh and the geogrid mesh reinforcement were below their working limit ($f_{max} < f_w$), and the safety mesh failed locally ($f_{max} > f_w$).

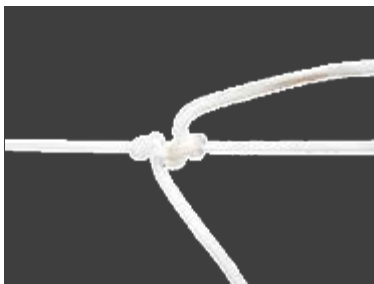
Fig. 16 - Selected knot to join the nylon ropes

The reinforcement mesh used at the laboratory consisted of nylon ropes joined by metal turnbuckles costing around US\$ 1.20 each. Eight turnbuckles are needed for each m^2 of wall. This is too expensive for rural dwellers in developing countries, and furthermore, the turnbuckles are not easy to find in rural areas. Therefore it was decided to discard their use and to join the ropes using knots. A short experimental program was developed to select a simple and adequate knot, able to keep the tension for a long time. Several knot combinations were tested, based on their ease to be made and their ability to keep the original tension. Finally, a combination of an “eight” knot and a “half-hitch” knot, shown in Fig.16, was selected. Constant load tests showed that 5/32” halyard ropes joined with the selected knot combination were able to hold about 60% of its initial tension after a week, as can be seen in Fig.17.

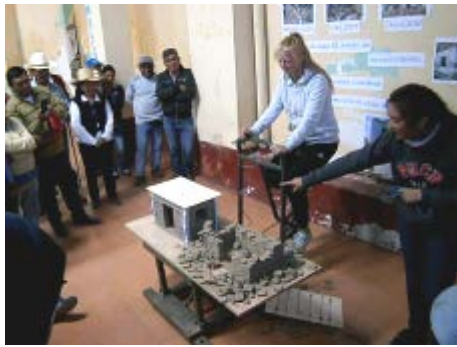
Fig. 18 - Demonstration on the portable shaking table

assistance or seismic reinforcement criteria [7] [8]. Two communication and educational tools were used to disseminate the nylon rope mesh seismic reinforcement among rural dwellers: a portable shaking table and an illustrated construction manual. The portable shaking table was used to perform dynamic tests on reduced-scale adobe models (Fig.18). Its main goal is to educate community members about the high seismic vulnerability of their dwellings, and to show the value of building earthquake-resistant adobe houses. The illustrated construction manual is a technical document that fully describes how to reinforce an adobe house with nylon ropes using simple language and easy-to-follow drawings (Fig.19).
