## SEISMIC ASSESSMENT OF PRECAST BEAM-TO-COLUMN CONNECTIONS AND RETROFITTING SOLUTIONS

**Keywords:** RC precast buildings; beam-to-column connections; cyclic tests; seismic retrofitting; three-hinged steel system.

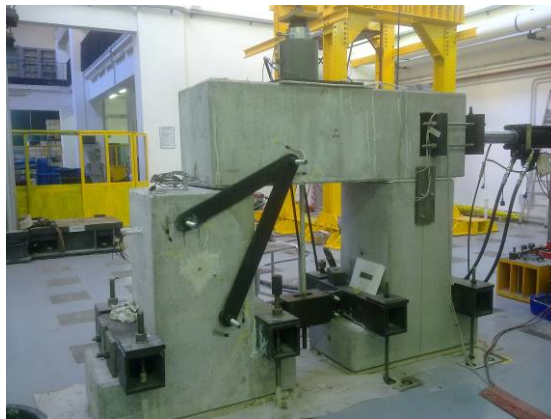
Fig. 3 - Retrofitting system configuration: test setup

After the cyclic shear test, the described beam-to-column connection was repaired, restoring the concrete elements, and retrofitted by means of a three-hinged steel system, which is a connection system patented by Capozzi and Magliulo [23] and Capozzi et al. [22]. In this kind of application, it consists of two inclined steel profiles anchored to the concrete elements, by means of horizontal steel dowels passing through holes in the concrete elements, and tightened by means of nuts and washers (Fig. 3). In the reference specimen the horizontal dowel, passing through the beam, is covered by a rubber sheath to avoid high local stresses.

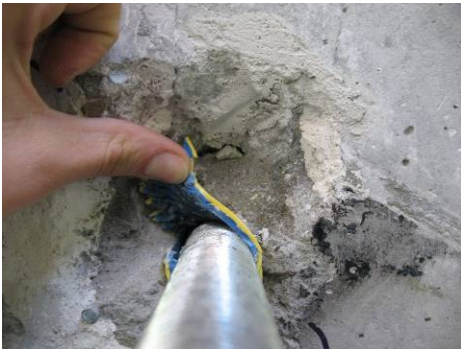
Fig. 7 - Rubber sheath deformation

At the end of the test, the rubber sheath around the steel dowel in the beam was significantly damaged (Fig. 7) and the surrounding grout crushed. Moreover, the neoprene pad showed large deformations due to the

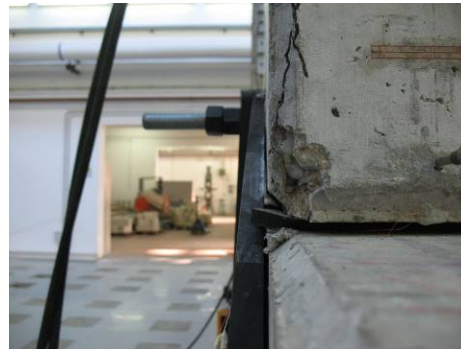
Fig. 8 - Neoprene pad deformation

high compressive loads (Fig. 8). Several inclined cracks appeared in the concrete around the node in the beam at both the sides of the specimen (Fig. 9). However, the thickness and the length of the crack were small.

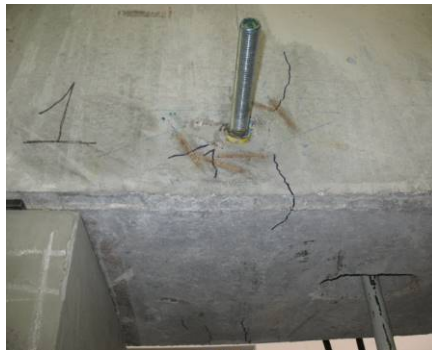
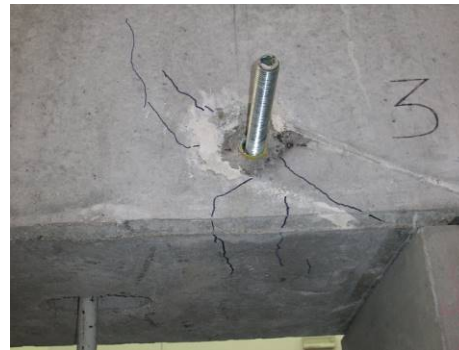
Fig. 9 - Cracks pattern at the node in the beam at the end of the test: (a) West and (b) East view
