## SEISMIC PROTECTION OF BUILDINGS IN PERU USING ENERGY DISSIPATION AND BASE ISOLATION

### ***Abstract***

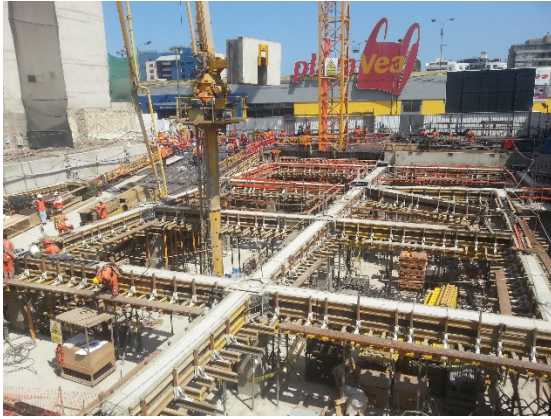
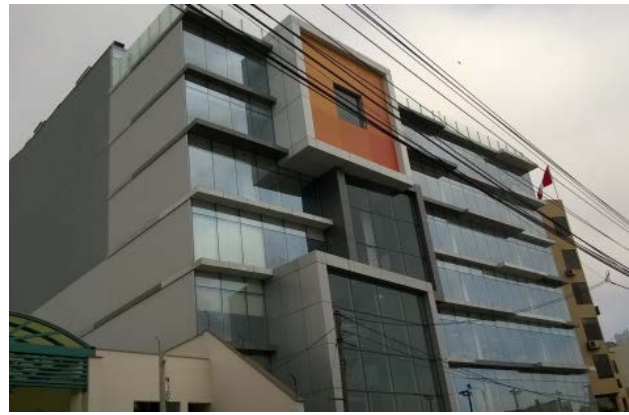
The first office building with isolators built in Peru, was the building of private company GyM headquarters office (Fig. 1) designed by the structural firm "Prisma" in 2013. Regarding such building, a cost comparison was done of the isolated building with respect to a conventional design (with RC frames and walls). The result of the study conducted by Prisma and GyM, gave that the isolation system was only 3% more expensive compared to the conventional system.

Fig. 1 “GyM” office building– Lima, Peru

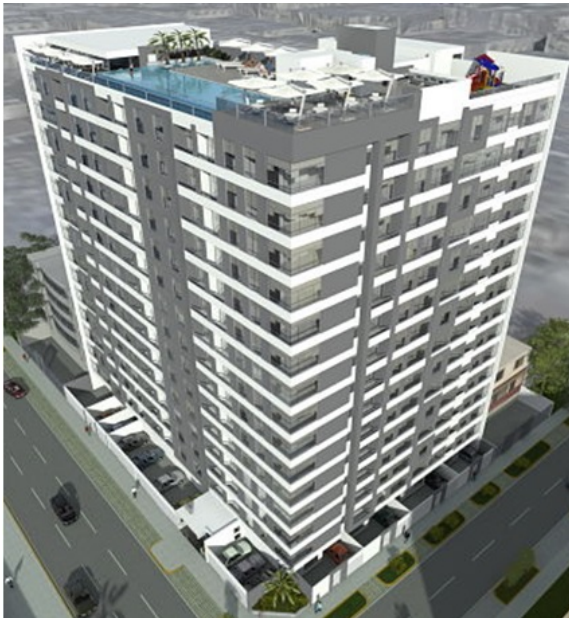
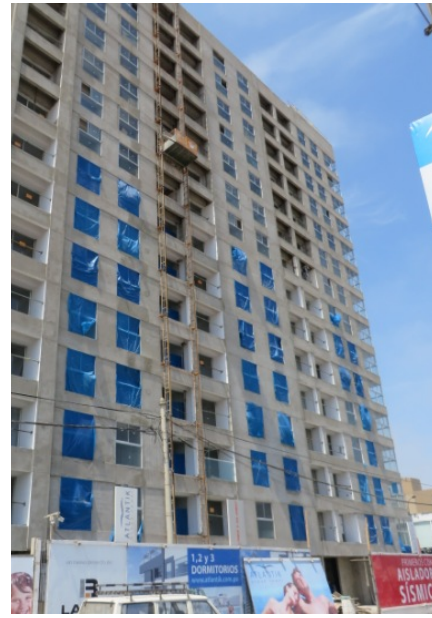
In 2014, the real estate “Labok” built the first apartment building with seismic isolators called “Atlantik Ocean Tower” in which the structural design was by Prisma. This 15-story plus 4 basements building, has 40 elastomeric isolators and friction sliders (Fig.2). Subsequently, Prisma developed in 2015 the first building for economic housing apartments, using a system of seismic protection. This building called “Paseo Colonial” has started construction in May 2016; it has 15 floors plus 2 basements and 72 elastomeric isolators (Fig. 3).

Fig. 2 “Atlantik Ocean Tower” building in Lima, Peru

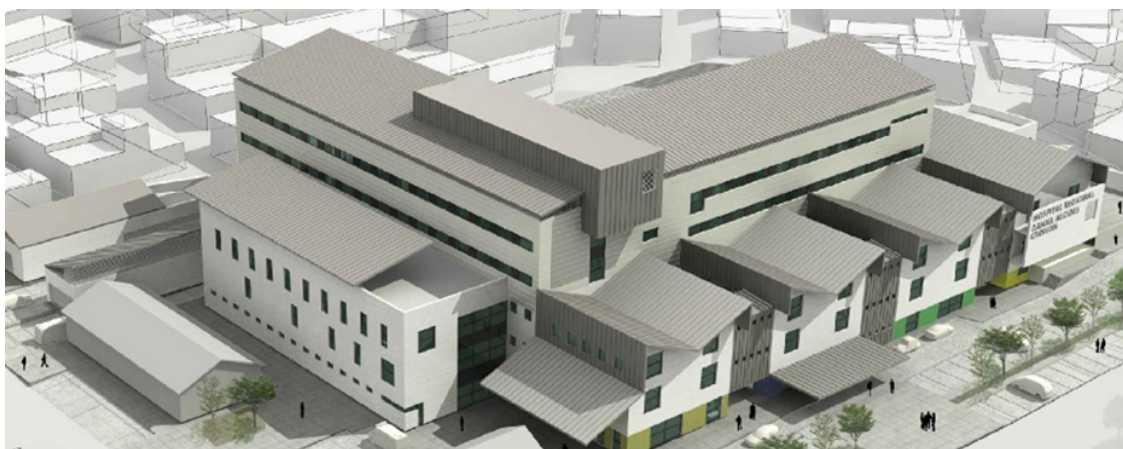
Fig. 4 “Daniel Alcides Carrión Hospital” in Cerro de Pasco, Peru

Since 2014, an addendum to the Peruvian seismic code, has been enforcing that major hospitals must have seismic base isolation, if they are in seismic zones 3 and 2 of the 2003 Peruvian seismic code [6]. The new Seismic Code that was recently published in January 2016 keeps this requirement. Therefore, currently there are more than 10 hospitals in design or construction with an elastomeric system of isolation, as the one shown in Fig.4. Also, some private clinics took the initiative to incorporate isolation systems in new buildings. This is the case of the Medical Specialties Clinic in San Borja, Lima, or The Hamilton Naki Clinic in Huancayo. However, since the publication of the Code in January 2016, the new buildings in private clinics are required to have base isolation, if they are located in the new seismic zones 4 and 3, and they belong to the second and third tier in the classification of health establishments from the health ministry of Peru.

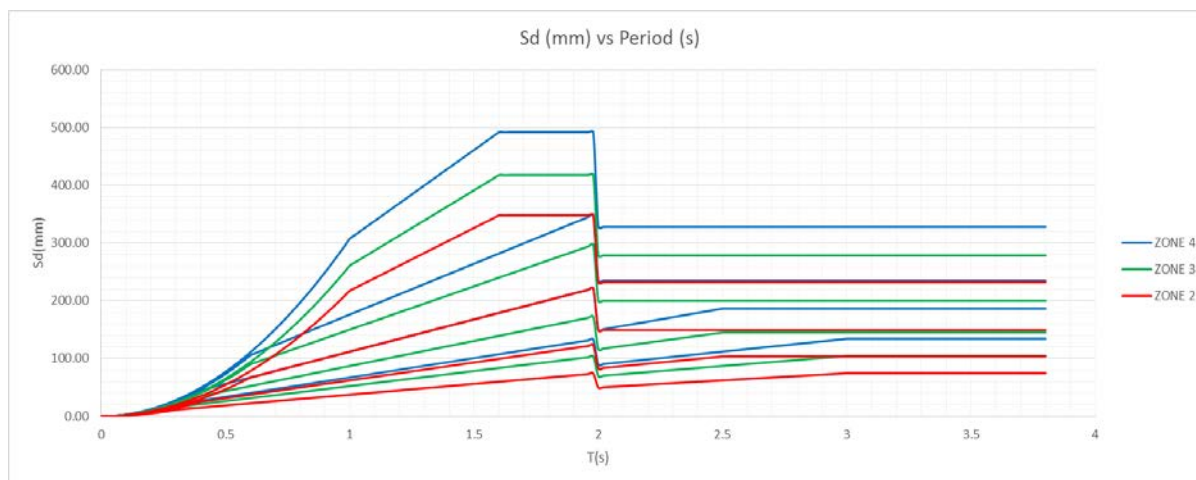
The displacement spectra for isolated buildings, obtained using the 2016 Peruvian Seismic Code, on the three seismic zones of higher hazard (zones 4, 3 and 2), and the four types of soils defined in the Code, are shown in Fig. 6. A correctly designed building in seismic zone 4 (the most hazardous), without torsional effects and having an effective damping of 20%, should have a seismic joint less than 400 mm between the isolated and non-isolated parts. If the same building is located in seismic zone 3, the seismic joint could be less than 300 mm, and for seismic zone 2, it could be less than 250 mm.

Fig. 6 Displacement spectra according to the Peruvian seismic code (2016)

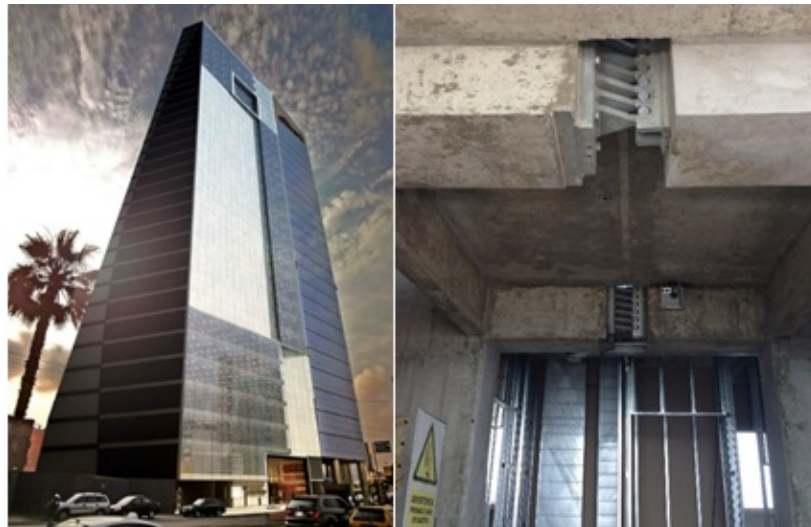
Some of the most representative new buildings with energy dissipation systems in Perú are as follows. The “Barlovento Tower” is a new office building with 31 stories and 9 basements, designed with 156 hysteretic dampers TADAS, located between coupling beams that connect the structural walls of the elevators (Fig. 7). The construction of this building ended in 2015. Till now, this is the tallest building in Peru having an energy dissipation system. Also, the “Orquídeas Tower” is another office building, with 27 stories and 10 basements that finished its construction by the end of 2015. The design included 94 hysteretic dampers TADAS, in locations and distribution similar to the Barlovento tower (Fig. 8).

Fig. 7 “Barlovento Tower” building in Lima, Peru

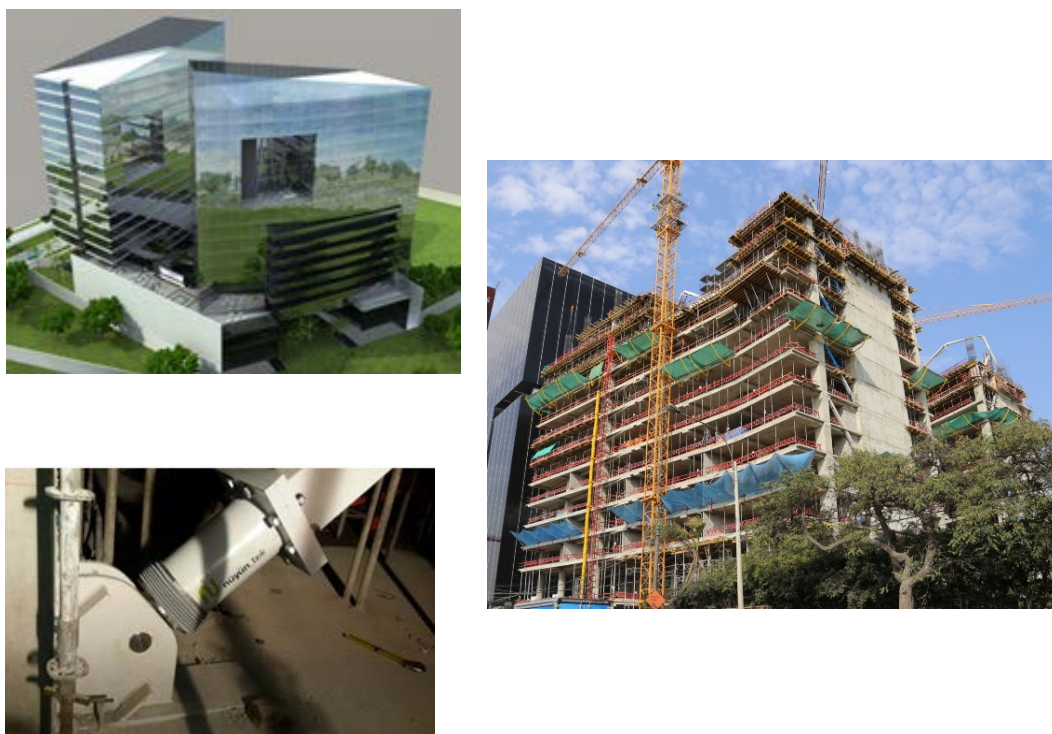
Regarding seismic energy dissipation devices in Peru, the “Panorama Business Center” is an office building that has a singular role (Fig. 9). The project consists in two building towers of 20 stories each, and 8 common basement levels. This was the first project having viscous dampers, featuring 39 of such devices in each tower. The construction started in 2012, and finished in 2015. There were strict tolerances in the fabrication and construction of the steel structural elements holding the energy dissipation devices, which enforced the local factories to improve their control process in order to handle the small installation tolerances.

Fig. 9 “Panorama business center” tower buildings in Lima, Peru
