## EXPERIMENTAL STUDY ON TRADITIONAL ASSAM-TYPE WOODEN HOUSE FOR SEISMIC ASSESSMENT

### Abstract

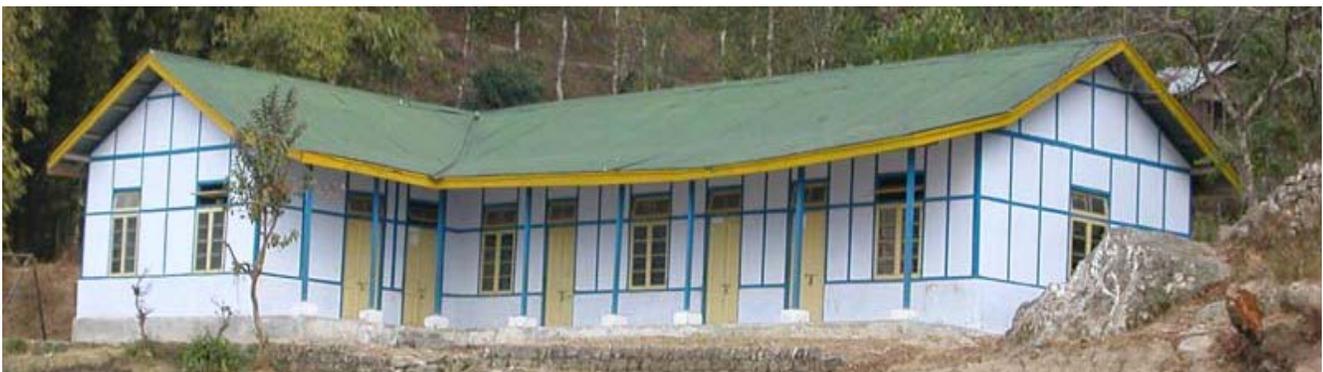
Fig. 1 – A typical Assam-type house [10]

Assam-type houses are one of the very few housing systems in India that have performed exceptionally well during past earthquakes compared to other popular structural systems, such as, reinforced concrete frame buildings and masonry buildings. Due to the historical high seismicity of the North-Eastern region of India, the local people have developed a unique housing system in terms of both its construction technique and the material used in the structural components. This type of construction has been in practice for many decades, and is mostly seen in the North-Eastern part of India, where the local people mostly use the local resources in construction of such houses. This makes Assam-type houses easy to construct, maintain, and an economical housing construction typology. The walls of Assam-type houses are made of Ikra (locally available reed found in river beds) or bamboo mesh material that makes it light weight due to which it does not require extensive foundations, and therefore, can be constructed in varied geotechnical conditions. It has excellent ability to withstand seismic events which has been proven in past earthquakes [9, 10, 11]. Also, these walls have good thermal and acoustic qualities. This type of construction does not require commercially processed materials or a skilled labour force; rather unskilled local labour can conveniently construct an Assam-type house. A typical Assam-type house is shown in Fig.1 [10].

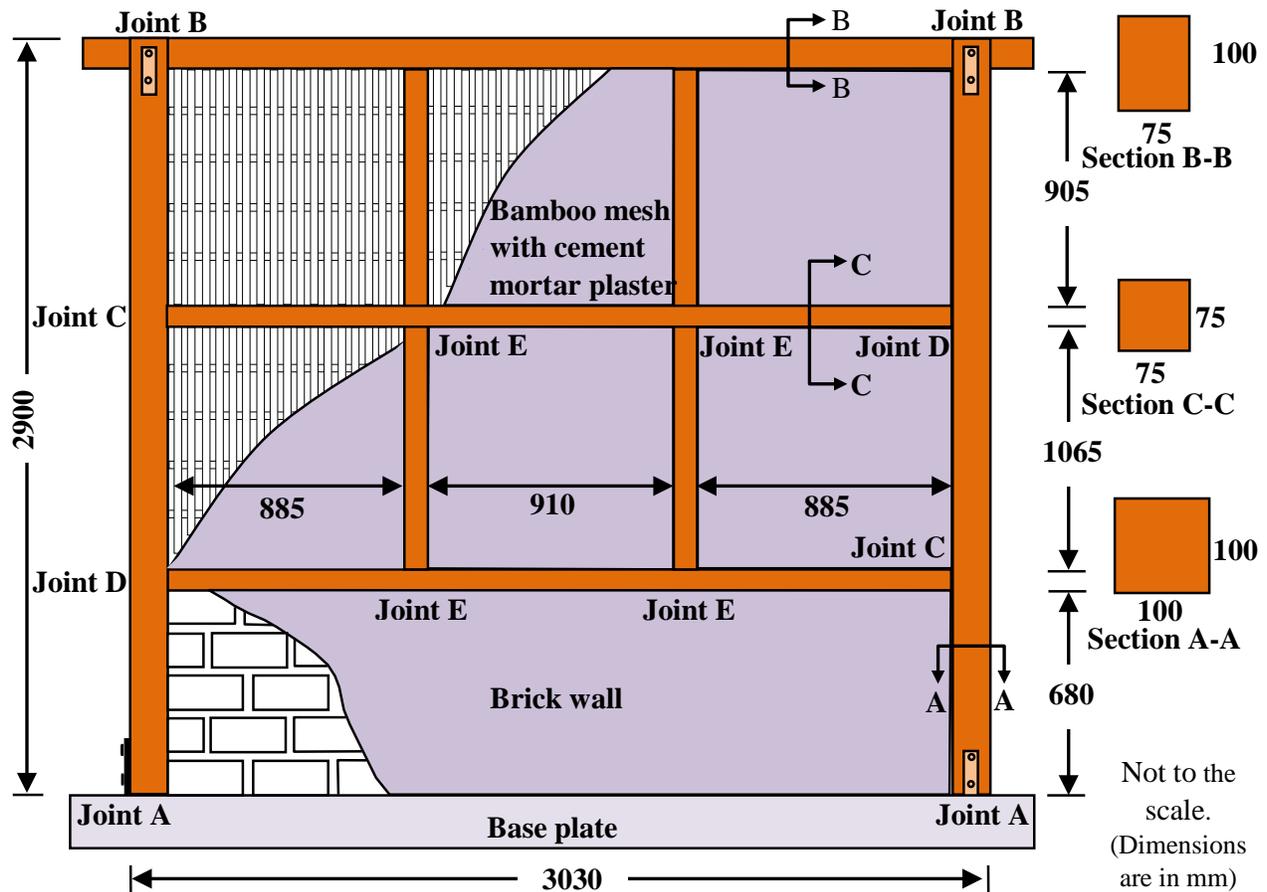
Fig. 2 – Details of member sizes and types of connections used in Assam-type frame specimens

In the present study, a 3 m × 3 m full scale Assam-type house is considered. Before construction of full scale specimen, a wall (2-D frame) of the full scale specimen was constructed. The wall specimen was fully infilled 2-D frame with masonry wall below sill and ikra wall without opening above sill (Frame 2). Besides this specimen, one 2-D frame specimen was also constructed which has masonry wall below sill and no ikra wall above sill (Frame 1). This frame was constructed to understand the influence presence of Ikra wall in overall lateral load response. The details of the tested 2D frames are shown in Table 1. The details of the frame dimensions, section sizes and location of different types of joints in both specimens are shown in Fig.2.

The connections between each vertical post and the concrete pillars are achieved using two L-clamps and steel bolts as shown in Fig. 3(a). These connections resist load in the direction of the clamps and allow rotation in the other direction. The orientation of L-clamps changes at various post locations (Fig. 2). At the top of main post, wall plate is inserted through the open mortise and tenon joint as shown in Fig. 3(b). The connection is also known as tongue and fork joints or Bridle joint. The tongue part is bolted with the main post using one bolt at the center of the joint, and in order to reduce the sway due to flexible joints, this connection is extended with the help of a steel plate and another bolt connecting the main post with the steel plate as shown in Fig. 3(b). The intermediate vertical and horizontal studs are placed at a spacing of about 800-900 mm. At one end, the connection is mortise and tenon joint (Fig. 3c) and at the other end the horizontal stud rests on the shear key type of arrangement as shown in Fig. 3(d). For inserting the vertical bamboo meshing and vertical intermediate studs, grooves of size 5 mm width and depth 15 mm are made along the length of the horizontal studs (Fig. 3e). The vertical studs are toothed on both sides so that they can fit into the groove of the horizontal stud (Fig. 3e). Single nail is driven in all the connections between vertical and horizontal stud members of the wooden frame. Brick masonry of thickness of about 75 mm is used as infill up to sill level, and above sill level locally available bamboo mesh of thickness of about 45 mm is used as infill. For out of plane stability of masonry walls, two long nails are provided in the mortar joint which are driven in each main post so that the masonry wall should not fall out of the plane.

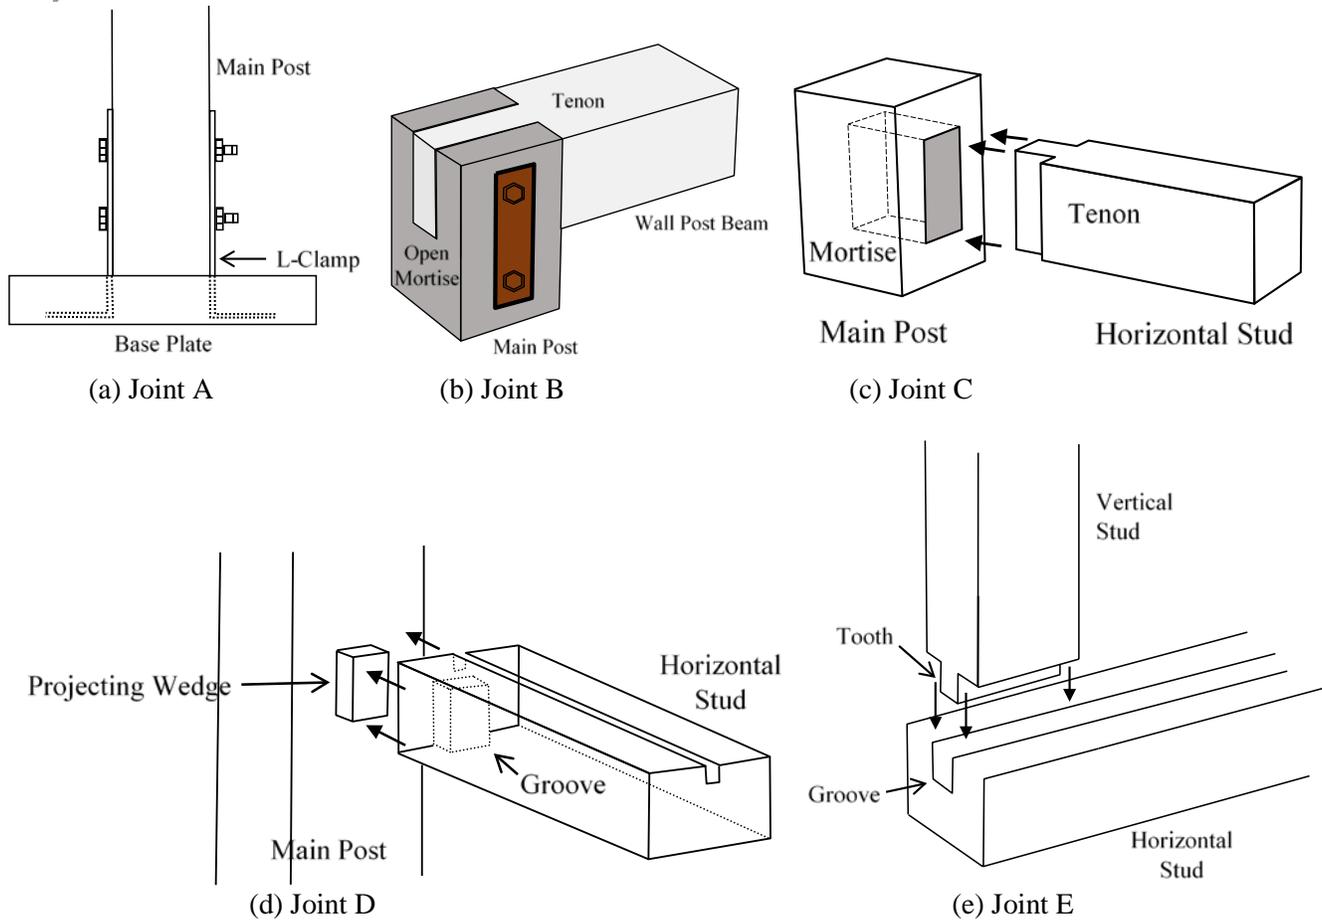
Fig. 3 – Details of various connections between different members of the frame (location shown in Fig. 2)

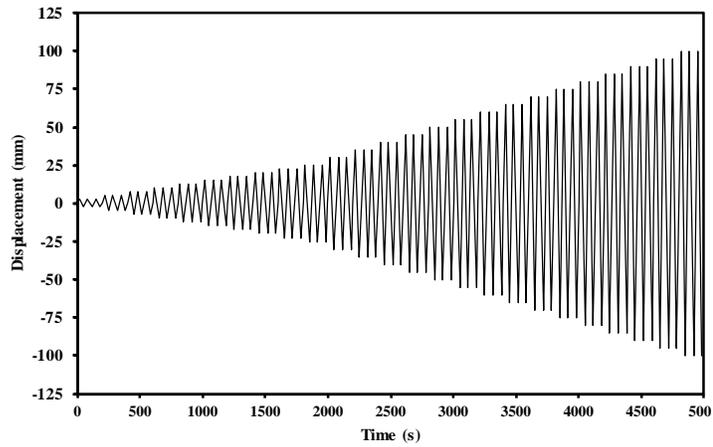
Fig. 4 – Testing program for all specimens

Servo controlled hydraulic actuators of 250 kN load capacity and a stroke length of  $\pm 250$  mm was used to apply slow cyclic lateral load followed by monotonic loads over the specimens. The experimental procedure followed in testing was same for all the specimens and the displacement history is shown in Fig. 4. Three cycles of each displacement level were applied and the response was recorded using a data acquisition system. The displacement was increased by 2.5 mm after every displacement cycle up to 25 mm, and by 5 mm thereafter with the frequency of each cycle being 0.015 Hz. Maximum lateral load resistance of the specimens is reported in both push (-) and pull (+) directions.

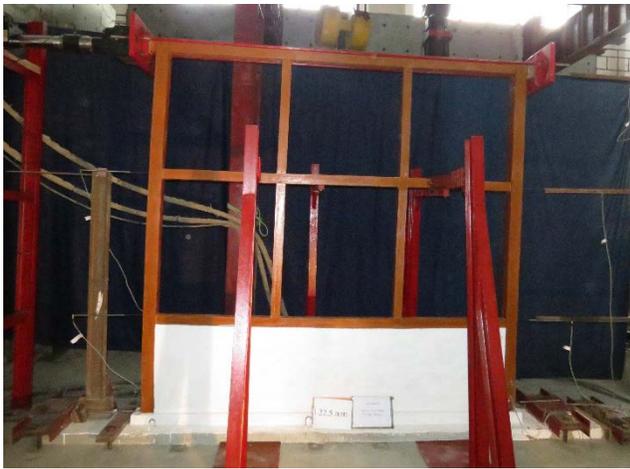
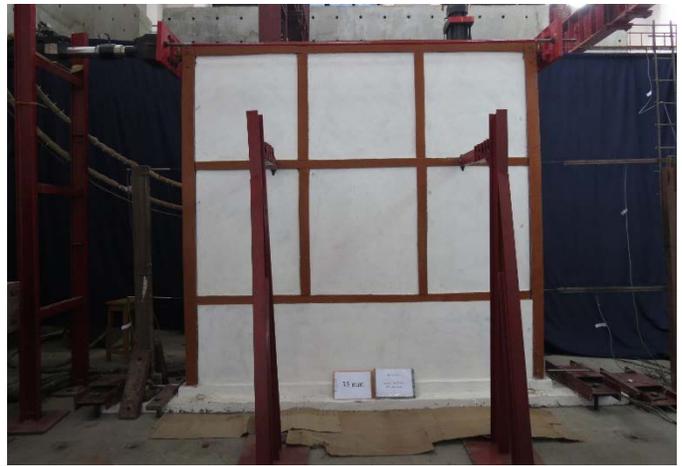
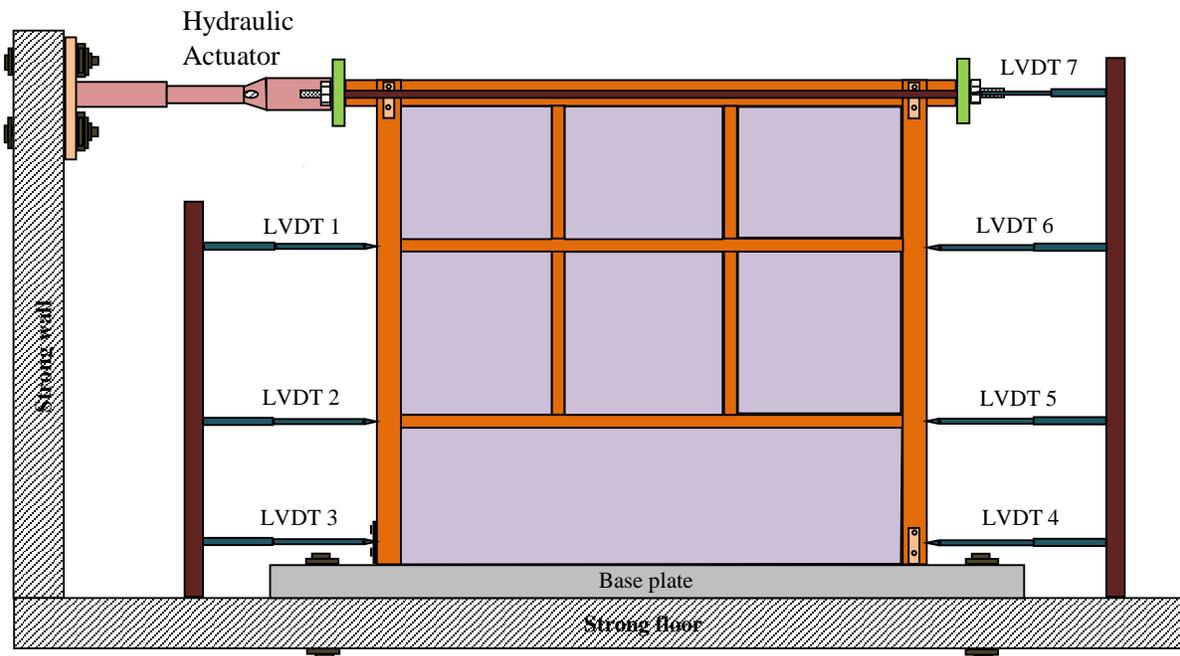
Fig. 5 – Details of experimental test set up: (a) Test set up of Frame 1, (b) Test set up of Frame 2, (c) Sensor locations in the set up

The experimental test setup for testing of the specimens in the laboratory is shown in Fig. 5. The main posts and masonry wall of the test specimens were supported by concrete slab (Fig. 5) and the concrete slab was fixed with the strong floor with the help of the nut and bolts. To prevent the out of plane movement of the specimens during in plane loading, lateral supports with roller bearing arrangement were provided in both sides of the specimens as shown in Fig. 5(a) and Fig. 5(b). The main lateral response of the specimens were recorded by load cell and displacement transducer in the hydraulic actuator. To record the lateral displacements at different levels of the specimens, LVDTs (linear varying displacement transducers) were used as shown in Fig. 5(c).

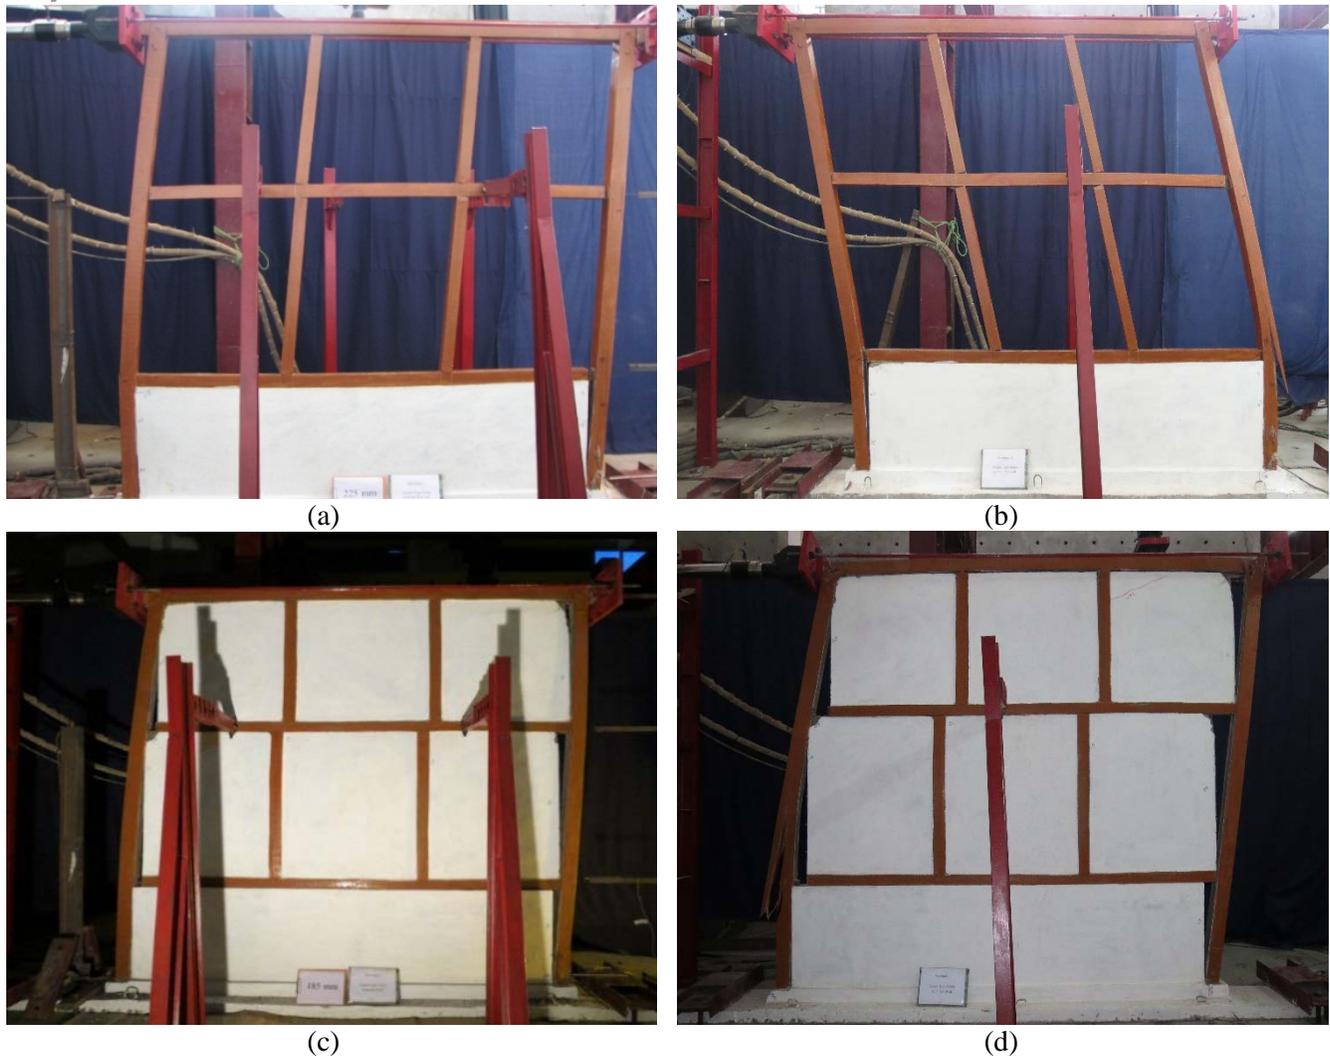
Fig. 6 – Assam-type housing frame wall tested specimens: (a) Frame 1 during cyclic loading, (b) Frame 1 at the end of monotonic loading, (c) Frame 2 during cyclic loading, and (d) Frame 2 at the end of monotonic loading

The common behavior observed during the testing are summarized here. Both the specimens were first subjected to a cyclic loading up to a lateral displacement of  $\pm 250$  mm. Since failure of the specimens was not observed even up to a lateral displacement of 250 mm, the damaged specimens were subjected to a monotonic displacement controlled loading for another 250 mm. Fig. 6 shows behavior of both tested frame specimens during cyclic testing and after monotonic testing. When horizontal displacement was imparted to the frames, the single nail connection between the horizontal and the vertical studs loosened, and at higher drifts, the nails pulled out from the joints. As shown in Fig. 2, the connection of the horizontal studs with the main post is such that if one side is mortise and tenon joint then the other side is open grooved which rests on a small wooden projection in the main post. Thus, such connections in the horizontal studs make the frame more flexible. Similarly, the connections between vertical and horizontal studs are also flexible as the joints are tooth and groove joint, and at higher drift, the vertical members slide in the groove of horizontal stud as shown in Fig. 6. Due to this, differential movement of wall panels was observed above and below the lintel stud level without damage in wall panels (Figs. 6c and 6d).

Though internal member joints were loosened during the tests, no major damage occurred in structural members during cyclic testing. Since the wooden posts were neither inserted in the foundation nor fixed on any wooden member, the damage in main joints are unlikely contrary to the damages in the main joints of other traditional frames [1,2,7] which resulted in very high lateral drift and ductility. The main post connections in the frame allow rotation in one direction whereas restrict in the other direction. Due to the difference in support conditions of the main post joints, the deformation profile of both the posts were different under the same lateral load. Joints of the main framing members of all the specimens were fully intact during the entire testing. At a very high lateral drift level (4.74% - 4.9%), minor flexural cracks at sill level and lintel level were observed in the main post of Frame 1 due to excessive bending at those locations as it can be seen in Fig. 6(a). In Frame 2, no major crack was observed in both the masonry wall as well as the Ikra walls during the entire 8.77% drift level in cyclic testing, because the excessive bending that was seen in Frame 1, reduced by the presence of ikra infill panel above the sill level. The major damage occurred in the framing members of Frame 1 and Frame 2 during the monotonic testing only. The damage locations in both the frames at the junction of main post and horizontal stud at sill level during monotonic testing are shown in Figs. 6b and 6d. Interestingly, the infill (ikra) panels were least damaged during the cyclic and monotonic loadings and some corner crushing of the plaster were observed in the specimen (Figs. 6c and 6d). Unlike Frame 1, the Ikra walls helped in maintaining the lateral stability of Frame 2 and reducing the excessive bending of main posts even under large lateral drifts; this resulted in the highly deformable lateral load behavior of Frame 2.

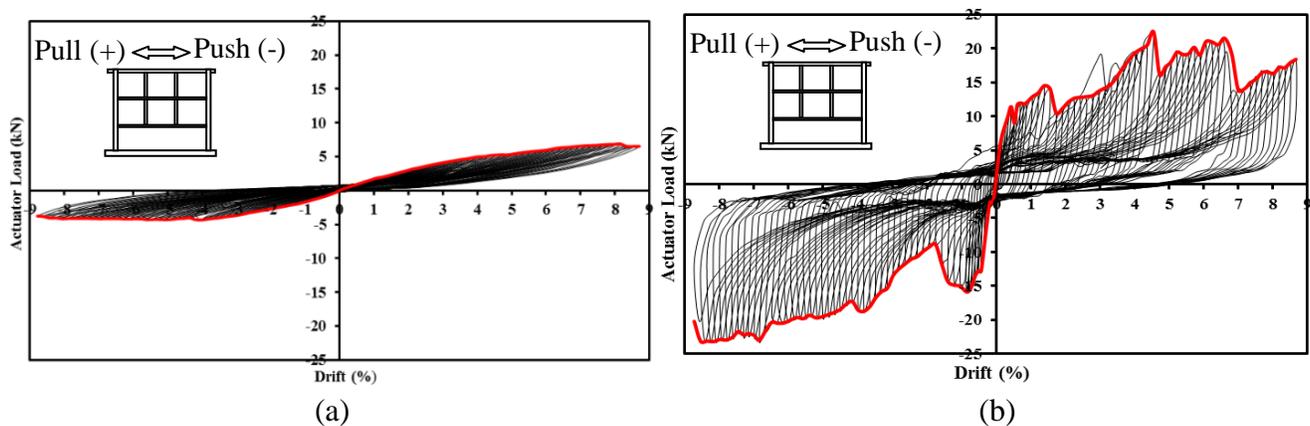
Fig. 7 – Hysteretic response and envelop curve of the tested specimens: (a) Frame 1, (b) Frame 2

The hysteresis loops of all the test specimens were more or less symmetrical in push and pull directions. The small difference was due to the different support and joint condition at the main post locations causing the force of resistance to be different in both directions. From Fig. 7(a), it can be seen that the lateral load on Frame 1 in both pull and push directions increases and then remains more or less constant till a lateral drift of about 8.7% without significant loss of strength. From Fig.7 (b), it can be seen that the hysteresis loops for Frame 2 are not uniform as compared to Frame 1 and several drops (and further increase) in lateral loading is observed at increasing lateral drift levels signifying the separation of joints between the Ikra walls and the surrounding frame with increasing lateral drift. The increase in strength is comparatively more gradual and uniform in pull direction. This may be due to lesser readjustment of joints in pull direction and better utilization of tensile property of the main framing member. Strain hardening is more prominently observed in the pull direction in Frame 2. There is also a significant stiffness degradation in the hysteresis loops in Frame 2. From the hysteresis curves in Fig. 7a and 7b, it is seen that Frame 1 and Frame 2 have hysteretic response significantly different from each other. This is because of the presence of infill (Ikra) wall in the internal panel in Frame 2 when compared to the bare frame structure of Frame 1.

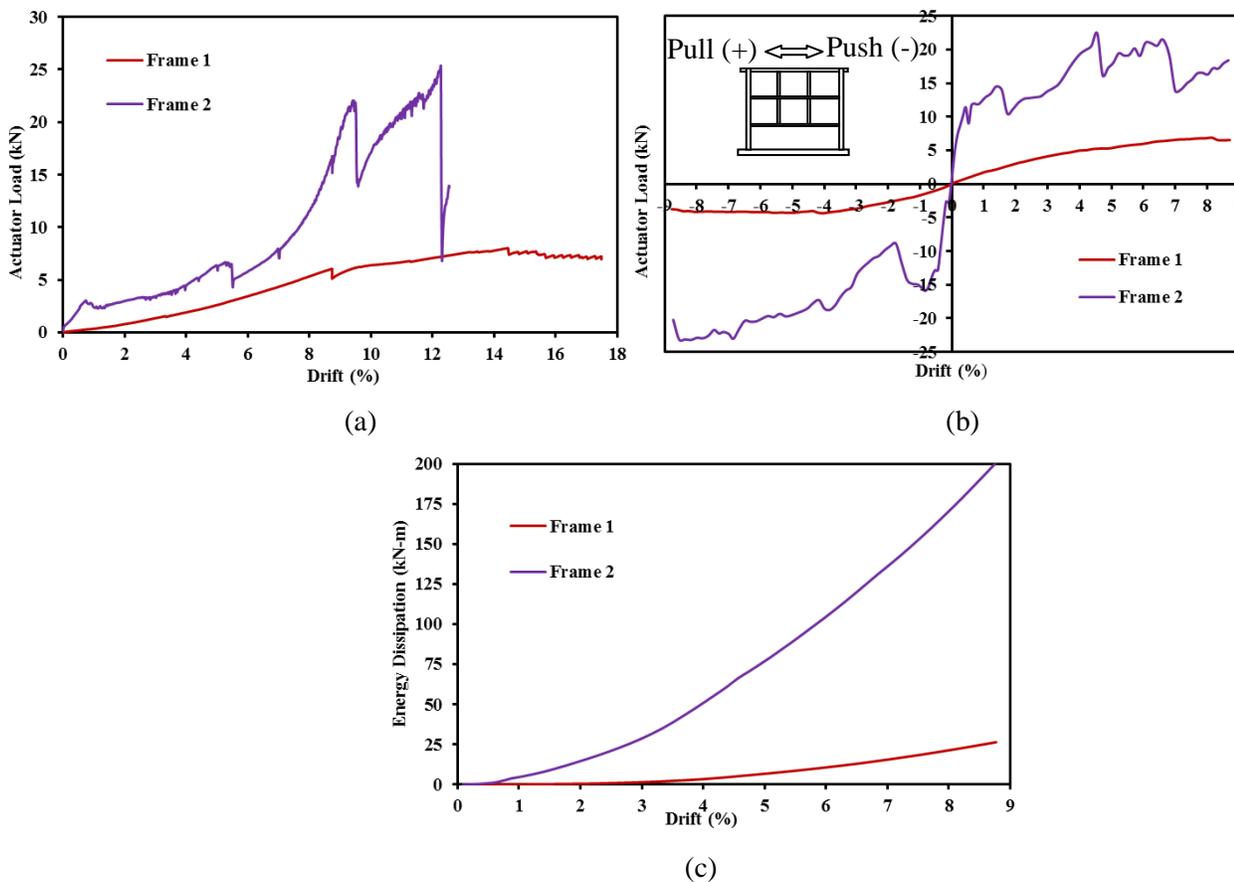
Fig. 8 – Comparisons of test results for both the specimens: (a) monotonic curves, (b) envelop curves, and (c) cumulative energy dissipation curves

As already discussed, the cyclic tests were followed by the monotonic tests on both frames. Fig. 8(a) shows the comparison of results of monotonic tests on two specimens. The monotonic tests were carried out after the 8.8% drift of cyclic testing and the tests were carried out till a maximum drift level of 17.5%. From the figure, it is clear that Frame 2 has the higher lateral load carrying capacity but it drops suddenly after 12.28% lateral drift due to the failure of the main post at the sill level of the specimen.

The plot between the lateral loads acting on the frame and the corresponding lateral displacement gives the envelope curve. Fig. 8(b) shows the comparison of envelop curves of the tested specimens. The lateral load carrying capacity and stiffness of the Frame 1 was obviously lesser that that of the Frame 2. Frame 2 has more lateral load carrying capacity due to presence of Ikra walls, which have significant influence on the overall lateral load behavior of Assam-type houses, unlike other traditional houses in which infill have little influence on the lateral strength [2, 12].

Energy dissipated is the area enclosed by the load-displacement hysteresis loops. The comparison of cumulative energy dissipation curve of both the tested specimens are shown in Fig. 8(c). From the figure, it is clear that Frame 2 showed very high energy dissipation as compared to Frame 1 which highlights the very high energy dissipation capability of the infill ikra panels in the Assam type houses.
