DEVELOPMENT OF FRAGILITY CURVES FOR THE EVALUATION OF A REINFORCEMENT TECHNIQUE ON URM PATRIMONIAL BUILDINGS IN CARACAS, VENEZUELA

F. Olbrich⁽¹⁾, A. Marinilli⁽²⁾

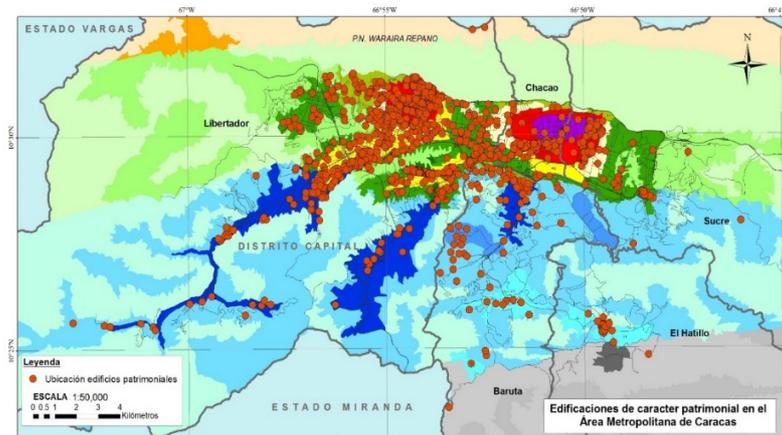
Fig. 1. Location of some Patrimonial Buildings of the AMC in the Microzoning Plane of Caracas [1].

According to the information provided by the “*Instituto del Patrimonio Cultural de Venezuela*” – IPC [1], in the downtown area of Caracas (AMC), approximately 1.311 patrimonial buildings have been identified (Fig. 1). A significant amount of these structures was built before the 20th Century, implementing an URM System, using Adobe, “*Tapia*” or mixed stone-masonry as construction materials. These buildings showed their vulnerability during the earthquakes of 1812 and 1967, both registering magnitudes of 7.1 Mw and 6.4 Mw respectively [2].

As part of the developments in the characterization of Venezuelan seismic hazard, in 2009, the Seismic Microzoning of Caracas City Project [2] was carried out under the supervision of the Venezuelan Foundation for Seismological Research (Funvisis). This project allowed a detailed characterization of the seismic hazard in the Caracas valley, using specific ground and topographic parameters (Fig. 1).

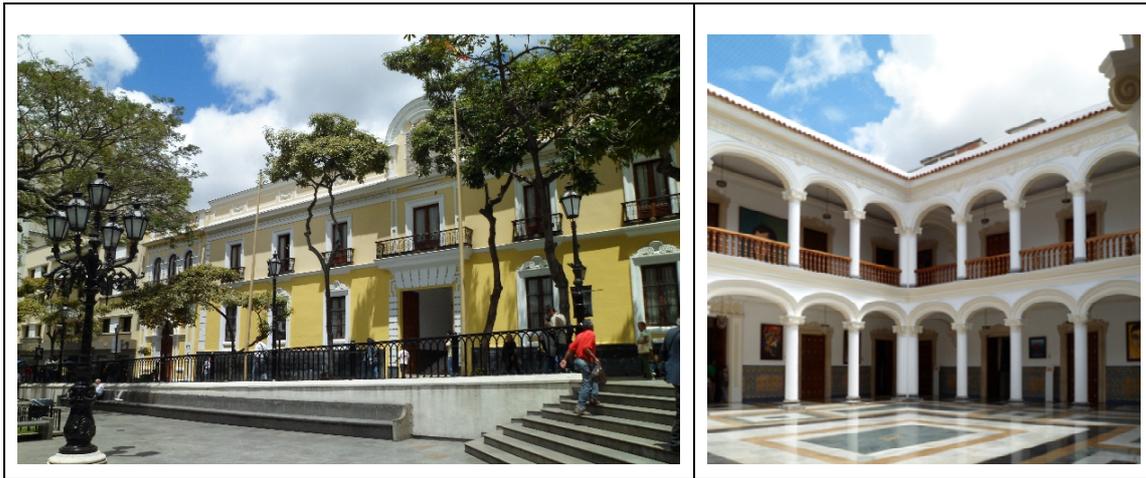
Fig. 2. Casa Amarilla “Antonio José de Sucre”: Facade (left) and Central courtyard (right).

This structure consists of a URM building built in 1596. It has suffered several interventions since then and it was damaged due to seismic events and fire. Since the beginning of the 20th Century and until now, it was adopted as the seat of The Venezuelan Chancellery. It presents a quadrangular plant with two level of 5.00 m high each one and its primary access leads to the central courtyard. The courtyard is delimited by arcades supported by circular columns. The corridors communicate different meeting rooms and departments of the first and second level (Fig. 2). The ground plan of the building presents an area of 1727.52 m², with 36.6 m width and 47.2 m length.

The URM walls are made of masonry bricks and in some areas by mixed stone-masonry (Fig. 3). Their thickness varies between a minimum of 50 cm and a maximum of 120 cm. There are 20 masonry circular columns with approximately 25 cm diameter around the courtyard and on both levels (Fig. 2). Concrete slabs reinforced with zen-zen steel meshes form part of the floor and roof system. The slabs rest over steel profiles that are directly supported on the structural walls.

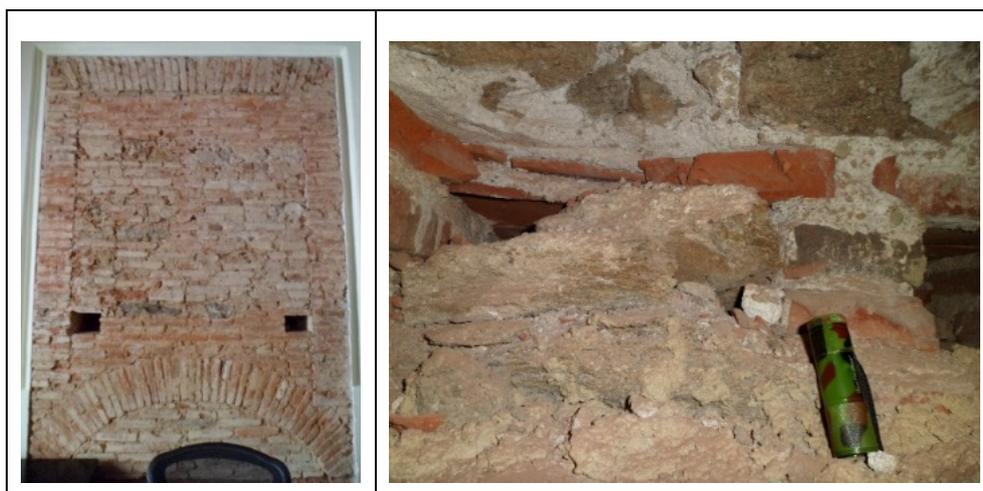
Fig. 3. Structural materials.

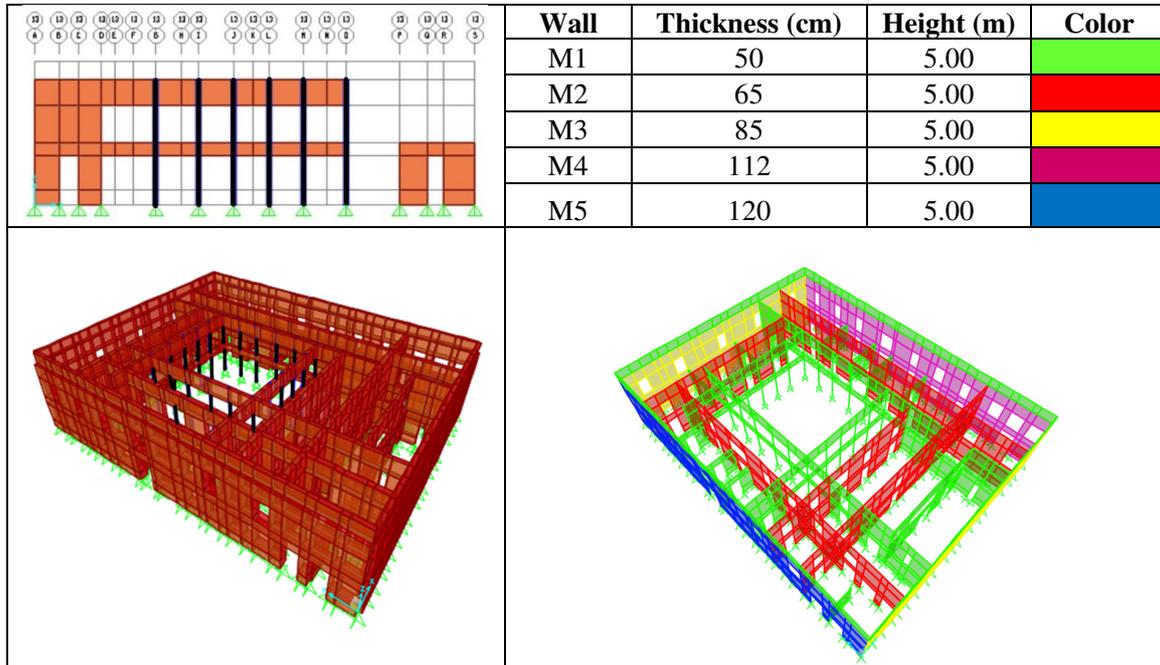
Fig. 4. Characteristics and distribution of the walls in the model.

The floor and roof system have an approximate rigid diaphragm behavior. Therefore, a diaphragm-constrain was assigned to all nodes contained in the respective planes. In total, 1200 Shell elements related to the URM were defined. Additionally, 40 circular columns were set trough frame elements (Fig. 4). The mean values of the material mechanical properties, as well as their coefficients of variation (COV), have been obtained from bibliographic resources [4], [5] and are defined in the Table 1.

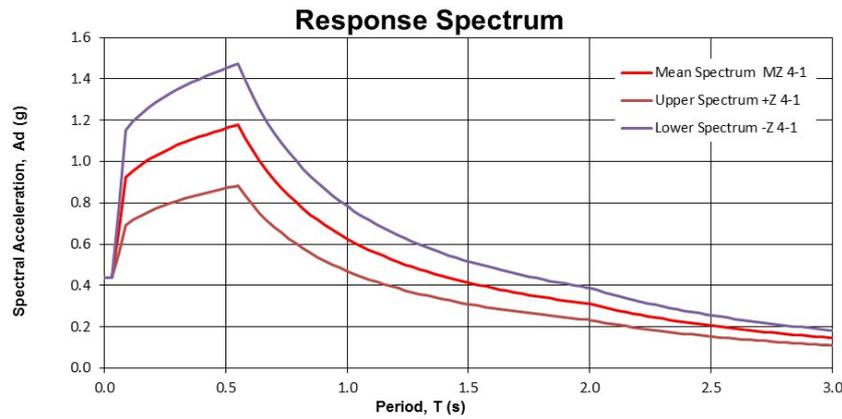
Fig. 5. Response spectrum for microzone 4-1 [2].

The design spectrum used in the estimation of seismic demands (Fig. 5), was defined according to the Caracas Seismic Microzoning Plan [2]. The building is located in the microzone 4-1 whose characteristics are shown in Table 3. Due to its patrimonial classification, the building belongs to the group A of the Venezuelan building code COVENIN 1756 [7], which attributes it an importance factor $\alpha = 1.30$. For analysis purposes, it was considered a response reduction factor $R = 1.00$ and a critical damping fraction $\zeta = 5\%$. Additionally, to represent the variation

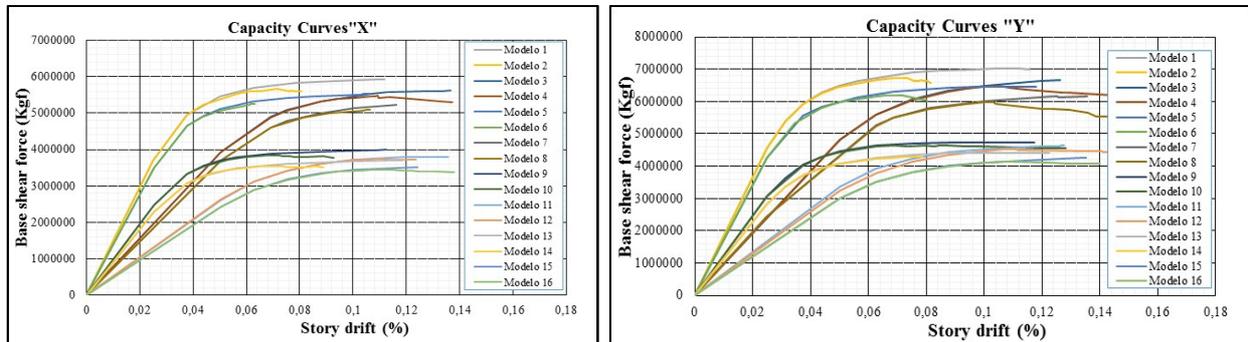
Fig. 6. Capacity curves: **a (left)**: direction “X”; **b (right)**: direction “Y”.

The capacity curves in the direction "X" and "Y" (Fig. 6a-b) were obtained after the calibration process of the analysis tool. The reference axes are oriented so that the direction of analysis "X" corresponds to the minor dimension in plant (east- west) and the direction "Y" to the larger plan (north- south).

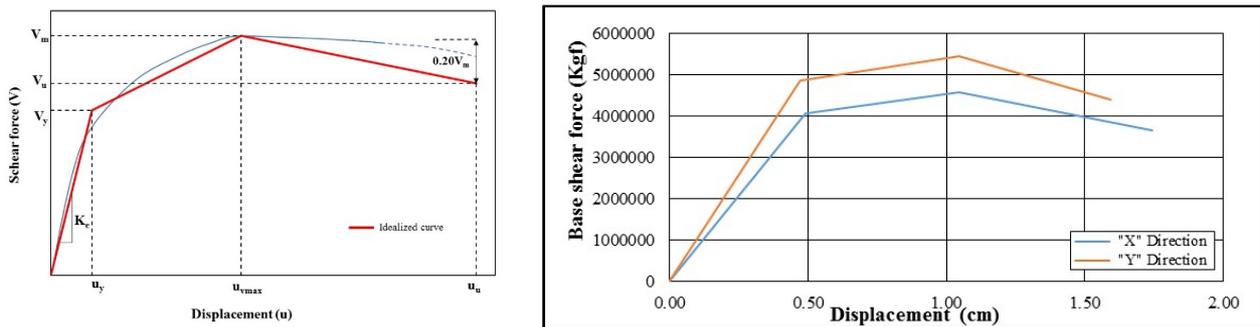
Fig. 7. **a (left)**: trilinear idealization; **b (right)**: average capacity curves.

Subsequently, the capacity curves were fitted with three (3) linear segments curve (Fig. 7a), according to the recommendations of the ASCE/SEI-41 code and [11]. The results of the average capacity fitted curves in the two analysis’s direction are presented in Fig. 7b and Table 4. The Maximum strength values exceed 4500 t and 5500 t in direction "X" and "Y", respectively. The initial stiffness in the direction "X" exceeded 8000 t /cm and in "Y" 10000 t/cm.

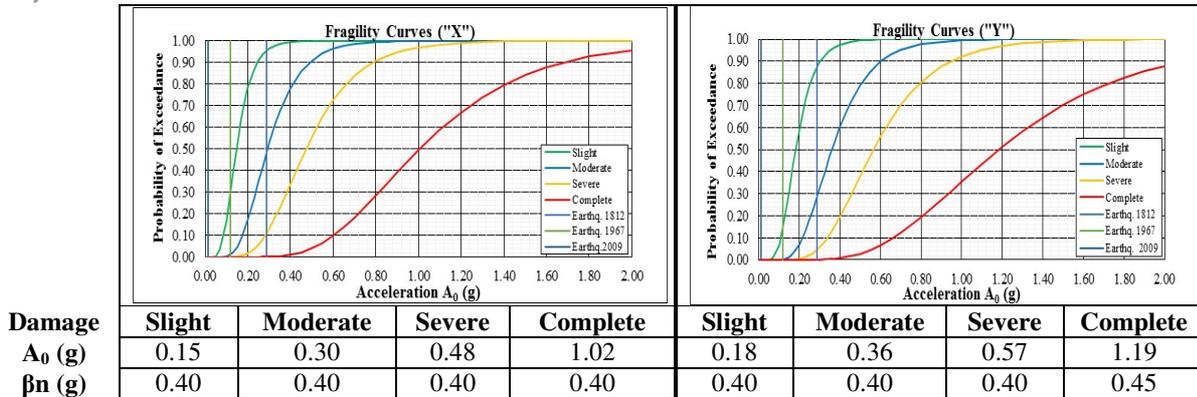
Fig. 8. Fragility curves of building’s actual conditions: a (left): direction “X”; b (right): direction “Y”.

Figure 8a-b represents the fragility curves in "X" and "Y" respectively, as well as the median (A_0) and deviation (β_n) values for both directions.

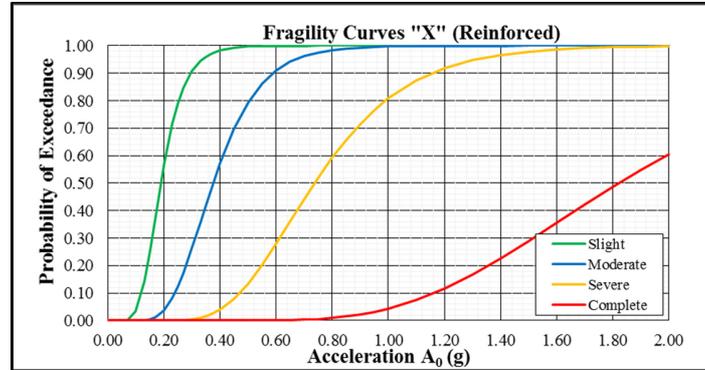
Damage	Slight	Moderate	Severe	Complete
A_0 (g)	0.19	0.38	0.74	1.82
β_n (g)	0.35	0.35	0.35	0.35

Fig. 9. Fragility curves of building's reinforced condition (direction "X")

marginally the capacity curves (less than 6 %). In Fig. 9, the fragility curves in direction "X" of the reinforced model are presented.

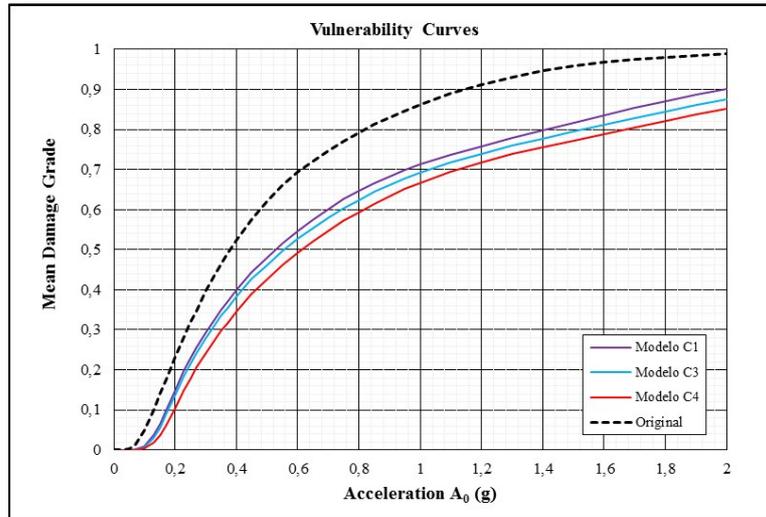
Fig. 10. Vulnerability curves for actual building's conditions and studied steel amounts.

Finally, to study their influence on the reduction of the seismic risk of the building, increments of steel amounts were performed. The comparison between vulnerability curves of the original models and the reinforced models in function of steel amounts are shown in Fig. 10, where $C1 = 0.62$, $C3 = 1.26$ and $C4 = 2.52$, in cm^2/m .
