## FULL-SCALE SEISMIC TESTING OF A BUILDING CONSTRUCTED WITH AAC PANELS

### Abstract

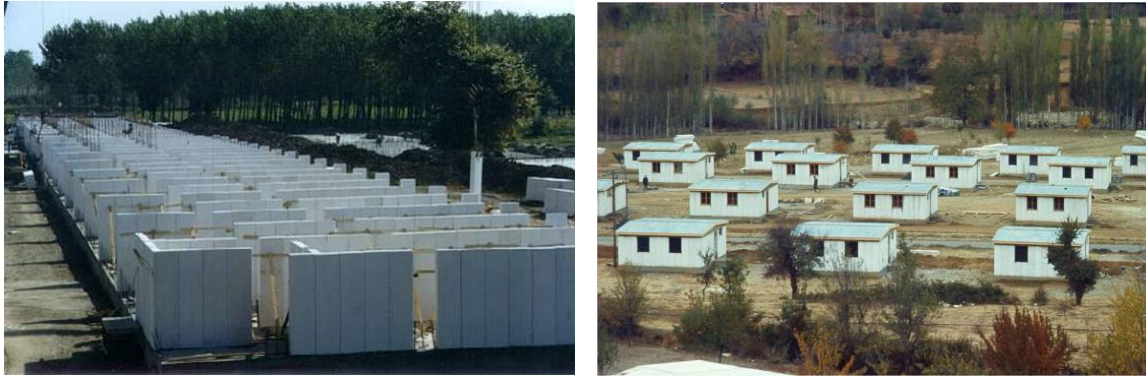
Fig. 2 – Post-earthquake housing units constructed with AAC reinforced panels [5]

buildings are still being used by their residents. Moreover, structures constructed with AAC reinforced panels were used as shelter houses for earthquake victims, as shown in Fig. 2 [5].

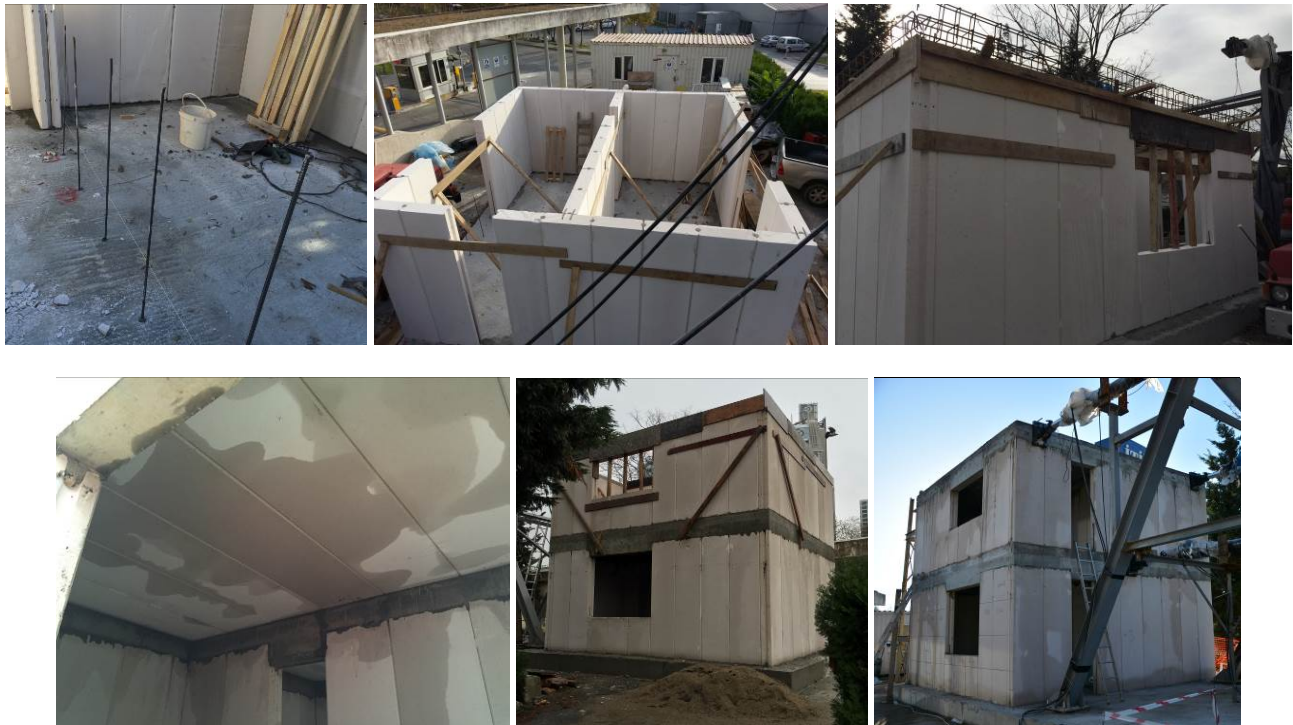
Fig. 6– Construction of the test building

Wall, floor and roof panels of the tested building were produced in Turk Ytong Inc. Pendik factory and transported to the test site available at the Istanbul Technical University Campus. The open air testing area was used before for other large-scale experiments, therefore, the 40 cm thick RC foundation was ready. Since the foundation was already available, the starter bars of the 10 mm diameter vertical panel joint reinforcements were anchored to the foundation by using epoxy bonding with an embedment length of 20 cm. The vertical wall panels were erected over a 2 cm thick cement mortar with the help of a mobile crane. Following the placement of vertical wall panels, the vertical panel reinforcements were placed (using an overlap length of 100 cm with the starter bars) and a cement grout with an approximate compressive strength of 10 MPa was poured into the joints. Then, the reinforced concrete bond beams (with cross-section dimensions of 20 cm × 35 cm at first floor level and 20 cm × 30 cm at roof level) over the vertical panels were cast by using a concrete mix with a mean compressive strength of 30 MPa. Both the panel joint and bond beam reinforcements were deformed bars with a specified yield strength of 420 MPa. The floor panels were placed over the bond beams and the 10 mm diameter joint reinforcements placed between the floor panels were anchored to the bond beams by using a cement based mortar. Lintels above the door and windows openings were integrated to the bond beams and total cross section height of the bond beams above doors and windows was 55 cm. Then, the similar procedures were followed for

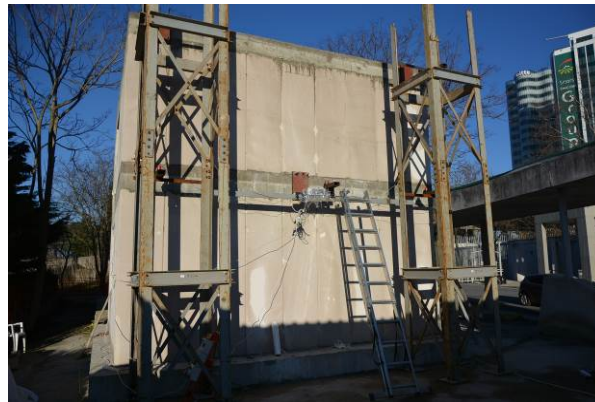
Fig. 8 – Reference frames for measuring the floor level displacements

The measurement system consisted of a 64-channel data logger, potentiometers and the internal load and displacement transducers actuators. The displacements used for controlling the loading pattern and out-of-plane rotations were measured at the floor levels by using wire gauges, mounted on rigid steel-construction towers independent from the test building (Fig 8). Displacement measurement plan for walls was made as to observe potential rocking and sliding response. Due to symmetry in loading direction (west to east), displacement measurements were basically carried out on the north wall and mid-wall panels of the both stories. As seen in Fig. 9, depending on the previous experience from the shear tests on AAC panel walls performed in the laboratory, linear potentiometers with 100 mm gage length were mounted on the two distant bottom corners of the panels. These potentiometers measured relative displacements between floors and panels. All wall panels were labelled in a systematic manner and in addition to the electronic measurements, crack widths and other damage indicators such as crushing, spalling or sliding were also manually registered and photographed.

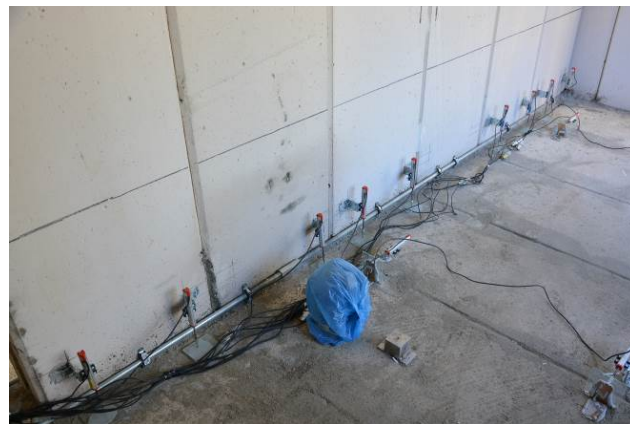
Fig. 9 – Measurement of the wall panel rocking

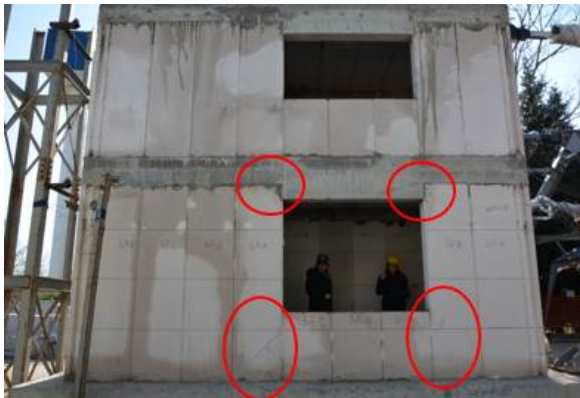
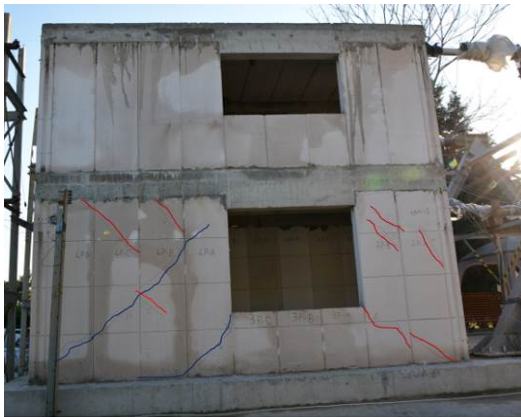
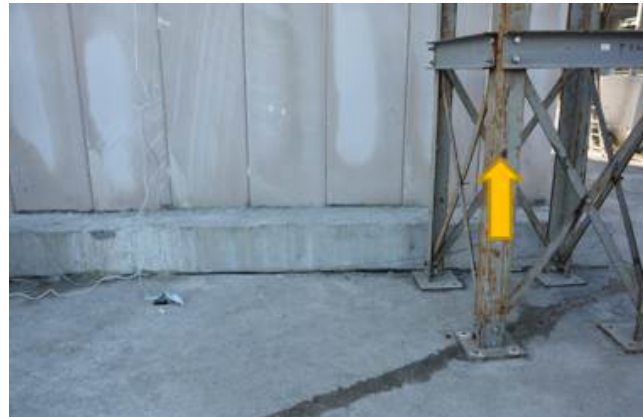
Fig. 10 – Evolution of damage

(a) 0.125% drift ratio

(b) 0.25% drift ratio

(c) 0.5% drift ratio

(d) 0.5% drift ratio

The damage was first seen as shear cracks at the corners of window openings of first story north and south walls (at 0.125% drift ratio, Fig. 10a). At about 0.25% drift ratio level, separation cracks initiated at the bottom of the first story wall panels (Fig. 10b) indicated that each of the panels were rocking. At 0.5% drift ratio, first shear cracks became visible on the first story four and six panel walls (Fig. 10c), widths of the panel bottom separation cracks increased and uplifting of the foundation in the pulling direction was observed (Fig. 10d). At about 0.75% drift ratio, number and width of shear cracks increased (Fig. 10e). Additionally, panel bottom separation cracks were observed at the east and west walls, which were subjected to out of plane loading (Fig. 10f). Although, shear cracks similar to northern and southern walls also occurred on the mid-wall, at about 1.0% drift ratio, the beginning of sliding over the foundation behavior could be observed. In the following cycles, the sliding of the wall panels above the foundation became apparently visible (Fig. 10h and Fig. 10i) and this sliding dominated the behavior. After drift ratio of 1.5%, six panel walls of mid-wall significantly separated from west and east walls due to sliding on the foundation. At drift ratio of 2%, the test was terminated due to extensive damage and significant strength loss. Although high levels of displacement cycles were achieved and extensive damages occurred on the load bearing walls of the building, no damage was observed in the AAC floor diaphragms.

- At early stages of the test, flexural behavior of panels dominated the structural response of the test building. When the drift ratio reached to 0.50% (at this drift ratio the building reaches to lateral load capacity, Fig. 11), shear damages became clearly visible (Fig. 10c). Between 0.5% drift ratio and 1.0% drift ratio, shear damages progressed (Fig. 10e). After 1.0% drift ratio, sliding failure of panels at bottom dominated the overall response of the test building (Fig. 10g-I and Fig. 11).

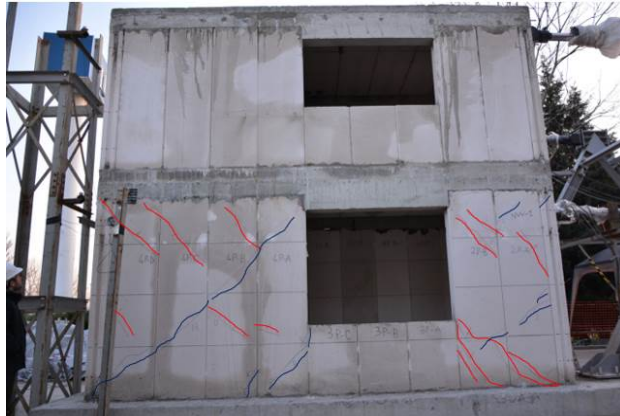
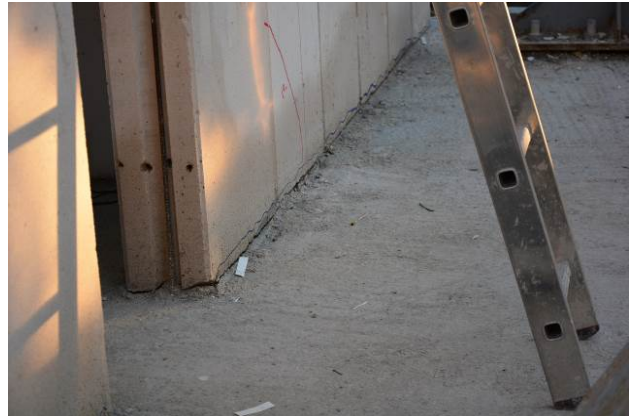
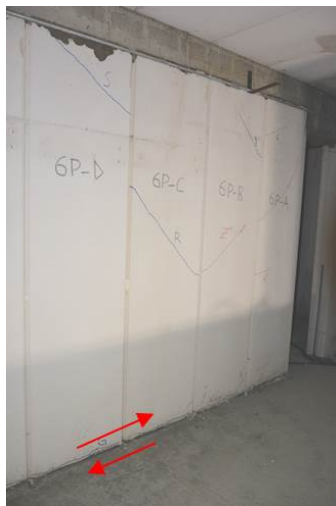
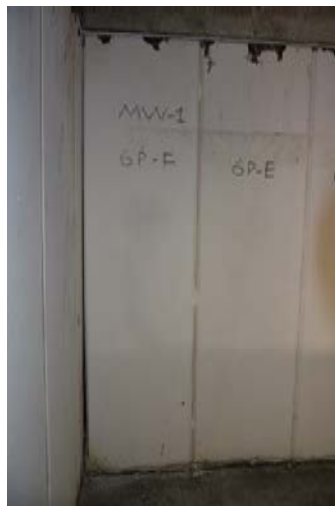
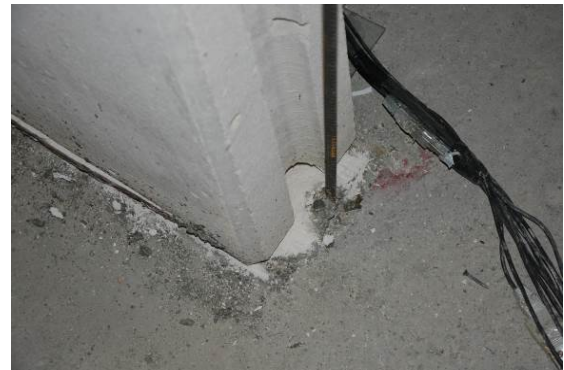
Fig. 10 – Evolution of damage (continued)

(e) 0.75% drift ratio

(f) 0.75% drift ratio

(g) 1.0% drift ratio

(h) 1.5% drift ratio

(i) 1.5% drift ratio

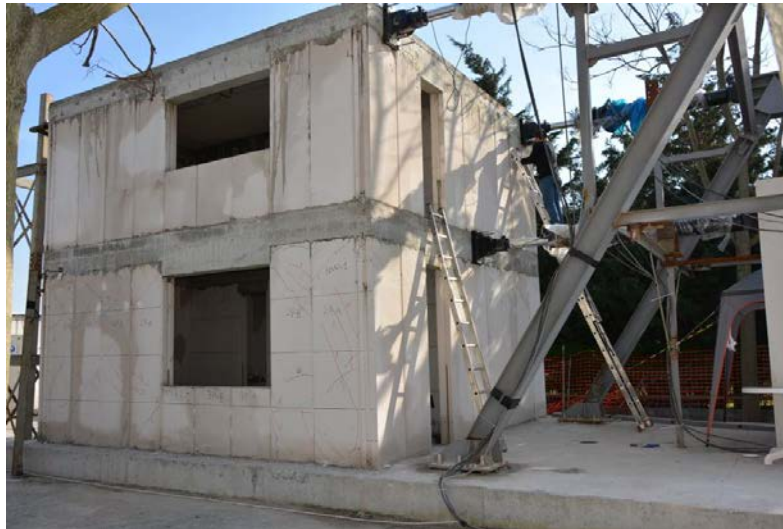
Fig. 12 – General view of the building after being tested to 2.0% drift ratio

Although the test building was loaded to a high level of lateral displacement, even after the 2.0% drift ratio the overall integrity of the structure was still maintained as seen in Fig. 12. After the test, most of the cracks were closed and only the slight dislocations of the panels were left. This indicates that, even after a major earthquake, the self-centering characteristic of the structural system can reduce the experienced damage.
