## Seismic Performance Evaluation based on Static Loading Tests of Timber Frame Structures with Large Hanging Walls and Full Walls

**Keywords:** Historical timber building; Hanging wall; seismic performance evaluation; Static loading test

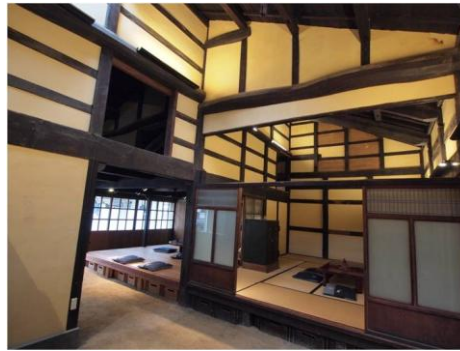
Fig. 1 – Example of structures with large hanging wall  
(Wakayama, Japan)

In Japan, there are a lot of traditional timber buildings. In our investigation of the traditional timber houses, the structures which consist of tall hanging walls and beams called *Sashigamoi* in Japanese were found. Fig. 1 shows an example of the structures with large hanging walls in the historical timber houses. Timber frame structures with hanging walls are very important factor to think of seismic safety of timber buildings because the timber frames with hanging walls can lead to collapse of the whole buildings by breakage of the columns at the joints of the lower end of the hanging walls.

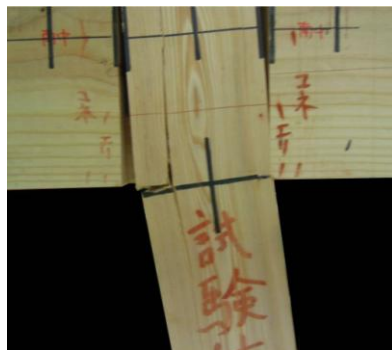
(a) Breakage of column  
(5P12-12-12f, Column Cl)

Fig. 10 – Examples of main damage

Fig. 9 shows the relationship of the restoring force  $P$  and the rotational angle  $R$  (restoring force characteristics) of each specimen, and breakage of each columns are shown in Table. 1. The test results of the two specimens of 2P12-12 and 4P12-12-12 are detailed in the previous paper [1]. There is little difference between the plus direction and the minus direction in the restoring force characteristics of each specimen. The main damage of the timber frames with large hanging walls were roughly classified into breakage of the columns at the height of lower end of the *Sashigamoi* and the damage of the mud-panels. Fig. 10 shows the examples of the main damage.

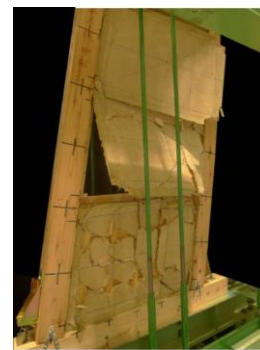
(b) Breakage of wall  
(5P12-12-12f, First story section)

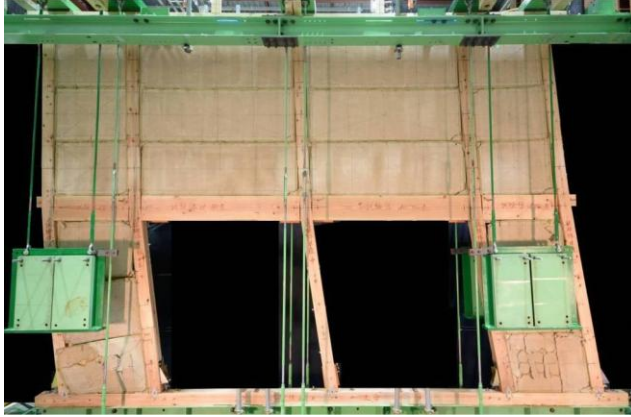
(a) Before collapse  
(First loop of  $R = 1/10\text{rad}$ )

Fig. 11 – Pictures of 6Pf12-12-12f during test

Fig. 11 shows pictures of 6Pf12-12-12f during the test about (a) before collapse and (b) after collapse. As shown in Fig. 9 (f), 6Pf12-12-12f had the restoring force  $P$  of about 20kN in the first loop of  $R = 1/10\text{rad}$  (refer to Fig. 11 (a)). However, the mud-panels in the first story section fell down and all the columns was fractured by bending at the joints one after the other in the second loop of  $R = 1/10\text{rad}$  (refer to Fig. 11 (b)). As a result, 6Pf12-12-12f lost the restoring force  $P$  suddenly and collapsed. It is considered as a factor that the shear force of the columns increase by breakage of the walls in the first story section. In the same way, by the columns broken at the joints after breakage of the walls in the first story section, the whole structure caused collapse in 5P12-12-12f and 6P12-12-12F.

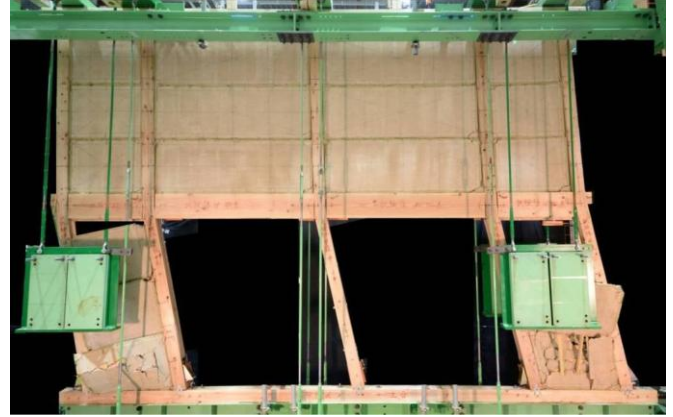
(b) After collapse  
(Second loop of  $R = 1/10\text{rad}$ )
