## SHEAR WALL TEST AND VERIFICATION OF ASEISMIC EFFECTS FOR UNIT 2 REACTOR BUILDING OF ONAGAWA NPP

The tendency of stiffness reduction due to small cracks generated by the 2011 off the Pacific coast of Tohoku Earthquake was recognized for Onagawa Unit 2 Reactor Building. This paper reports the outline of shear wall tests for seismic retrofit and the analysis results of examination of the aseismic effects by system identification with recursive least squares method for observation records.

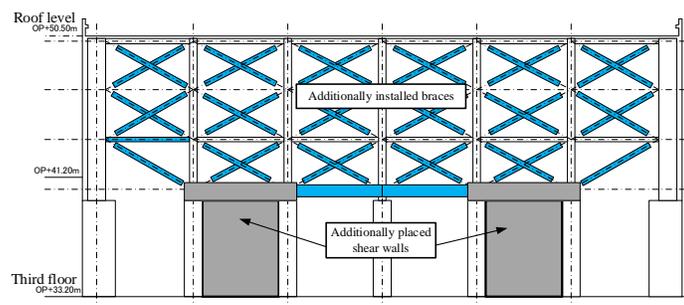
Fig.1 – Outline of additionally installed members (West wall)

reinforcing methods for RC construction shear walls are additionally placed between the SRC columns in the lower section and steel frame braces are installed on the S construction columns for the upper section as planned (Figure 1). In addition, in order to secure integrity with the existing base frames, it was planned that the shear walls to be additionally placed are joined to both side columns and the foundation section with post-construction anchors, and the SRC construction beams (partially S beams) are newly provided to the interface of the lower and upper sections.

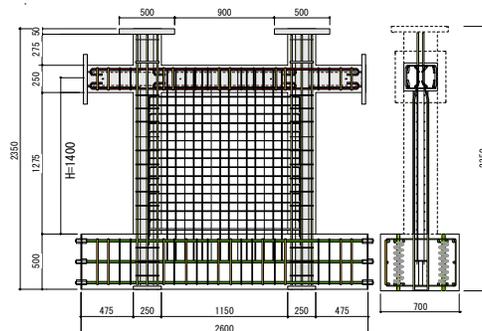
Fig. 2 – Dimensions and bar arrangement of test specimen

Figure 2 and Table 1 show the dimensions and the parameters of the test specimen, respectively. Concrete used for the test specimen is ordinary one with nominal strength of  $33.0 \text{ N/mm}^2$  and the maximum aggregate size of  $13.0 \text{ mm}$  with column span (center distance) and distance  $H$  from the top end of the stub to the force application core (hereafter  $H$ ) of  $1400 \text{ mm}$  each and with nearly square shaped walls. The cross-section of the steel reinforced concrete structure wall having built-in steel frames is  $300 \text{ mm} \times 250 \text{ mm}$ , and the shear wall has a thickness of  $120 \text{ mm}$  and wall rebars of  $2\text{-D6@80}$ .

The four test specimens consist of one integrally constructed specimen M (M100) and three specimens P (P100, P125 and P150) with the anchor rebar ratio of 1.00, 1.25, and 1.50 times the wall rebar ratio, respectively, and the beams and walls were post-constructed, and all specimens designed so that the shear fracture of wall

precedes. Furthermore, an adhesive type anchor capsule system was used for the post-installed anchors. Rebars of test specimens P100, P125 and P150 were assumed to be 2-D6@150, 2-D6@65 and 3-D6@70, respectively.

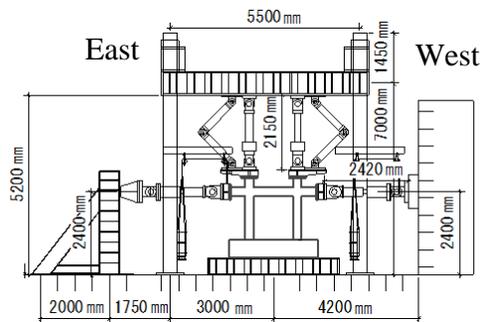
Fig. 3 – Force application equipment

Figures 3 and 4 show the force application equipment and the inflection point height, respectively. The test specimen was mounted on the force application equipment to which two hydraulic jacks for axial force and two of those for shear force were vertically and horizontally, respectively, installed to the steel frames, test bed, and reaction walls. The equipment was controlled by providing the test specimen with shear force using the right and left horizontal jacks and providing with return bending using the vertical jack so that the inflection point is located in the middle of  $H = 1400$  mm ( $H/2$ ).

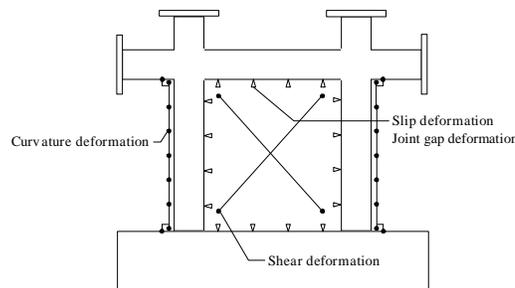
Fig. 5 – Displacement meter installation position

The load, deformation, and rebar stress of each part were measured using the test specimens, a load cell attached to the hydraulic jack, a displacement meter, and strain gauges. Figure 5 shows the installation of the displacement meter. The displacement between the layers and the deformation angle between them were obtained from the deformation of the whole base frame, the deformation of only post-constructed shear wall sections from the shear deformation, the bending deformation from curvature deformation, the integrity of skeleton from slip deformation and joint gap deformation, and the deformation component from the deformation ratio.

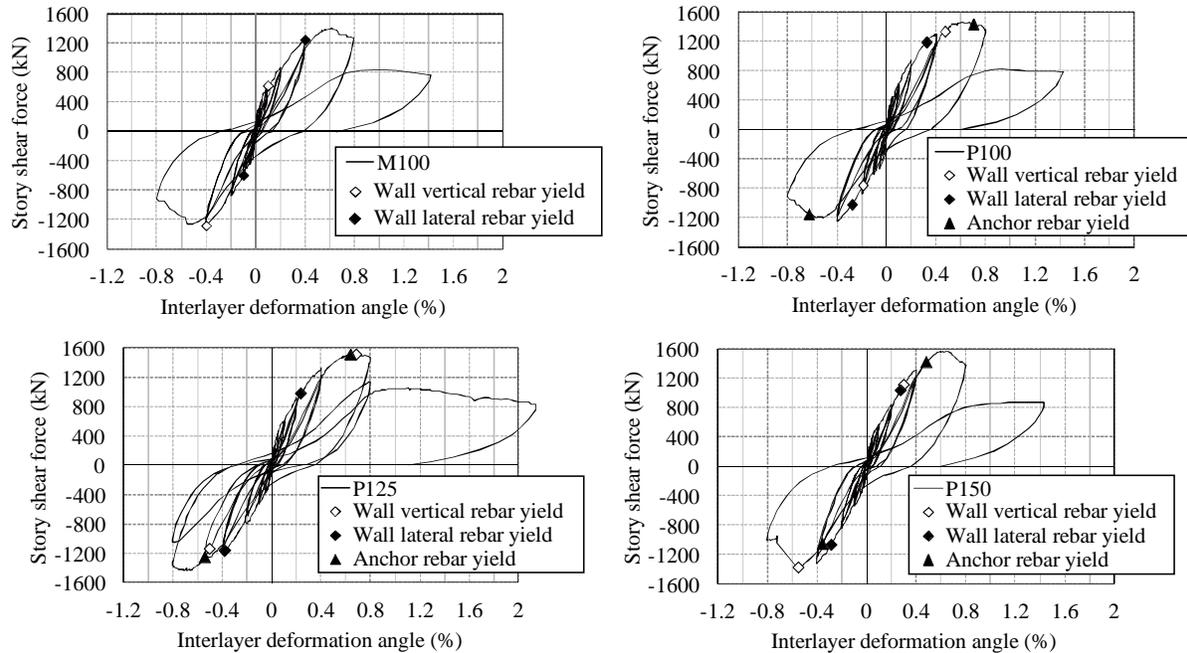
Fig. 6 – Load-deformation relation

Figure 6 and Photos 1 and 2 (results of M100 and P100 because almost same tendency was found among test specimens) show the relation between the load and the deformation and the final destruction properties, respectively.

The difference in the destruction properties between the test specimens was hardly found. The wall rebar yielded at 4/1000 rad cycle and the maximum yield strength appeared at around 6/1000 rad. The width of the maximum shear crack at that time was that of the crack generated diagonally to a wall plate. Although the anchor rebar of test specimen P yields at 8/1000 rad, the damage to the joint surface was hardly generated, and all the test specimens showed compression fracture of the wall plate. Since the difference in the maximum yield strength and the deformation performance between the integrally constructed test specimen and the post-construction specimen is hardly found in the case of large deformations and the maximum yield strengths of test specimens P125 and P150 are rather higher, it is not thought that the influence of the post-construction joint surface and the anchors is much greater at the time when the ultimate performance is exhibited.

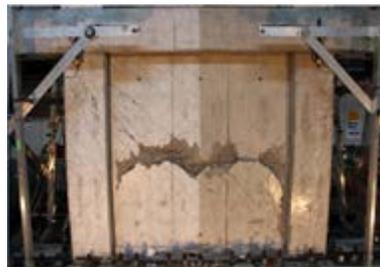
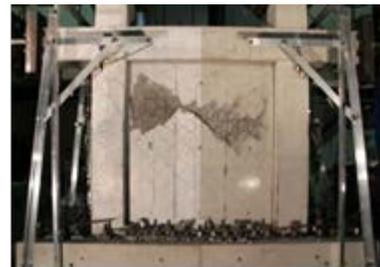
M100 test specimen

P100 test specimen

Photos 1 and 2 – Final fracture shape

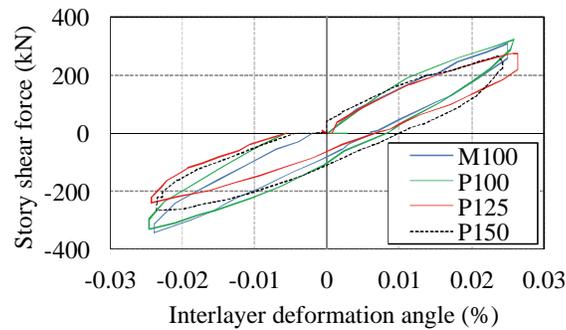
Fig. 7 – Initial stiffness

Figure 7 and Table 6 show the load-deformation relation up to at the time of 0.25/1000 rad and the initial stiffness values and the maximum yield force values, respectively. As for the initial stiffness, an approximate curve was obtained from each point of the measured data at 0.25/1000 rad cycle using the least squares method to make its slope. The initial stiffness of the integrally constructed test specimen is the highest and that of the post-construction specimen (up to 0.25/1000 rad) is slightly lower than the former. The stiffness at a small deformation is considered to be possibly affected by the joint surface or the post-construction anchors. However, the cause of the fact that the initial stiffness of test specimens P125 and P150 is lower than that of specimens M100 and P100 is not yet identified whether it is the difference of the amount of anchor rebar or the amount of initial cracking due to drying shrinkage.

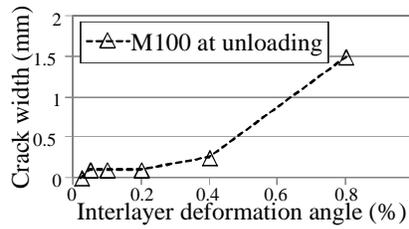
Fig. 8 – Crack width

Figure 8 shows the crack width in each cycle (shows the result of M100 because almost same tendency was found in all the test specimens). The maximum crack width of all the test specimens at unloading was about 0.2 mm even at 4/1000 rad, and the tendency that the crack width increases after reaching the maximum yield strength was revealed.

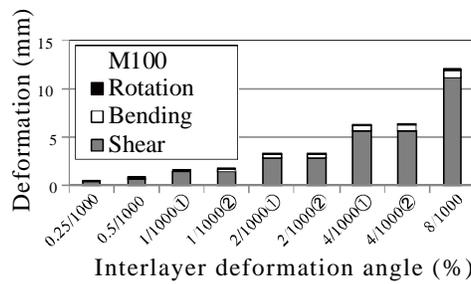
Fig. 9 – Degree of deformation in each cycle

Figure 9 shows deformation components (shows the result of M100 because almost same tendency was found in all the test specimens). In all test specimens, the shear deformation component occupied 90% or more.

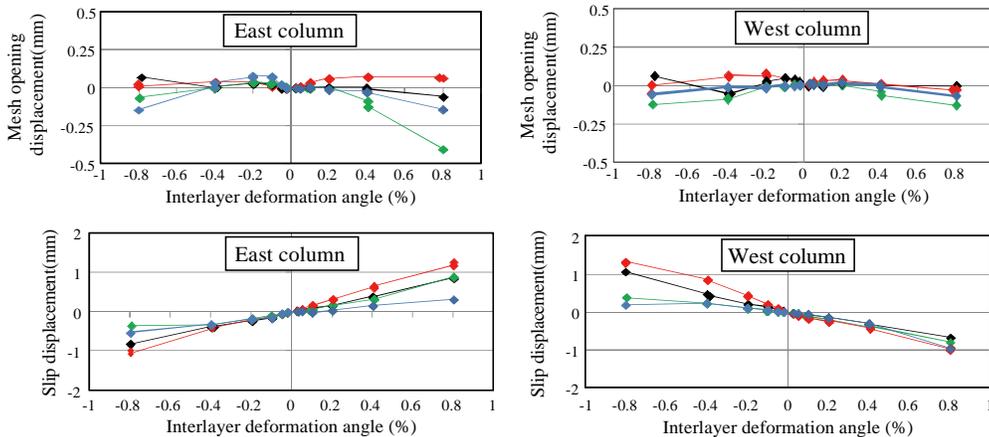
Fig. 10 – Slip and joint gap deformations

Figure 10 shows the joint gap and slip deformations. The direction in which a wall plate leaves from the column beam frame was assumed to be positive for the joint gap deformation, the horizontal direction as the west direction and the upward direction as positive for the vertical direction. Joint gap and slip deformations were almost not generated at the lower surface of beam and at the upper surface of slab in each test specimen. The displacement of the west and east columns was large in comparison with the two afore-mentioned locations. Test specimen M exhibited almost no joint gap and slip deformations. In addition, test specimen P exhibited almost no slip deformation up to 4/1000 rad near the maximum yield strength and showed a larger deformation later. It is thought that this is because the yield of anchor rebar generated large slip deformation on the joint surface.

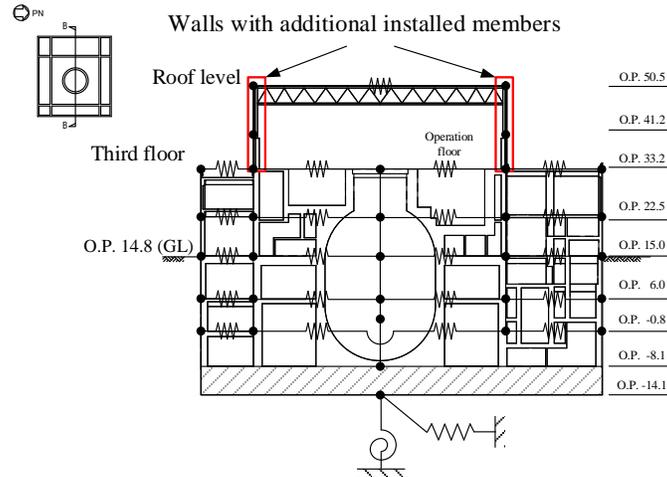
Fig. 11 – Earthquake response analysis model for Onagawa Unit 2 Reactor Building

The change in the vibration characteristics of the building due to additional installation of earthquake resistant members was analyzed through the earthquake records before and after the seismic retrofit. The purposes are to confirm effectiveness of the seismic retrofit and to verify the earthquake response analysis model considering the additionally installed members. Figure 11 shows the earthquake response analysis model. Figures 12 and 13 show the locations of seismometers for the verification.

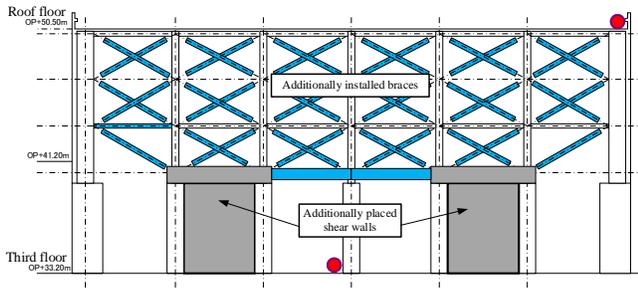
Fig. 12 – Locations of seismometers for verification (Elevation of west side wall)

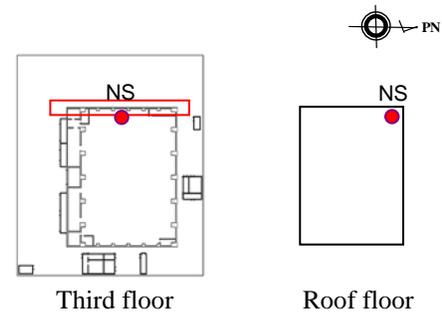
Fig. 13 – Location of seismometers for verification (plan view)

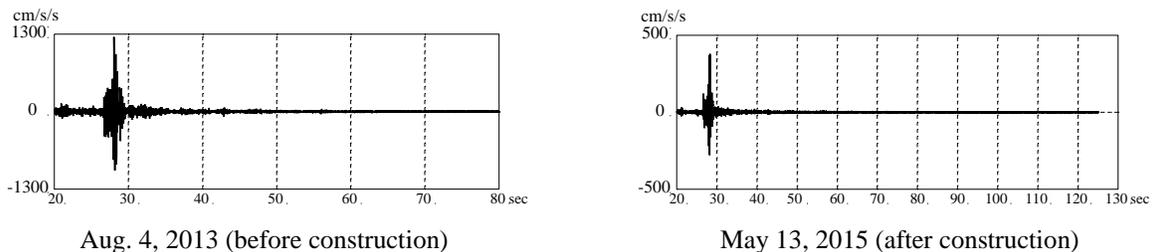
Fig. 14 – Observed accelerograms at roof level (NS)

System identification was implemented by using 15 sets of earthquake observation records, which were selected from all observation records before, during and after the construction. Figure 14 shows the observed accelerograms on the roof level in two representative earthquakes. Figures 15 and 16 show the changes of the first natural frequency and the damping ratio, corresponding to Figure 14. The natural frequency decreases when the earthquake response increase. Figure 17 shows the natural frequency tends to increase and the damping ratio tends to decrease. Figure 18 shows the relation between the maximum accelerations and the natural frequencies in 15 selected earthquakes. A tendency is found that the higher the maximum acceleration, the smaller the natural frequency.

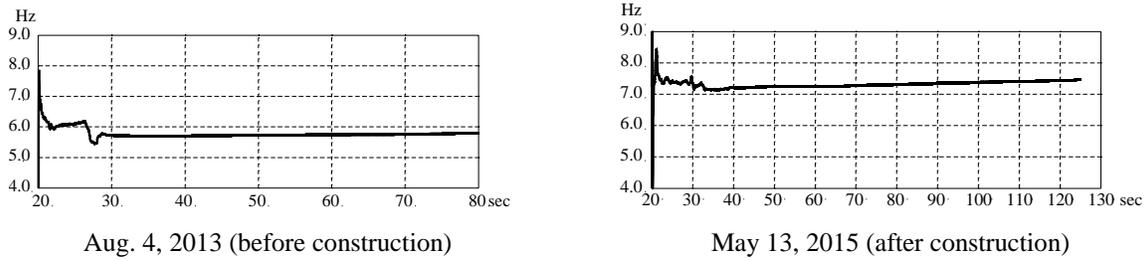
Fig. 15 – Variation of first natural frequency during earthquake

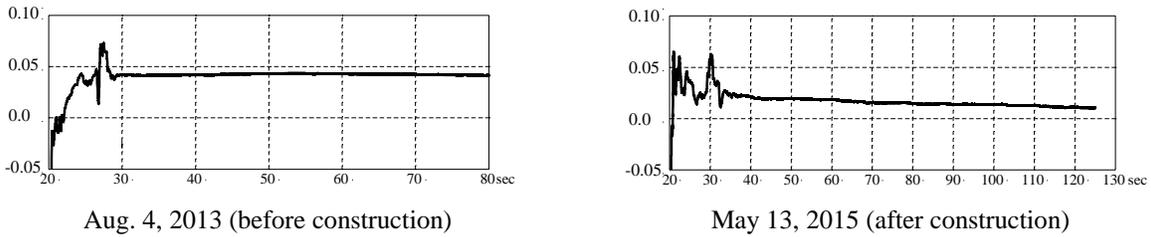
Fig. 16 – Variation of first modal damping ratio during earthquake

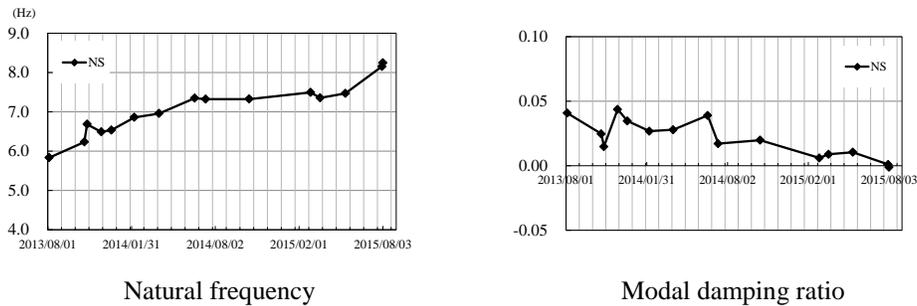
Fig. 17 – Variation of first modal properties during 15 earthquakes

The identified modal values became constant responding to a decrease of earthquake vibration. Consequently, the effectiveness of seismic retrofit were confirmed by comparing the natural frequencies at the final measurement times of earthquakes each other.

The comparison proved that the first natural frequency increased after the seismic retrofit. This verified the increase of stiffness in the third and upper stories that were retrofitted. The identified first natural frequency after the retrofit corresponds to the first natural frequency of the earthquake response analysis model. This correspondence proved the validity of the earthquake response analysis model considering the additionally installed members.

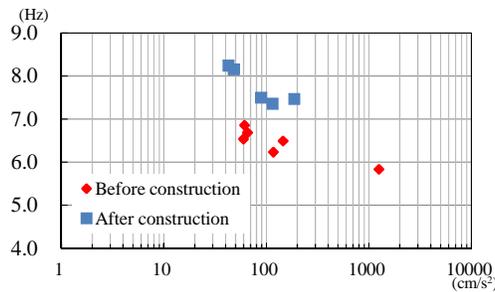
Fig. 18 – Maximum acceleration versus first natural frequency during 15 earthquakes

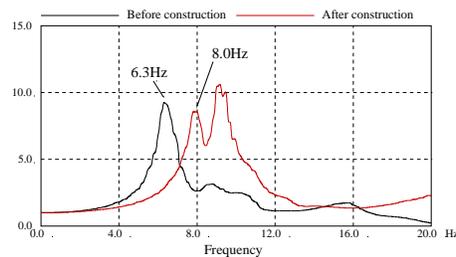
Fig. 19 – Transmissibilities of roof level to third floor in earthquake response analysis models

Figure 19 shows the acceleration transmissibilities of the roof level to the third floor in the earthquake response analysis models. The models consider two states before and after the earthquake resistant construction. These accelerations are selected at the lumped masses corresponding to the seismometer locations. The change of the first peak frequencies of the earthquake response analysis models are almost in consistent with the natural frequencies shown in Figure 17.
