## Effect of post-liquefaction long shaking on roads and buried pipes during the 2011 Great East Japan Earthquake

**Keywords:** megathrust earthquake, liquefaction, sloshing

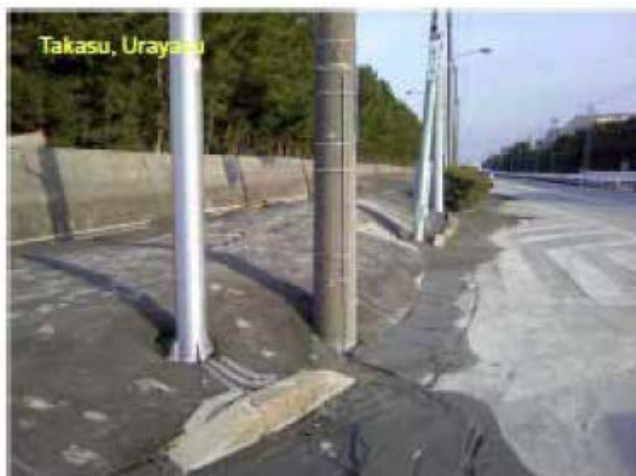
Fig. 2 Heaving of a footway in the Takasu district of Urayasu City

One of the authors visited Takasu and Imagawa in Urayasu on the day after the earthquake and was surprised that a footway heaved and an alley thrust, as shown in Figures 2. On the other hand, at Maihama in Urayasu, the thrust of an alley was observed though there was no such boundary, as shown in Figure 3.

In the case of Figure 2, the first impression was that the footway heaved due to uplift force of some buried pipes, such as sewage pipes. However, after that, strange thrusts and heavings of footways and alleys were also found in Ichikawa, Chiba and other cities. So, he concluded that some boundaries beside the footways and alleys, such as banks of old sea walls and elevated bridges, caused the thrust or heaving due to a kind of sloshing of liquefied ground, as schematically shown in Figure 4 (1), because shaking continued for a long time after the occurrence of liquefaction, as mentioned above.

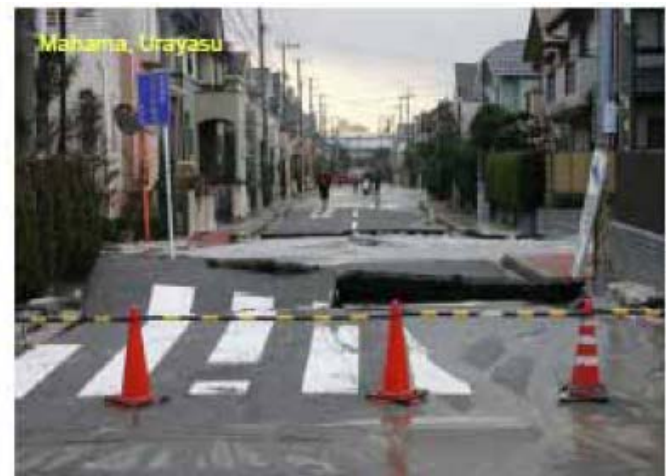
Fig. 3 Thrust of an alley in the Maihama district of Urayasu City (Photo by Ogawa)

In the case of Figure 3, the locations of heaved footways and alleys in Urayasu City, with and without boundaries, are plotted in Figure 5. By comparing the locations of heaved footways and alleys without boundaries with the contour lines of the thickness of the filled layer under the groundwater table, it may be said that the heaving occurred at the sites where the bottoms of the fill layer, in other words, the liquefied layer, was sloped. This implies that a kind of horizontal buckling of the surface layer might have occurred due to the concentration of horizontal compressive stress, as schematically shown in Figure 4 (2).

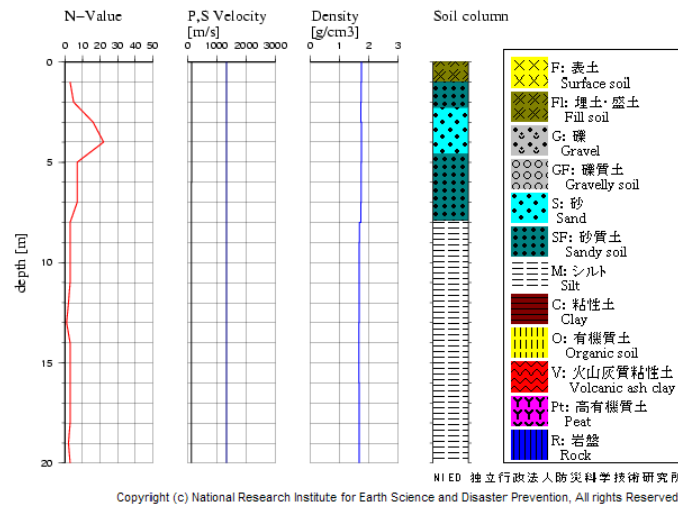
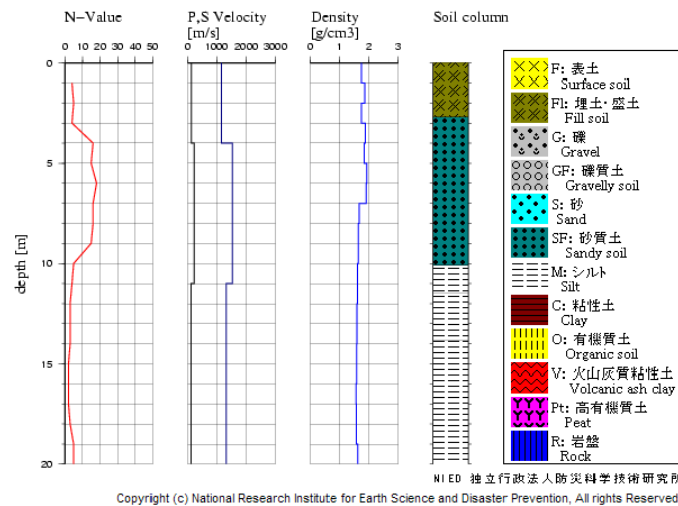
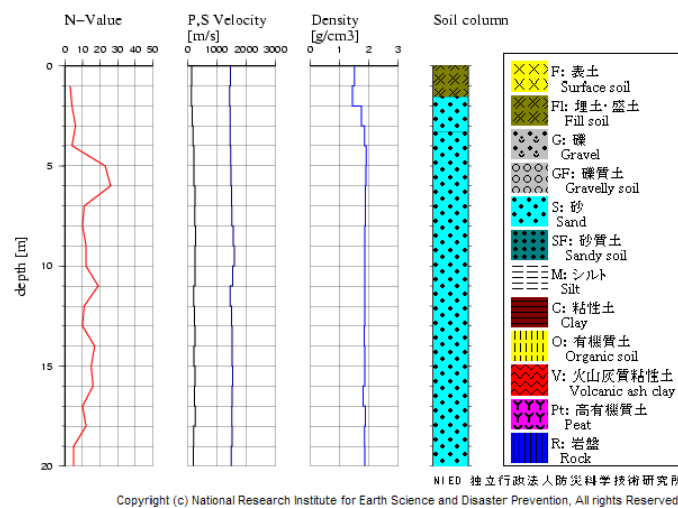
Fig. 9 Soil profiles at K-NET observation site

Among many seismic records obtained in the Tokyo Bay area, the observed records at three K-NET sites plotted in the Figure 1 are examined, where borehole data are published on the web site [7]. Soil profiles from borehole data are shown in Figure 9.

The surface layer at CHB008 is sandy soil but was not liquefied, since N-values are larger than those at reclaimed lands. Soils deeper than 8m are clay. Similarly, the surface layer at CHB009 was not liquefied, since soils deeper than 10m are soft silt. On the other hand, N-values of shallow sandy layers at CHB024 are smaller than 10. Consequently, many boiled sands were observed, so it is clear that the liquefaction occurred in the site.

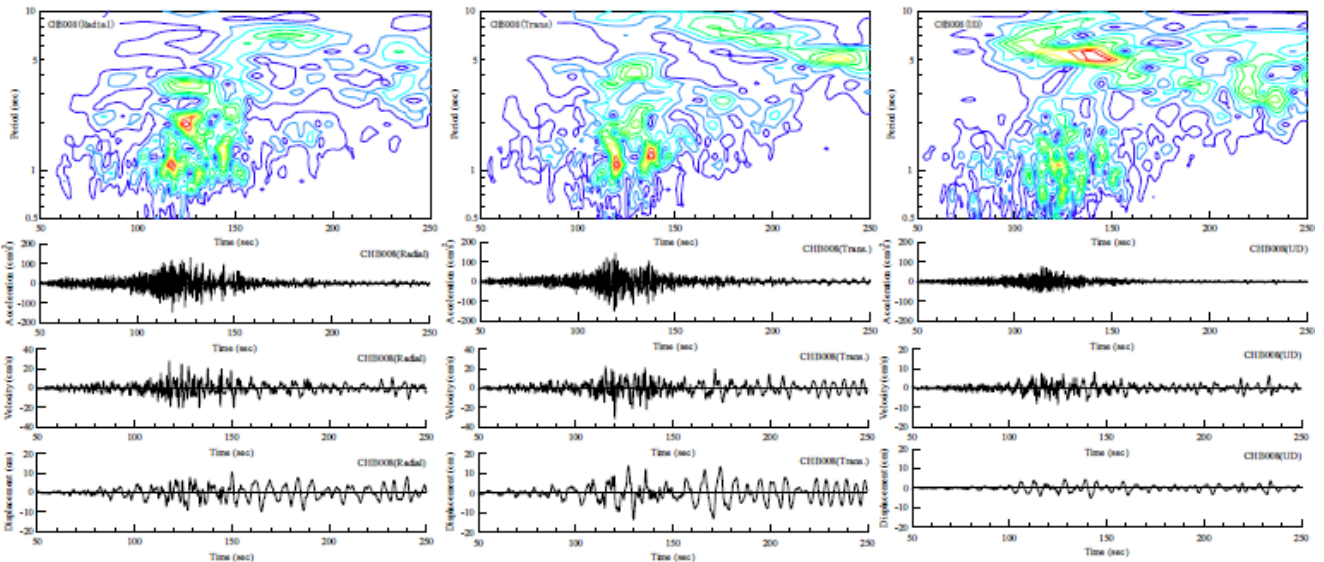
(a)radial (b)transverse (c)vertical  
Fig. 10 Nonstationary spectra and waveforms of acc., vel. and dis.(CHB008, Urayasu)

Non-stationary spectra [8] of velocity waves observed at three K-NET sites are shown at Figures 10 to 13. Radial and transverse components are calculated by the condition that waves are propagated from the direction of 50 degrees from the north.

In the transverse component, waves of 4 sec period are predominant in the back part of the principal motion. Waves of around 8 sec reach later than the principal motion and show the dispersion characteristics, so they are seems to be typical Love waves. Though it is similar in the radial component, waves of 5 sec period are predominant in the vertical component, which seems to be Rayleigh waves.

Among them, accelerograms recorded at K-NET Inage in Chiba, shown in Figure 12, where boiled sand was observed are very important because the liquefaction time can be judged from the recorded waves. Figure 10 shows the accelerograph recorded at Urayasu on ground where liquefaction did not occur. Both records started at almost the same time; 14:46:16 at Inage and 14:46:15 at Urayasu. At Urayasu, the wave frequency did not change drastically after the peak acceleration, which was induced at about 118 sec. (14:48:13). On the contrary, at Inage, the wave frequency dropped to a low value after two peaks at 120 sec. (14:48:16) and 126 sec. (14:48:22) and the amplitude of acceleration decreased suddenly. Therefore, it can be judged that liquefaction occurred at around 14:48:16 to 14:48:22 at Inage. This means many cycles of shear stress, say around 20 cycles over 110 sec., might have caused liquefaction at the Inage site.

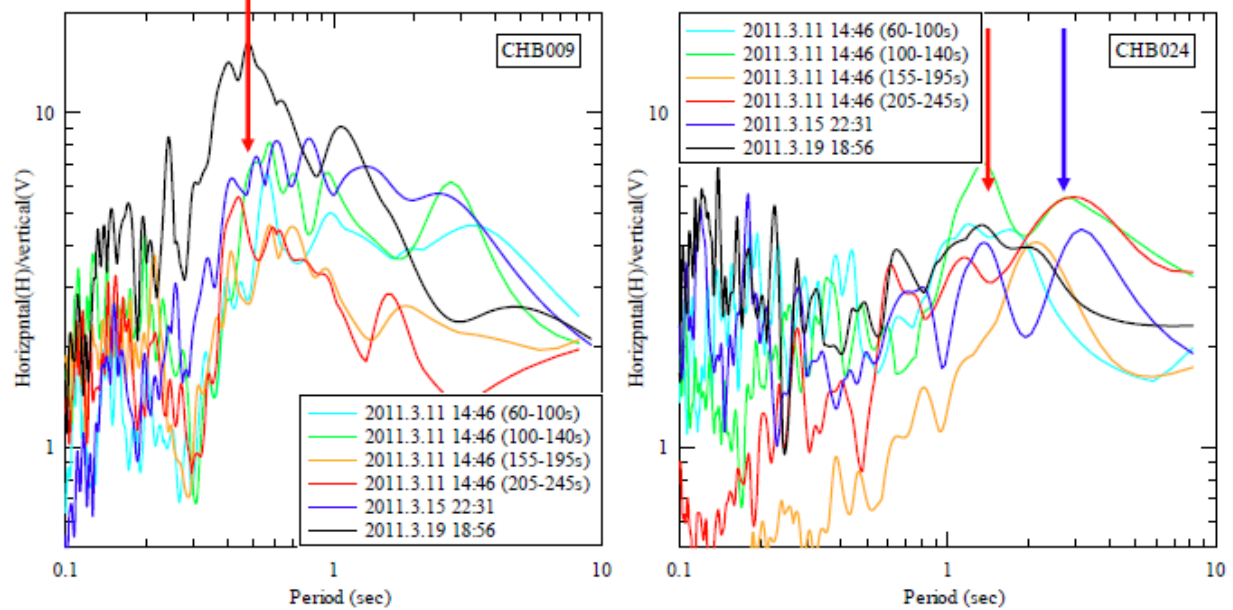
Fig. 14 Ratio of the Horizontal spectrum to Vertical spectrum (H/V)

In the rather long-period range from 1 to 5 seconds, non-linear effect of surface soil should be considered. So, the spectral ratios of horizontal to vertical ( H/V spectra) are calculated in the 4 sections as shown in Figure 14. Predominant periods are almost constant at CHB008 and CHB009. On the other hand, predominant periods at CHB024 are changed from 1.3 sec indicated by a red arrow to 2.8 sec indicated by a blue arrow. This change to long-period is caused by the nonlinear behavior of the liquefaction. On the other hand, more longer waves of 4 or 5 seconds are originated in surface waves caused by the underground structure deeper than about 1km.
