## SEISMIC BEHAVIOR OF BEAM-TO-COLUMN MOMENT CONNECTIONS USING HIGH-STRENGTH STEEL

### **Abstract**

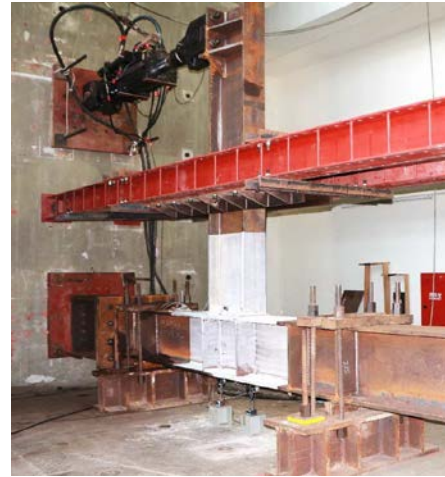
Fig. 4 – Test setup

The test setup for the beam-to-column connection is displayed in Fig. 4. The column was placed horizontally while the beam was set upright. The column was axially restrained and two hinged supports were provided at the inflection points. A horizontal hydraulic actuator applied a lateral force to the beam tip which represented an inflection point. Lateral brace was installed to prevent out of plane deformation of the specimens.

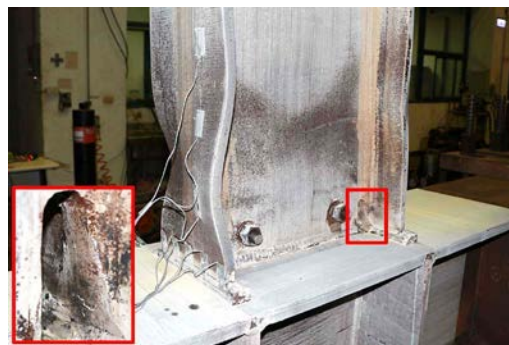
Specimen WUF-W behaved linearly before 1.5% rad SDA. A crack occurred at the edges between the completely joint penetration weld and the beam bottom flange at 2% rad SDA, and this crack enlarged at the successive cycles. The flaking of the whitewash happened on the beam flange and web close to the column at 3% rad SDA, and the beam flange began to buckle locally at 4% rad SDA. At 5% rad SDA, additional crack was observed on the beam bottom flange at the root of the weld access hole, and severe local buckling of the beam flange was observed as shown in Fig. 8.

Fig. 8 – Local buckling and cracking at weld access hole of specimen WUF-W
