NEW DETAILS FOR REINFORCED CONCRETE BEAM-COLUMN JOINTS TO IMPROVE THEIR BEHAVIOR NEAR FAILURE

R. Tobar (1)

Abstract

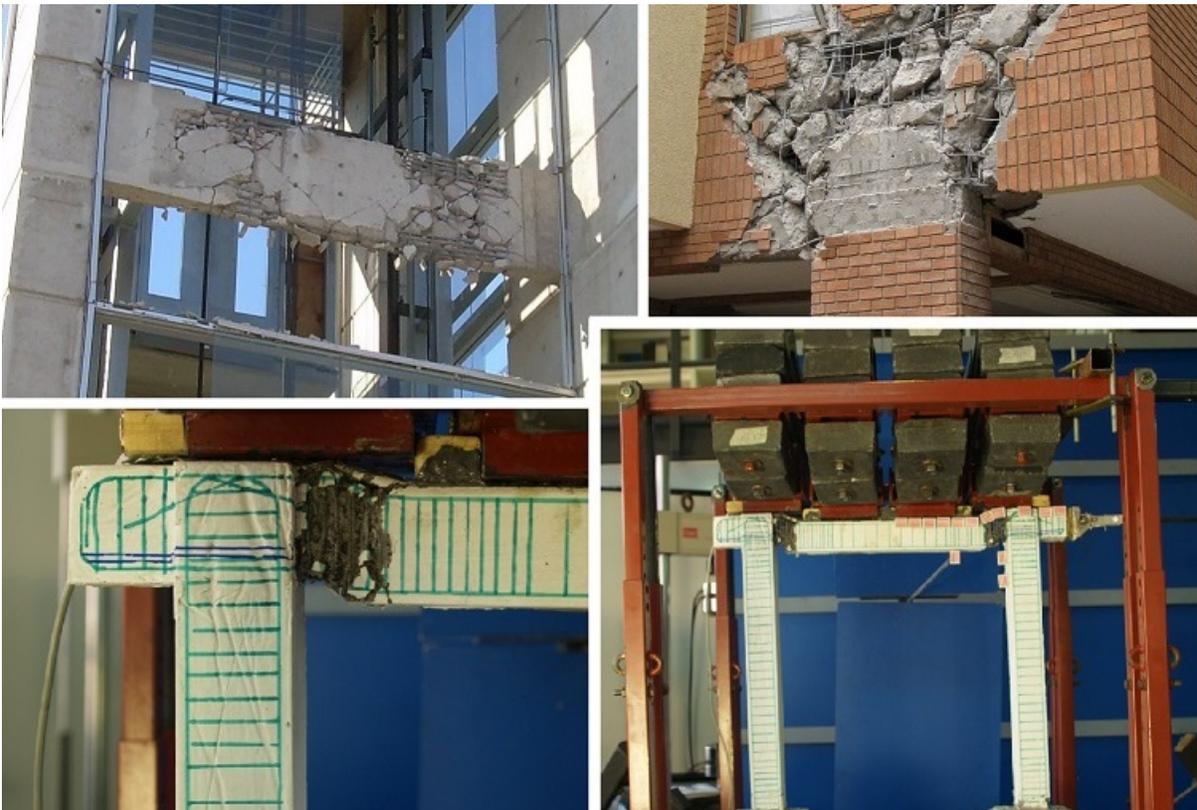
Fig. 1 - Damage concentration in real structures and scale models

The aim of this research is to find some ways to avoid damage concentration in reinforced concrete structures during earthquakes. This concern comes from observation of many collapsed 1/10 scale models tested on the seismic table at the UTFSM laboratory. During first stages of tests, under moderate solicitation, models carefully detailed following code regulations, develop ideal well distributed fine crack patterns. However when intense seismic solicitation is applied, cracks grow and open very fast in a few points, usually the end of beams, while close in the rest of the structure. Crushing and spalling caused for diagonal compression of concrete occur in those points, and the material escapes through spaces between reinforcing bars, reducing the capacity of plastic hinges to almost zero, and leaving the structure in danger. Actually, the same can be observed in real structures after a strong earthquake, as Fig. 1 shows. It seems to be that damage in modern reinforced concrete structures during recent earthquakes exceeded expectative.

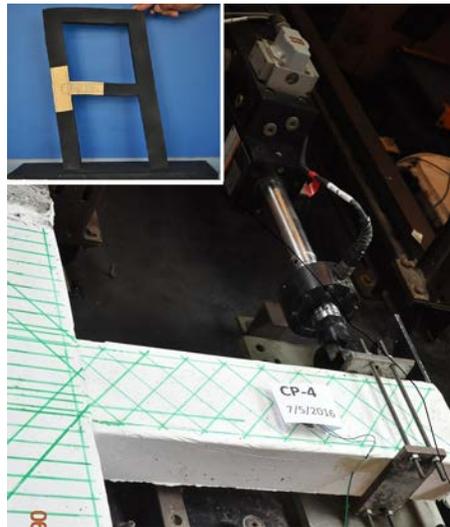
Fig. 2 Test specimen and MTS servo-hydraulic actuator used to apply the cycling load

About fifty close to real size (1/3 scale) reinforced concrete corbel beams anchored to a column segment representing external beam-column joints of seismic frames or, better said, the part of the beam close to the joint, were tested subjected to an alternating rapidly variable cyclic load acting on the free end, simulating seismic solicitation, as shown on Fig. 2. Large displacements were applied, most time destroying test specimens.

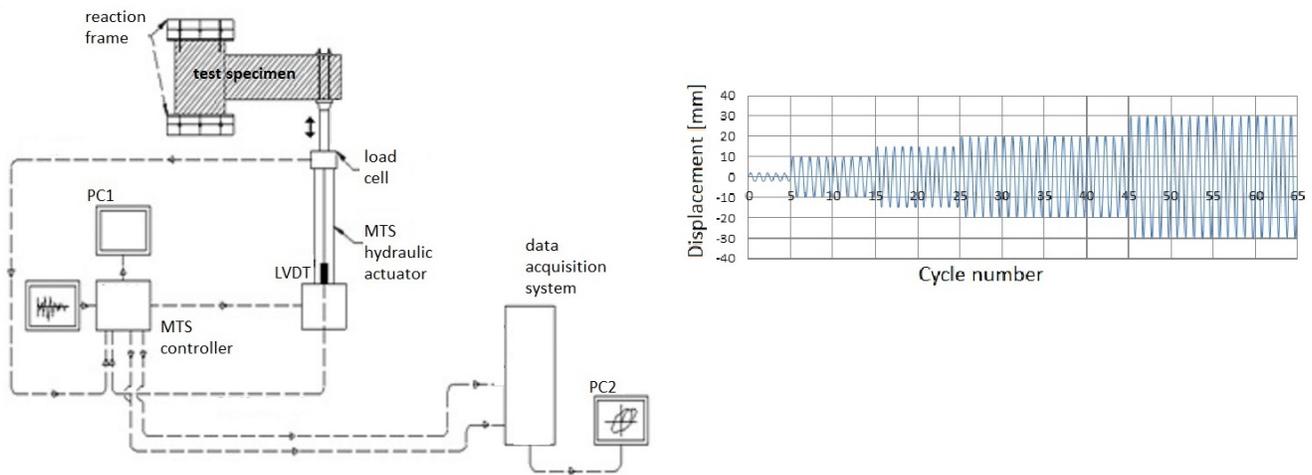
Fig. 3 - Test setup and typical loading program

Previous work [5],[8], also showed that, even when at the beginning of tests, velocity of deformation does not influence results more than 10%, it does affect the way that specimens collapse. For this reason tests were performed at a velocity representative of the real earthquake. 5 Hz were used in the first two series of table 1, and 2 Hz were used in the following series. Loading program is shown in Fig. 3. A 10 min. pause was done between families of cycles. MTS controller added two or three cycles of lower amplitude, not shown in Fig. 3, every time the system was started or stopped.

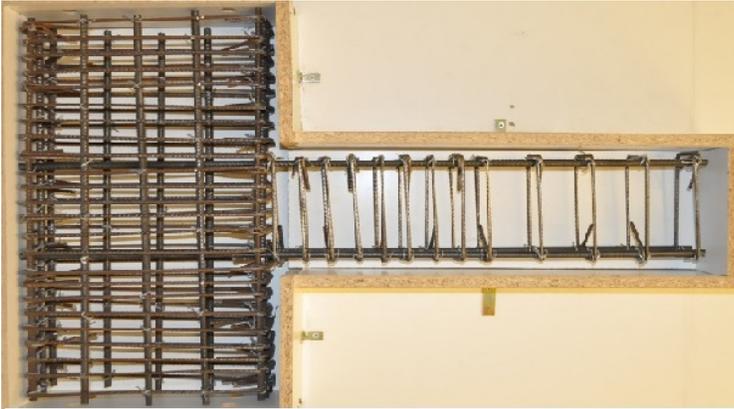
Fig. 4 Original specimen reinforcement [8]

Figure 4 shows the original specimen tested in first series of Table 1. In order to improve results of this first series two modifications to the distribution of reinforcement were considered:

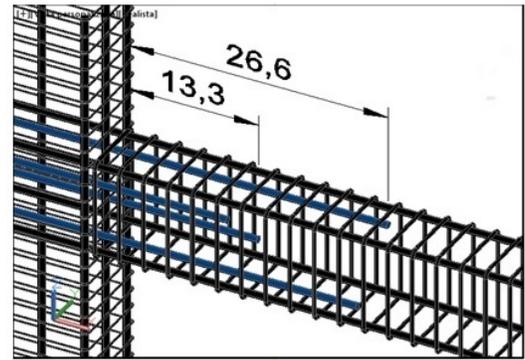
Fig. 5 Short supplementary bars added

- To extend length of plastic hinge zone and to move it away from the column, four short supplementary bars were added, as shown in Fig. 5. Steel grade was reduced from A630-420H ($f_y = 4200 \text{ kgf/cm}^2$) to A440-280H ($f_y = 2800 \text{ kgf/cm}^2$), to keep moment capacity of beams near the same value than before. Selected results of tests of one of these specimens are shown in figures 6 and 7.
- 45° (and 135°) inclined hoops were used for transverse reinforcement, instead of conventional 90° hoops, as shown in figures 8 and 9. Short supplementary bars mentioned before were also added. Selected results of tests of one of these specimens are shown in figure 10.

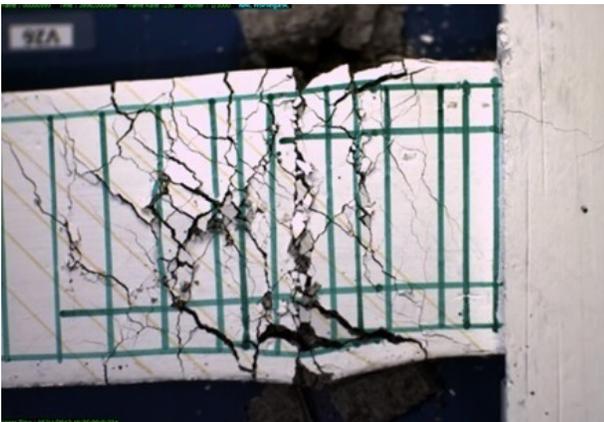
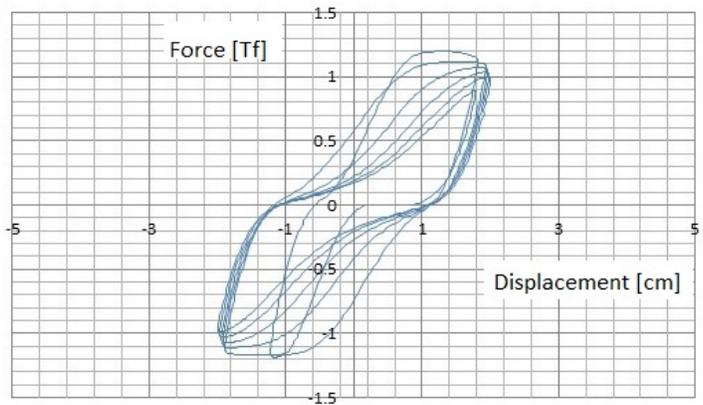
Fig. 6 External view of specimen v23 and hysteresis curve corresponding to the first series of cycles of 18 mm

Results shown in figures 7 and 10 are representative of specimens with 90 ° conventional hoops and 45° inclined hoops respectively. Actually, short supplementary bars did not change significantly strength or ductility of original specimens. They succeed in moving plastic hinges away from columns though, as Figs 6 and 7 show. Because results of tests of original specimens and those modified with short supplementary bars are similar, they are treated jointly in the analysis that follows.

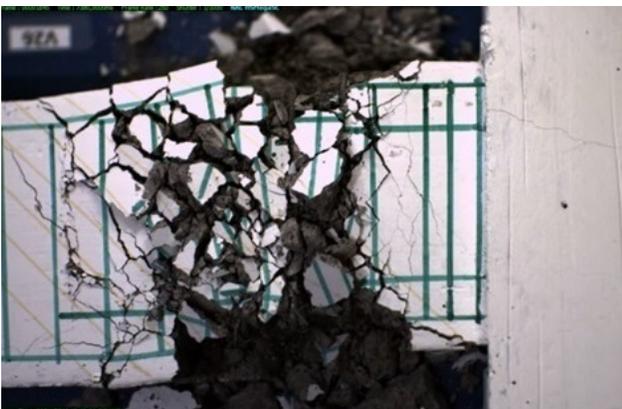
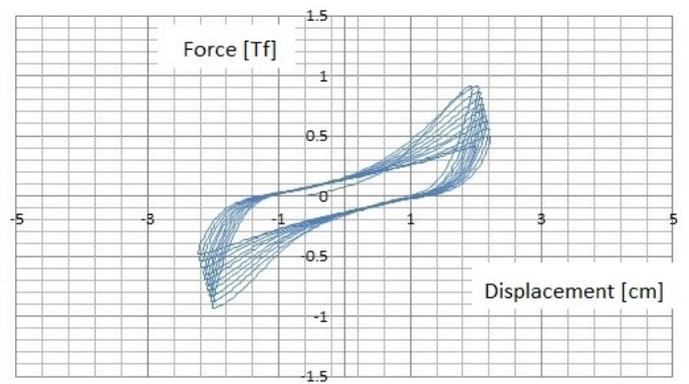
Fig. 7 External view of specimen v23 and hysteresis curve corresponding to the second series of cycles 18 mm

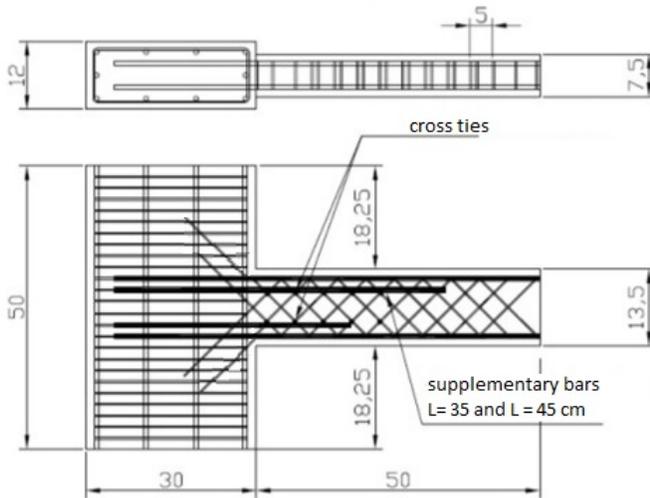
Fig.8 45° inclined hoops specimen (Adapted from [9])

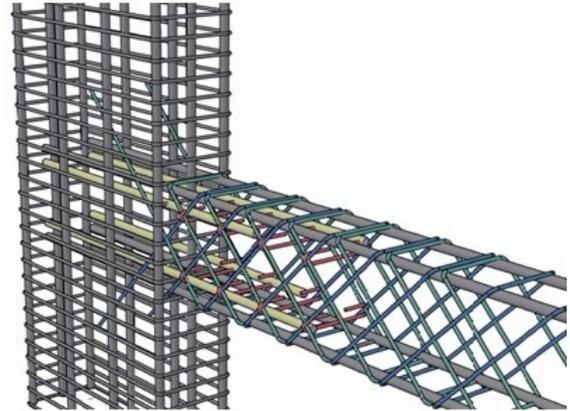
Fig. 9 Perspective view of reinforcement

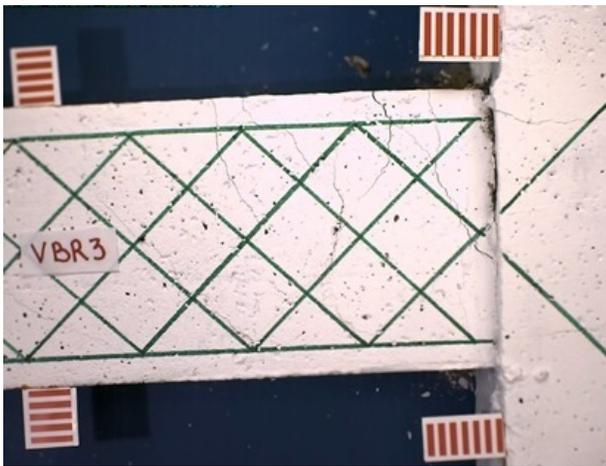
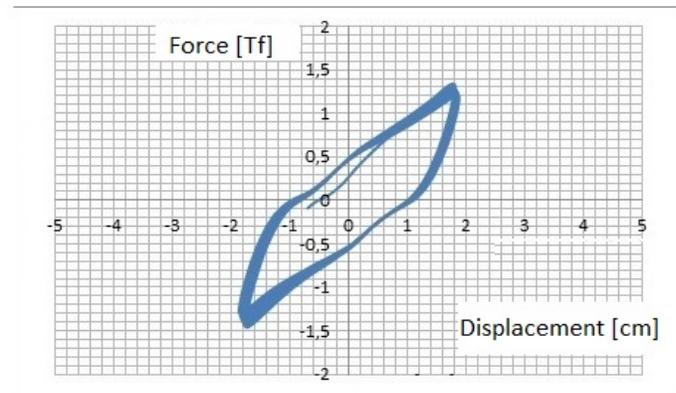
Fig.10 External view of specimen vBR3 and hysteresis curve corresponding to the second series of 18 mm cycles. More than seventy cycles with almost no degradation compares positively with results shown in Fig. 7.

Positive results of inclining hoops 45° were remarkable, in terms of ductility, stability of hysteresis curves, and strength. Fig. 10 shows that specimen VBR3, could have sustained cycles of 18 mm (4.5% drift) almost indefinitely, which is far from possibilities of conventionally reinforced concrete elements (Fig.8). Also, the maximum cycle load improved significantly respecting original specimens.

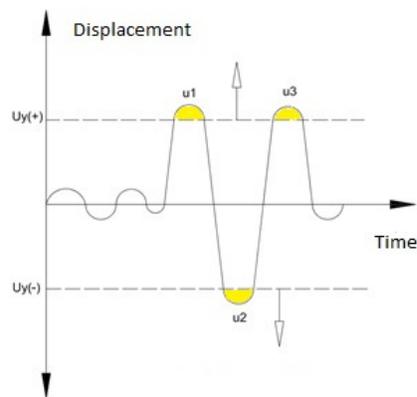
Fig. 11 Accumulated ductility [11]

Loading programs of specimens were equal until the first series of 18 mm amplitude only. For this reason, in order to compare their behavior, the accumulated ductility was taken as reference. This quantity was calculated as shown in Fig. 11 below:

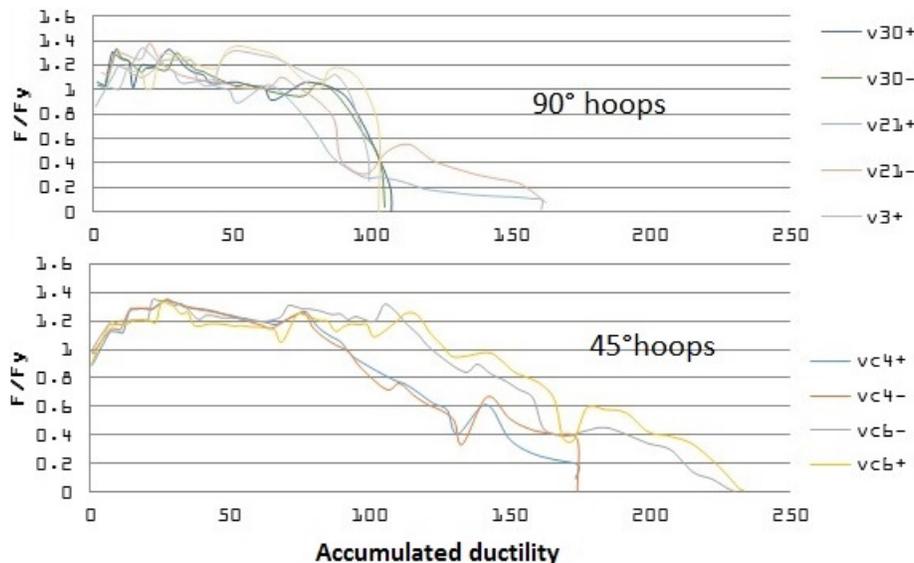
Fig. 11 Cyclic force amplitude versus accumulated ductility of selected specimens [11]

Figures 11, and 12 compares cycle force amplitude and dissipated energy v/s accumulated ductility for different specimens. From all curves it is clear the advantage of using inclined transverse reinforcement in beams. In the following pages the reasons for this favorable behavior are explained.

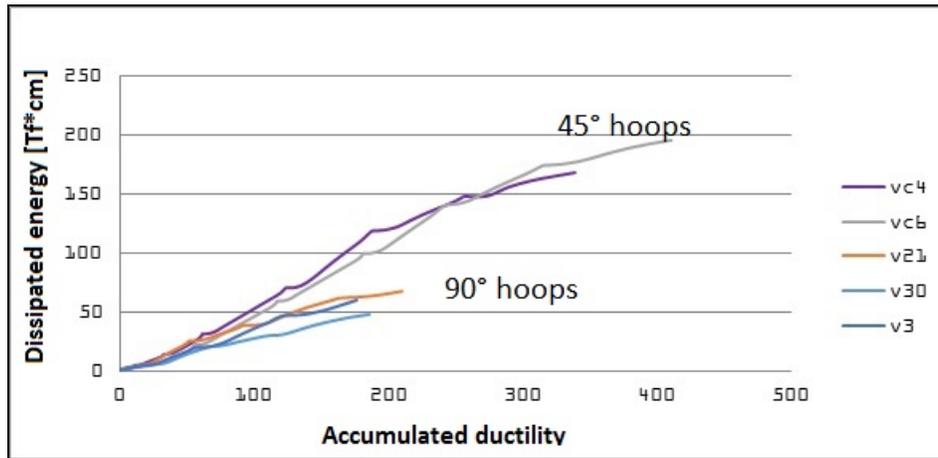
Fig. 12 Dissipated energy versus accumulated ductility for selected specimens (Adapted from [11])

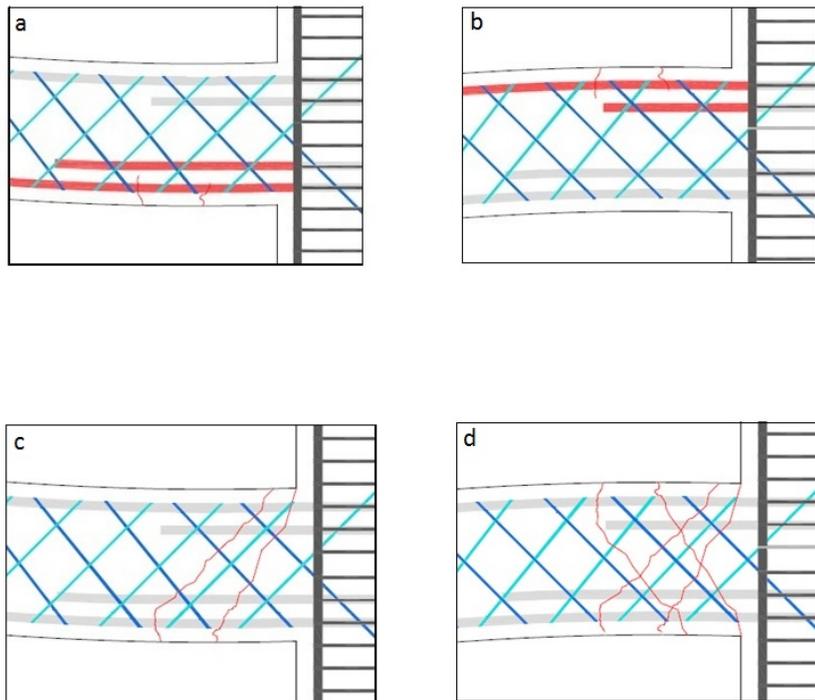
Figures 13 Sequence of cracking of an element with 45° inclined transverse reinforcement subjected to alternating increasing load. Picture (d) shows how concrete fragments results trapped by the reinforcement. (Adapted from [9])

Figures 13 a,b,c and d shows the sequence of cracking of an element with 45° inclined transverse reinforcement, as those described in this report, subjected to an alternating increasing load. During the first stages of the test, flexural cracking is observed only, pictures (a), (d). After load increases shear cracking appears, pictures (c) and (d), forming a net of concrete fragments. It was observed during tests that inclined shear cracks usually progress following a 45 deg. inclined line between two stirrups. Thus, concrete fragments are “trapped” by two perpendicular inclined stirrups, and integrity of the element is maintained for a while. On the contrary, fragments are free and escape rapidly through spaces left by conventional 90° stirrups.

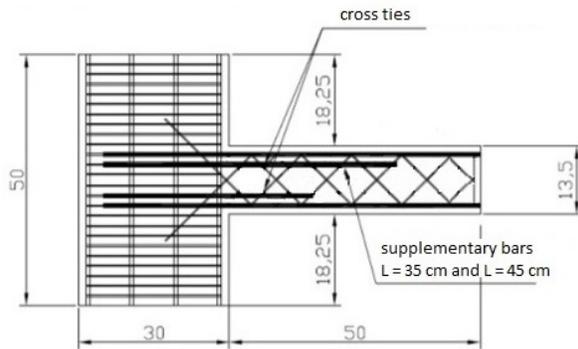
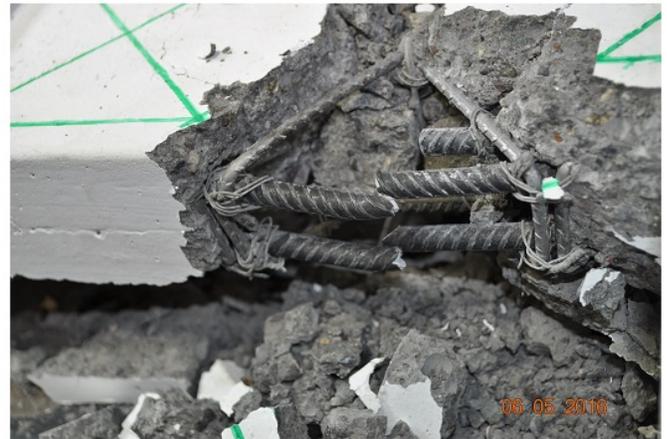
Figures 14: Inclined transverse hoops are not convenient for elements with low transverse reinforcement

However, inclined transverse reinforcement has some drawbacks. Beginning: for the same amount of hoops, they are longer and pitch is twice of conventional 90° hoops. Thus, tendency of buckling and fracture of main reinforcing bars in elements with low transverse reinforcement is noticeable, as Figs 15 show. Furthermore, inclined hoops have a tendency to slip after concrete cover is lost, as shown in figure 16. Thus, they need to be effectively tied to the longitudinal bars. Welding, if possible, is desirable. Finally, for the same reason, a pair of 45° and 135° hoops should be tied together. Fig. 16 shows an especially bad way of configuring transverse reinforcement.

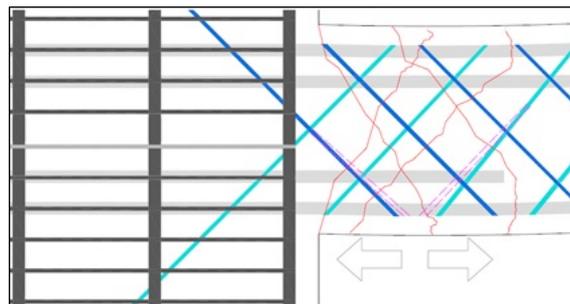
Fig. 16 Tendency of slipping of inclined transverse reinforcement
