## 2015 Gorkha Post-Earthquake Reconnaissance of a Historic Village with Micro Unmanned Aerial Systems

The M7.8 Gorkha earthquake that occurred in Nepal in April 2015 and its resulting aftershocks caused extensive widespread damage to numerous built-up urban centers. One example is Bungamati, a small village approximately 12 kilometers south of Kathmandu, Nepal, that overlooks the Bagmati River. This village dates back to the 6th century and contains the Temple of Macchindranath within its city limits. Within this village, numerous, tightly-spaced masonry and earthen style structures exist in a non-grid pattern with many streets only passable by pedestrian traffic. Such a village presents significant challenges for efficient damage assessment following an extreme event, where both narrow streets and urban canyons limit vehicular access for equipment and the clear sky required to collect global navigation satellite system (GNSS) data.

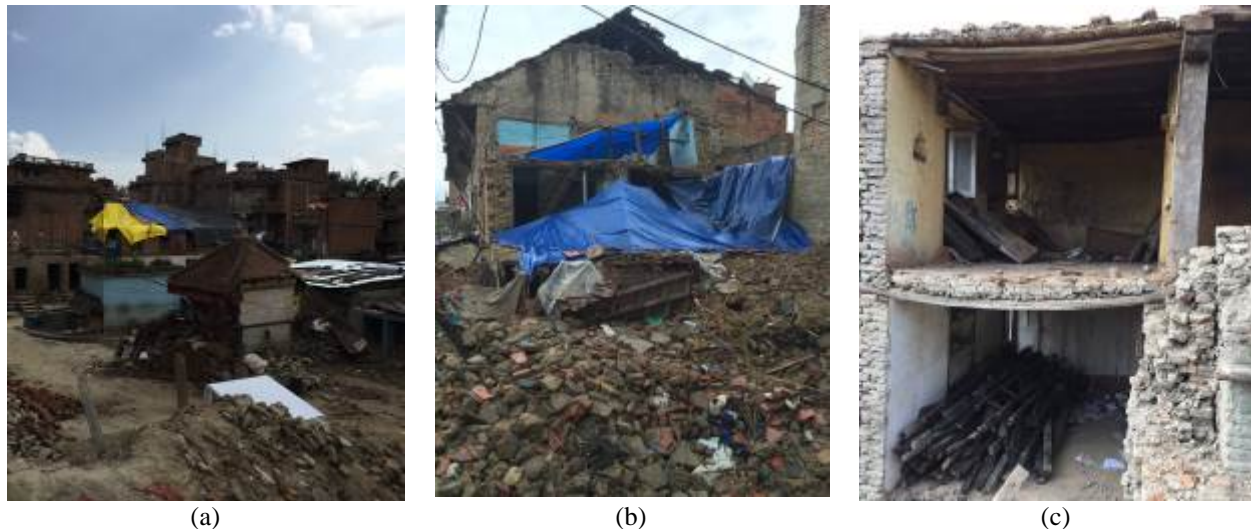
Fig. 2 – Overview of post-earthquake damage observed in Bungamati: (a) widespread damage to unreinforced masonry structures, (b) complete collapse of an example masonry structure, and (c) example flexible timber-diaphragm floor system.

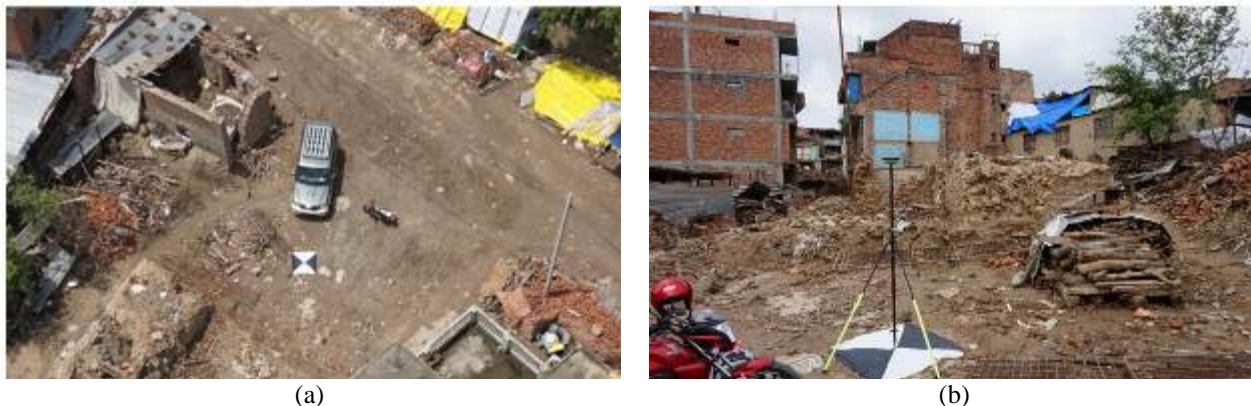
Fig. 3 - Demonstration of surveying technique: (a) an aerial target established in the study area, (b) GNSS rover station on an aerial target.

Four aerial targets (similar to those in Fig. 3a) were temporarily placed in the village as GCPs. The positions of these targets were determined using two Leica GS14 GNSS receivers. One receiver was setup as the “Base” receiver that logged static GNSS data at a 15-second epoch rate for 4 hours and 20 minutes—the duration of the UAS survey campaign in Bungamati. The second receiver, the “Rover”, collected 10 minutes of static GNSS data on each aerial target (Fig. 3b). Five additional points with coordinates derived from ground-based lidar were used as GCPs since it was later found that the four aerial targets were insufficient due to the village size.

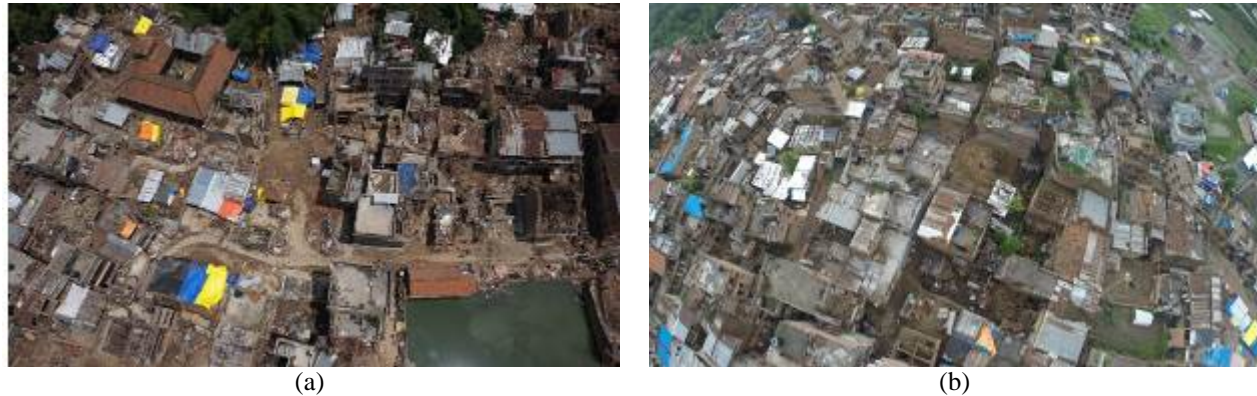
Fig. 5 - Example aerial imagery: (a) Sony α5000 and (b) example of aerial imagery from GoPro Hero3+.

The flights were performed on June 27 and 29, 2015. DJI's software package, Ground Station<sup>®</sup>, was used for photogrammetric flight mission planning. The DJI F550 flights were performed at an altitude of 65 m (resulting in a ground-sampling distance roughly equal to 1.5 cm), with a planned side overlap of 75% (Fig. 4b). The camera shuttered in automatic focus and automatic exposure modes at one second intervals, yielding 80% forward overlap at a forward flight speed of 7 m/s. More than 700 aerial images of the roughly 1.6 km<sup>2</sup> village were collected during a total of 30 minutes of flight. Fig. 5a is an example of an aerial image taken from the

F550. The imagery from DJI Phantom 2 were used as complimentary dataset to F550 data. Fig. 5b shows an example of aerial images taken with wide-angle GoPro image on Phantom system.

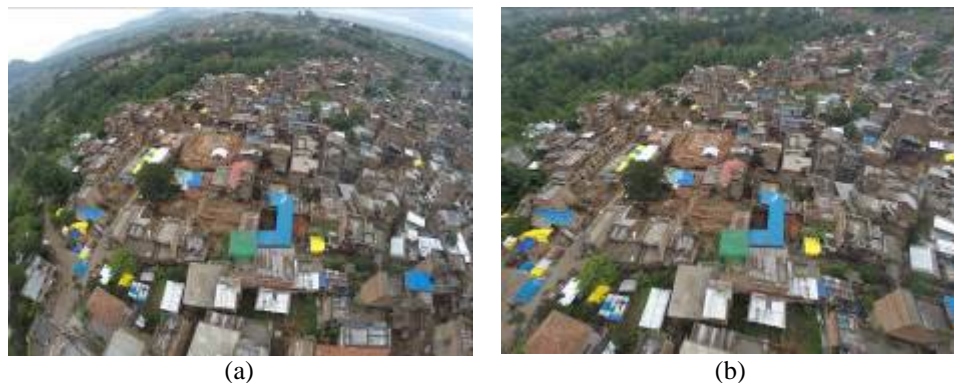
Fig. 6 - Example aerial image obtained from GoPro Hero 3+: (a) distorted image before correction and (b) after correction.

The GoPro HERO 3+ Black Edition camera contains a fisheye or wide-angle lens. While the fisheye lens captures extremely wide angles of view, (i.e., 14 mm in a 35 mm equivalent system) it produces extreme image distortion (Fig. 6a). Image distortion is a significant problem in many computer vision processes, especially within SfM algorithms that can create additional undesired noise. Image distortion can be classified in to three broad categories: barrel or radial distortion, pincushion or decentering distortion, and complex distortion [20, 21]. Within a fisheye lens, the distortion is primarily barrel; however, within the optics of a GoPro camera a significant complex distortion is noted. Consequently, a MATLAB procedure was utilized to geometrically correct the images based on Brown's distortion model (Fig. 6b) [13].

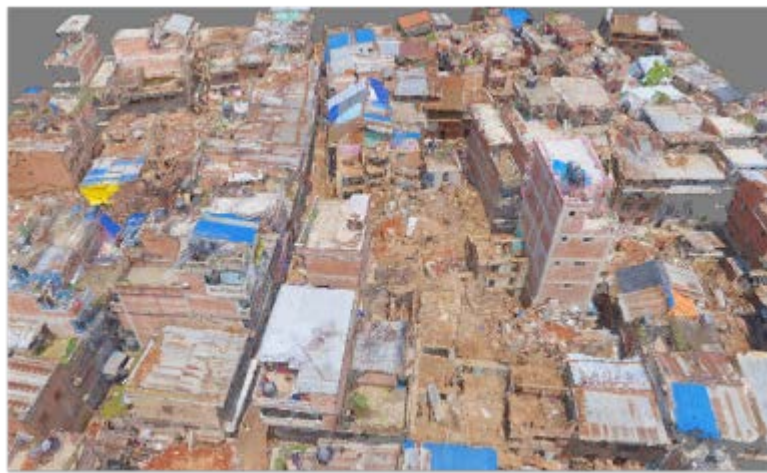
Fig. 7 - Section of the geo-referenced 3D point cloud of Bungamati village.

Fig. 7 shows the geo-referenced point cloud for a selected region of Bungamati village, where undamaged, damaged or completely collapsed buildings can be identified. A resulting orthophoto of the area from the UAS imagery is shown in Fig. 8a. This high-resolution UAS-derived orthophoto (Fig. 8b) has a ground resolution of 2 cm. The orthophoto was overlaid and compared to satellite imagery provided by Esri. The Esri satellite imagery (Fig. 8c) is sourced to DigitalGlobe's image of Kathmandu with 0.6 m resolution and 25 m accuracy, captured on March 4, 2010 (before the earthquake). As shown in Fig. 8, the orthophoto resulted from UAS imagery has a considerably higher resolution (2 cm) compared to the existing satellite image (60 cm). The highly detailed and resolute UAS imagery is due to the low altitude maneuvering capabilities of UAS, and highlights a benefit of UAS imagery over satellite imagery.

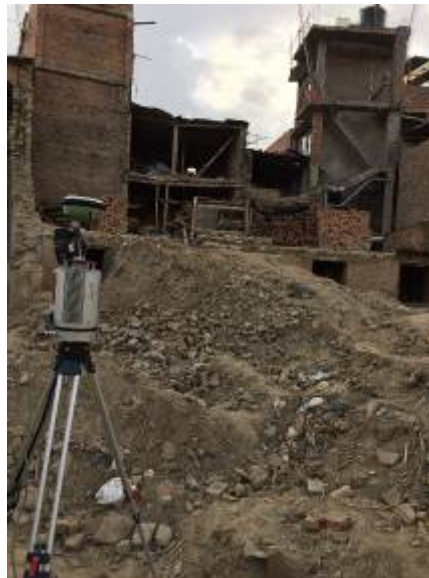
Fig. 9 - Riegl vz400 laser scanner with Leica GNSS GS14 on top.

In addition to the remote sensing with UAS, 33 ground-based lidar (GBL) scans were collected along the main road of Bungamati as well as in some of the more open areas in the village. The lidar scanner, Riegl Vz 400, was mounted onto a surveying tripod and transported from scan position to scan position. Due to the size of the village and ongoing recovery efforts, lidar targets were not utilized. Instead, a Leica GS14 GNSS rover antenna was fixed to the top of the scanner, and 5 minutes of static PPK GNSS data was collected at each scan position. Similar to post-processing the GNSS data on the GCPs, the baseline observations between the rover above the scanner and the base GNSS receiver were post-processed. The vertical offset between the GNSS receiver and the scanner enabled estimation of the scanner position for registration. Fig. 9 shows the Riegl Scanner with the GNSS receiver mounted on top.
