16<sup>th</sup> World Conference on Earthquake, 16WCEE 2017

Paper N° 2935 (Abstract ID)

## COLLAPSE MECHANISM OF WIDE-AREA SUSPENDED CEILING BASED ON FULL-SCALE SHAKE TABLE EXPERIMENT OF SCHOOL GYMNASIUM

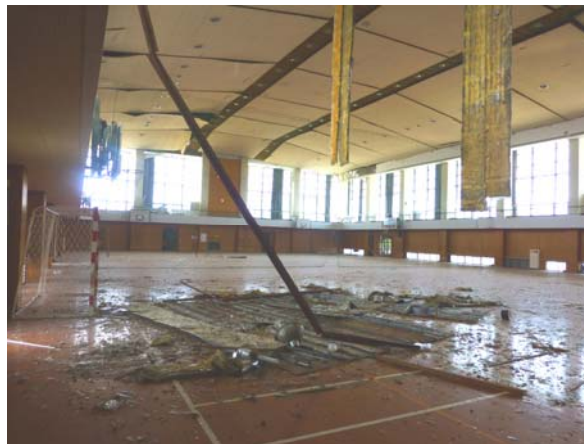
Photo 1 Collapse of Suspended Ceiling in Gymnasium during Kumamoto Earthquake

In the 2011 off the Pacific coast of Tohoku Earthquake, a lot of suspended ceilings in large-space structures such as gymnasium suffered damage and collapsed due to lack of their seismic performance[1]. In 2016 Kumamoto Earthquake, several gymnasium also suffered damage as shown in Photo 1. Because the school gymnasiums are generally expected to be used as evacuation shelters after strong earthquake, their seismic performance including nonstructural components and serviceability after earthquake is important. Thus, new seismic standards for wide-area suspended ceiling have been in effect from April 2014 in Japan. In the new standards, screw fastening to the connection of metal parts, a lot of bracings and clearance between ceilings and walls are required. However, collapse mechanism of ceiling is not yet clarified enough and effective seismic countermeasures are needed.

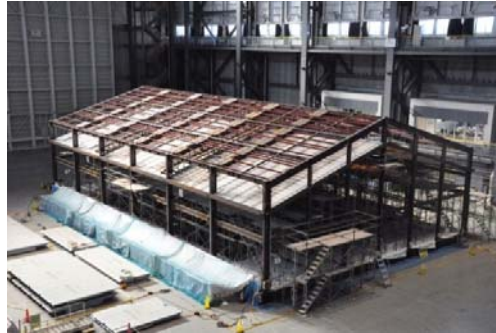
Photo 2 Full-scale Gymnasium Specimen

Photo 2, Figure 1 and Table 1 show gymnasium specimen used for full-scale shake table experiment. The gymnasium specimen is designed as a steel gymnasium in elementary or junior high schools based on current Japanese code. Its size is 18.6 m x 30 m, which is larger than E-Defense shaking table, its height is 9.09 m and it has 10:3 sloped roof.

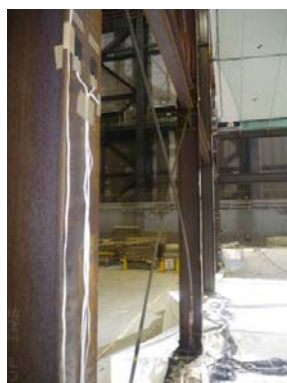
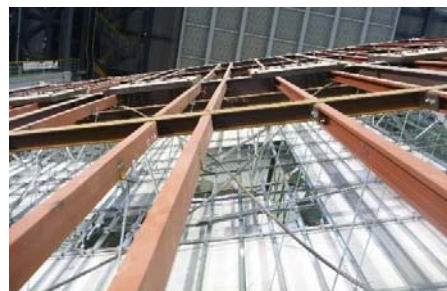
(1) Vertical Braces

(2) Lateral Braces

Photo 4 Damage of Braces after All Excitations

Photo 4 shows damage of braces after all excitations. All vertical and lateral braces are buckled due to expansion resulting from yielding braces. There is no specific damage to structural members except for braces, such as columns, girders and beams.

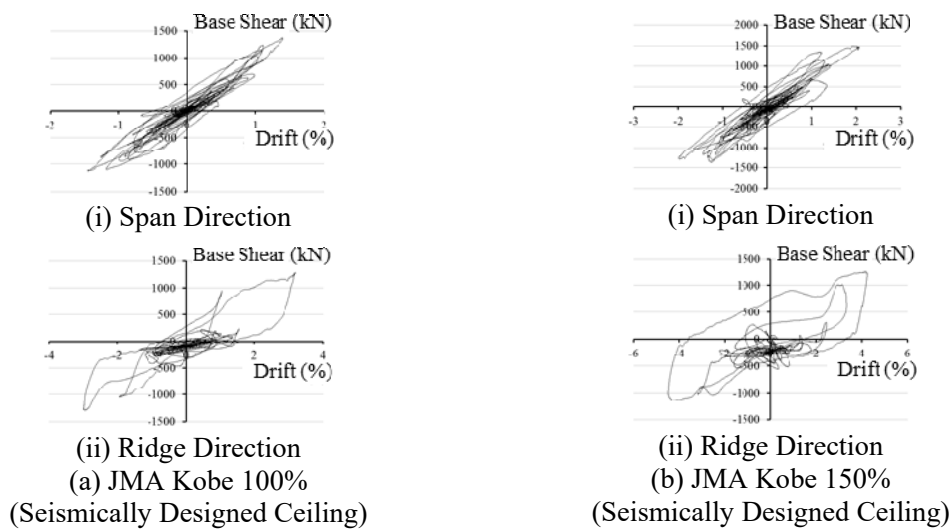
Fig. 6 Base Shear vs. Story Drift Hysteresis during JMA Kobe Excitations

Figs. 5 and 6 show base shear vs. story drift hysteresis. Base shear is calculated from summation of shear force of column and horizontal component of axial force of braces evaluated from measured strain. As shown in Fig 5(a), the gymnasium specimen remained elastic until K-NET Sendai 50% excitation. From K-NET Sendai 80%, Columns and vertical braces started to yield. As shown in Fig. 5, especially large measured displacement during JMA Kobe 100% and 150% excitations, bilinear hysteresis with slip response can be identified in shape of hysteresis loop.

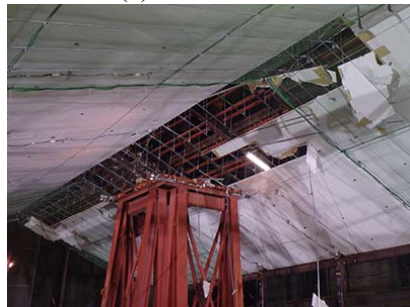
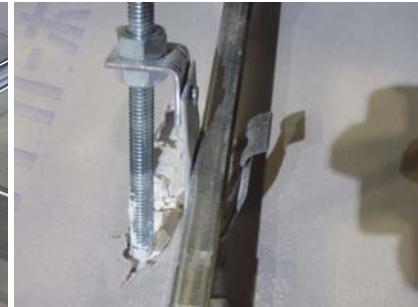
(a) 1st K-NET Sendai 50% Excitation

(b) 2nd K-NET Sendai 50% Excitation

(c) After All Excitations

Photo 5 Damage of Nonseismic Ceiling

Photo 5 shows damage of nonseismic ceiling. During 1st K-NET Sendai 50% excitation, hanging bolts near the top of roof first detached from ceiling joist receivers, then ceiling clips were broken and ceiling panels with ceiling joists warped. During 2nd K-NET Sendai 50% excitation, warped ceiling panels vibrated severely and ceiling panels with ceiling joists fell down. Based on the damage survey after shake table experiments, it was clarified that there is trace of gypsum boards due to uplifting of ceiling panels at the rooftop and less damage of ceiling panels at the edge.

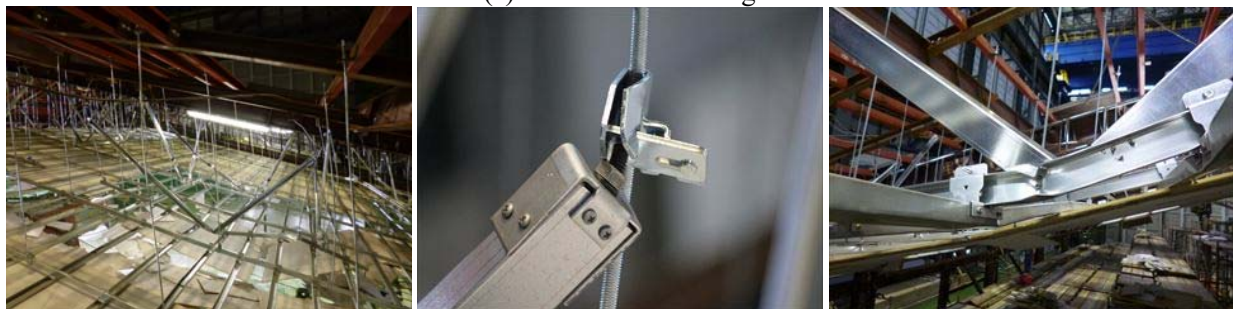
(a) 1.1G seismic ceiling

(b) 2.2G seismic ceiling

Photo 6 Damage of 1.1G and 2.2G seismic ceilings after JMA Kobe 150% excitation

Photo 6 shows damage of 1.1G and 2.2G seismic ceilings after JMA Kobe 150% excitation. In 1.1G seismic ceiling, ceiling braces buckled first during K-NET Sendai 80% excitation, horizontal ceiling displacement increased and edge of ceiling panels suffered severe damage due to collision of ceiling and columns during JMA Kobe 100% excitation. On the other hand, in 2.2G seismic ceiling, bottom and top connections of ceiling braces ruptured, ceiling joist receivers and ceiling joists deformed and ceiling panels fell down due to rupture of screws fasten the boards resulting from deformation of ceiling joists.
