ANCIENT MEASURES TAKEN FOR DISASTER MITIGATION IN ANATOLIA

E. G. Arun

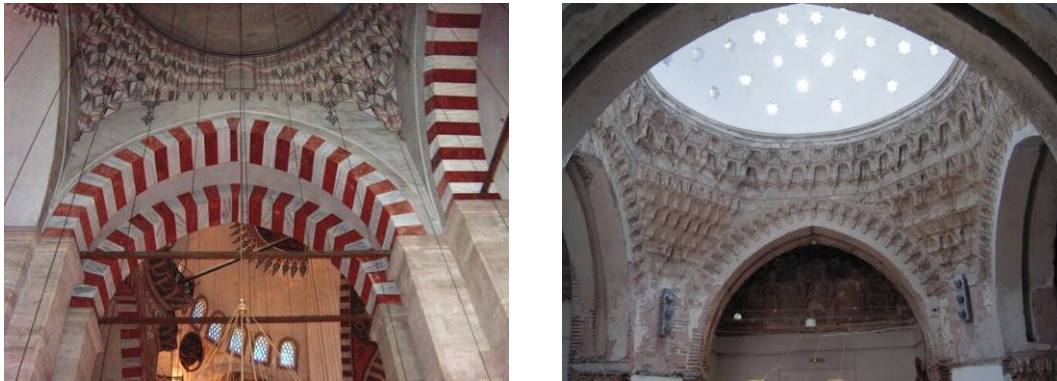
Building masters, knowing that long projections and different weights of building components should be separated, provided seismic joints by not joining the masonry units of the adjacent structures to each other. Such construction features may be incorrectly interpreted as damage. Different weighted parts of Süleymaniye mosque in Istanbul and the Davutpasha hammam in Skopje has two arches side by side belonging to different weighing parts of the buildings (Fig. 2). Also in the archaeological excavations, it is seen that the structures built upon old foundations and the foundations of different parts of the building were not completely bounded to each other.

Figure 2. Double arches in Süleymaniye mosque and Davutpasha hammam

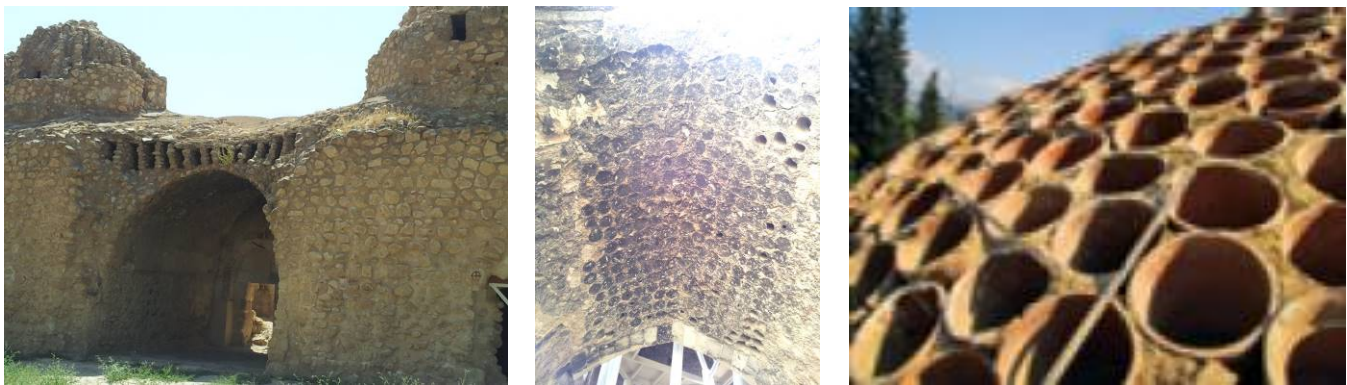
Masonry walls are heavy elements. The only way to reduce the weight of the structure was to make light roof and floors. In most places in Anatolia, due to the scarcity of wood, masonry vaults or domes were built to span plan areas. Ancient building masters knowing the geometry and behavior of these structural elements they constructed and provided proper measures to reduce the weaknesses. Some vault geometries such as cylindrical and torus vaults and spherical domes inherently have tension at the base along one of their principal curves. To counter the tensile stresses building masters provided wall thickening or changed the tension area into a corbelled system or closely spaced arched columns or piers at the base. While thickening the area of tensile stresses, they used clay pipes in the area of compression to reduce the weight of the vault or dome. To construct a flat roof or a floor over these vaults or domes, they either emptied the space between the compression area of the vault/dome and the roof/floor surface or filled it with amphora or clay pipes not to give extra weight to the vault or dome surface (Fig. 3). The steep vault with an elliptical parabolic surface which looks very similar to a pendantive dome and a paraboloid dome has compression on both of its principal curves. In this case these surfaces didn't necessitated any heavy area. So, to make a flat roof, whole space between the surface and the roof was filled with amphora or clay pipes.

Figure 3. Reducing the weight of the vault or dome

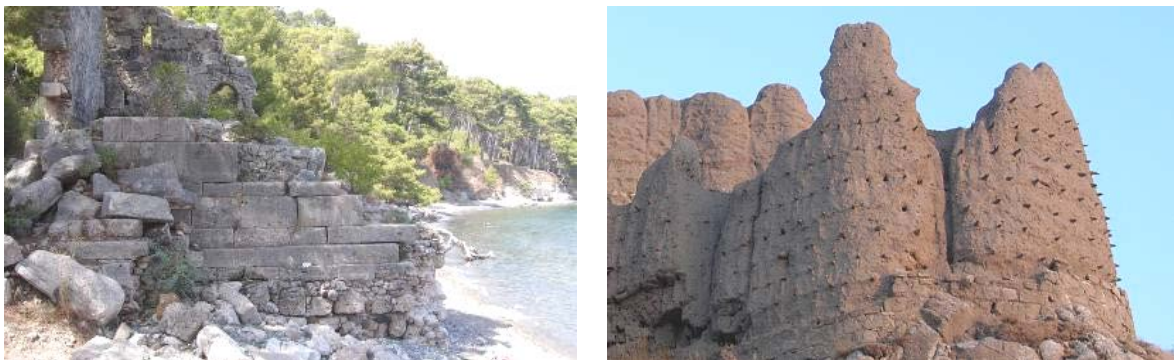
If the rock bed or hard soil was deep, the foundation walls rested on a pillow layer of sand, gravel or small stones as in Phaselis, Antalya (Fig. 5). If the hard soil was not so deep, the foundation walls rested on three layers of brick or stone blocks as in Alaca Höyük from Chalcolithic era [5], and in Urartian buildings at the east and Greek temples at the southwest of Turkey (Fig. 5). An Assyrian tablet says that the soil was cut to the rock and the foundation was placed after filling the trench to 28 elbows height [3]. The foundations of masonry village houses at east Anatolia were constructed on a layer of ~40cm sand till 1960s. The thick layer of sand, gravel or stone pieces provided a change in the natural frequency of soil as well as adequate subsurface permeability to avoid a high water table condition [6].

Figure 5. Pillow layer of gravel at Phaselis

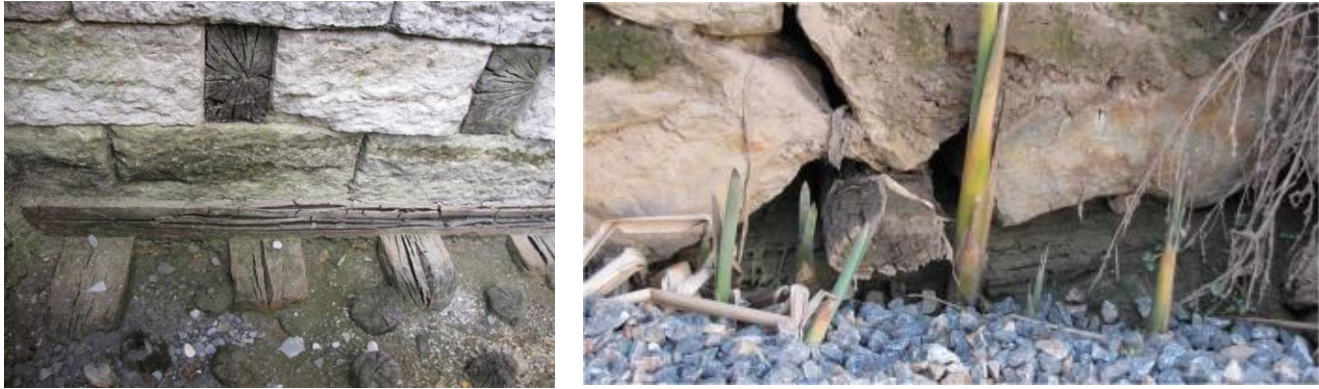
If the bed rock was close to the surface, a flexible base was provided by placing single or more layers of a wooden grillage at the foundation base (Fig. 6). At the bottom of the foundation wall in Beycesultan, a single layer of round wood poles projecting out 1.0-1.5m out from the foundation wall was laid side by side with small stones in between them [5]. Foundation walls of a Byzantine chapel in Üsküdar, Süleymaniye Mosque from 16th C. [6] and the inverted vault foundation of Edirnekapi Cistern from late 19th C. in Istanbul are constructed over two layers of wooden grillage laid perpendicular to each other (Fig. 4). The foundation of the Konjic Bridge, an Ottoman bridge in Bosnia & Herzegovina also contained two layers of wooden grillage laid in between two dolomite layers forming a platform for the foundation footing [8].

Figure 6. Wooden grillage of a Üsküdar and Sirkeci Byzantine chapels in Istanbul

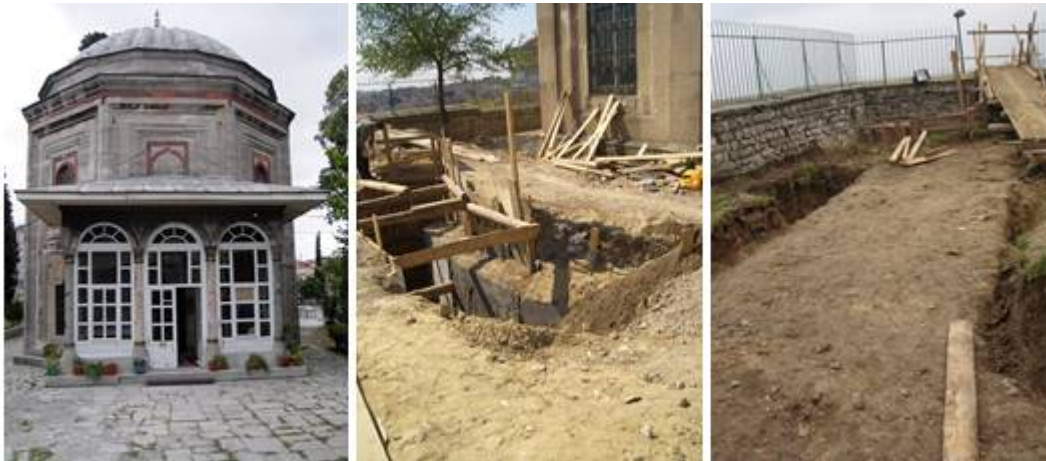
Another different foundation system practice was met at the 16th century octagonal tomb foundation of the Yavuz Selim Mosque complex. Around 4m distance away from the octagonal tomb, 6m high buried stone wall having 2m thickness in the same octagonal form was found as if a retaining wall to absorb the first shock of earthquake forces (Fig. 8). Its effect on keeping the octagonal building from seismic forces has to be studied.

Figure 8 Retaining wall of the tomb at Yavuz Selim Mosque
