## VULNERABILITY ASSESSMENT OF HISTORIC STRUCTURES IN KATHMANDU, NEPAL

*Keywords: historic structure; vulnerability assessment; brick masonry structure; experiment of masonry wall; RDEM*

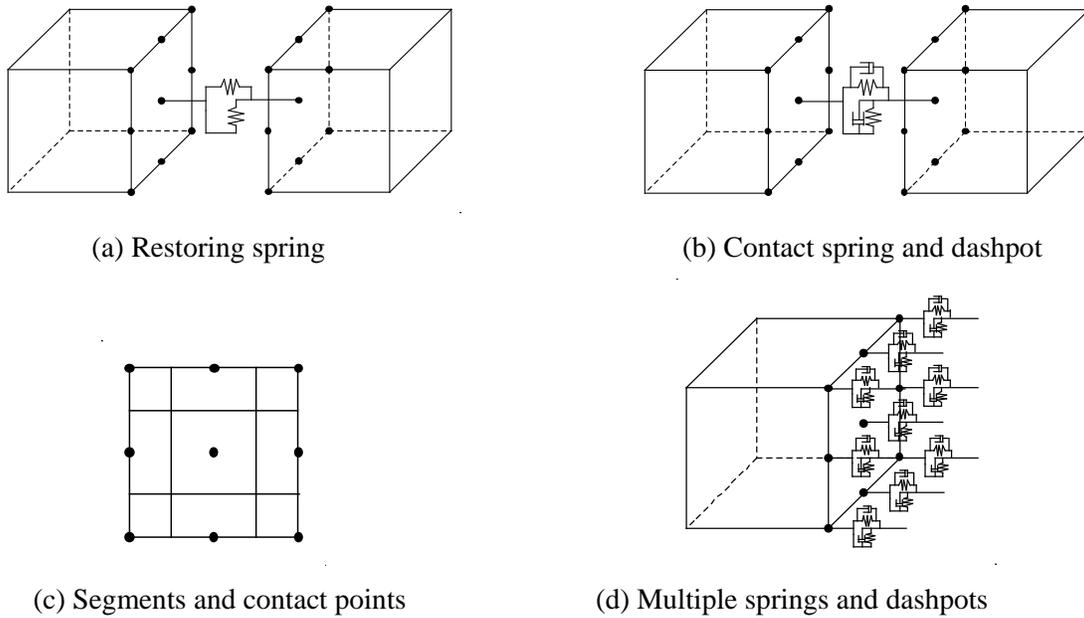
Figure 1a shows a spring for computing the restoring force (restoring spring), which models the elasticity of elements. For simplicity in the figure, a shear spring is set in one direction, but actually has two directions. The restoring spring is set between continuous elements. Structural failure is modeled as breakage of the restoring spring, at which time the restoring spring is replaced by a contact spring and contact dashpot (Fig. 1b). The latter figure shows the spring and dashpot for computing the contact force (contact spring and dashpot) and modeling the contact, separation, and re-contact between elements. The dashpots are introduced to express energy dissipation by the contact. Structural collapse behavior is determined using these springs and dashpots. The elements shown in Fig. 1a and b are rectangular parallelepipeds, but the method does not limit the element geometry.

The surface of an element is divided into small segments, as shown in Fig. 1c. The segment in the figure is rectangular, but the method does not limit segment geometry. Black points indicate points representative of each segment, and relative or contact displacements between elements are computed for these points. Such points are referred to as contact or master points in this study. One restoring spring and one combination of contact spring and dashpot were attached to one segment (Fig. 1d) at each of the representative points in Fig. 1c. The spring

Fig. 1 – Basic concept of analysis method [4]

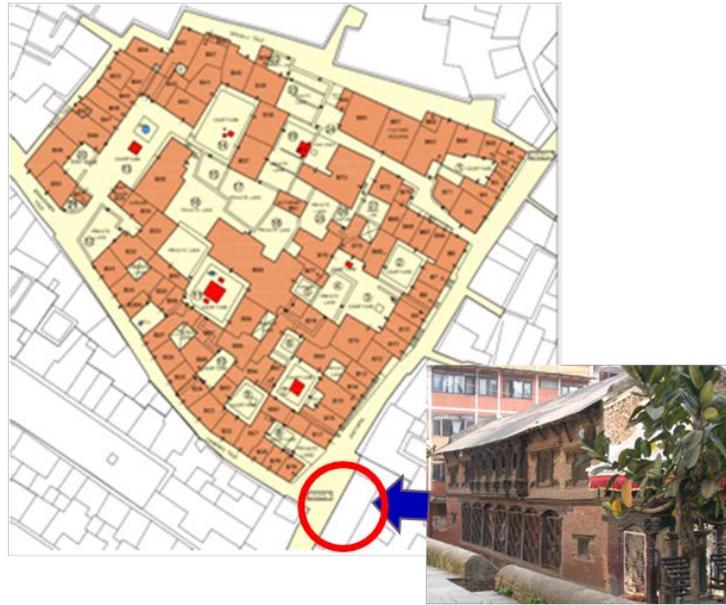
Fig. 2 – Target (Jhatapo) area and location of target building

The building analyzed is a historic composite building whose location and photos are shown in Figs. 2 and 3. It was built in the 17th century. It has been damaged by several earthquakes and repaired many times.

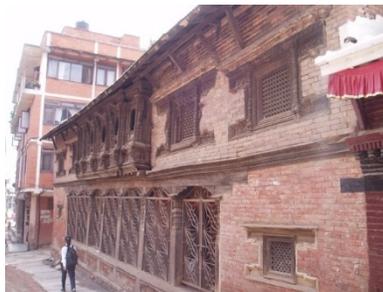
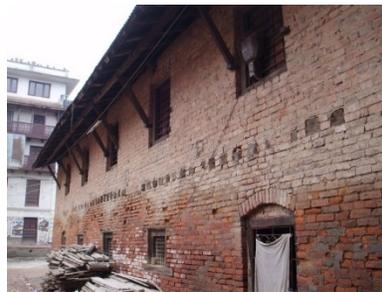
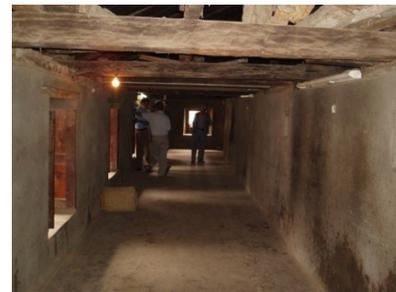
The building is two-storied and has dimensions 16.5 m  $\times$  5.6 m. Heights of the 1st and 2nd floors are 2.4 and 2.1 m, respectively. The maximum building height is 6.5 m. Each wall has openings, with the western wall having the largest (Fig. 3a). The walls are composed of bricks, which are connected with each other by mortar. The brick size is not uniform, and depends on when and where they were made. There are two separate rooms of width 2–3 m (Fig. 3c).

Fig. 3 – Target historic masonry building

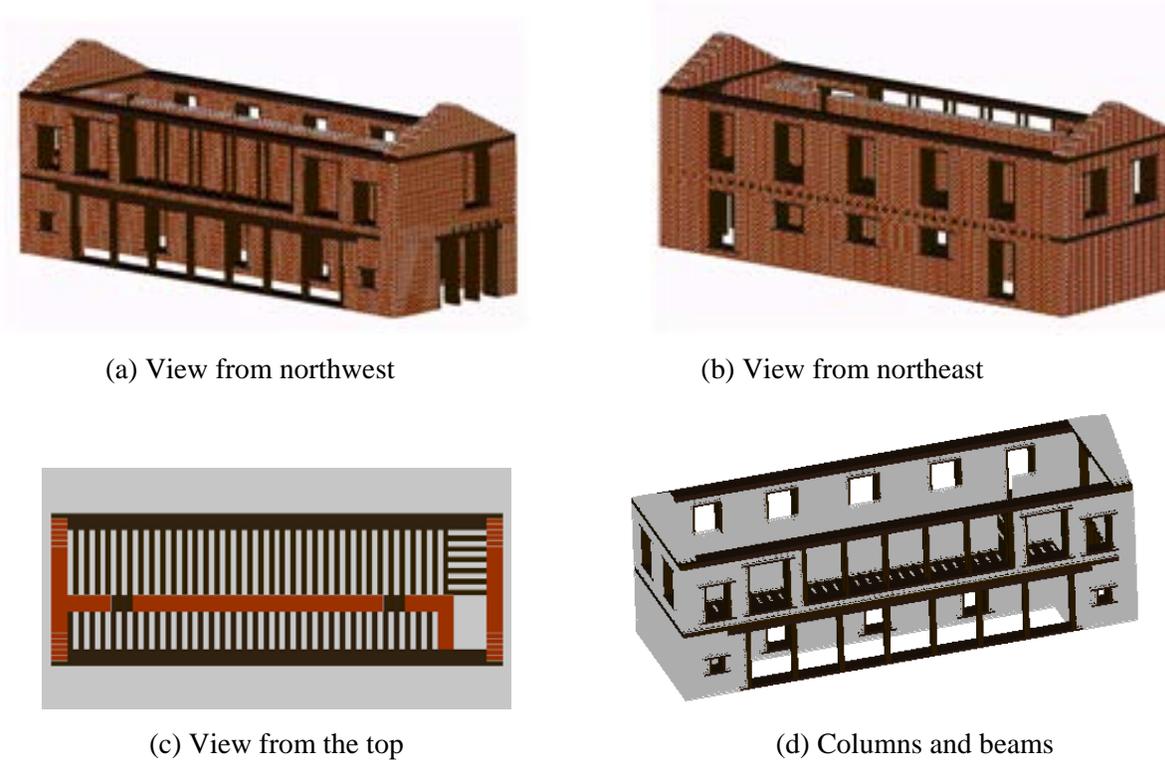
The analytical model is shown in Fig. 4a, b and c. Members except bricks, such as columns, beams and ring beams, are shown in Fig. 4d. The coordinate axis is shown in Fig. 4a. In the western wall, there are eight wooden vertical columns on the 1st floor, and six wooden vertical columns and two wooden horizontal beams on the 2nd floor. There are two ring beams atop both floors. The depth of the walls is 55 cm.

The building was modeled as an assembly of rigid elements of rectangular parallelepipeds. The size of each brick was  $10 \text{ cm} \times 10 \text{ cm} \times 20 \text{ cm}$ . The total number of elements was 63,978. The rigid elements were connected with each other by springs. The rigid element itself does not deform, but the building as a whole shows deformation by overlapping of the rigid elements. When one of the tensile, shear and compression stresses acting at the spring exceeds its strength, the spring is cut and failure occurrence is expressed.

Fig. 4 – Analytical model

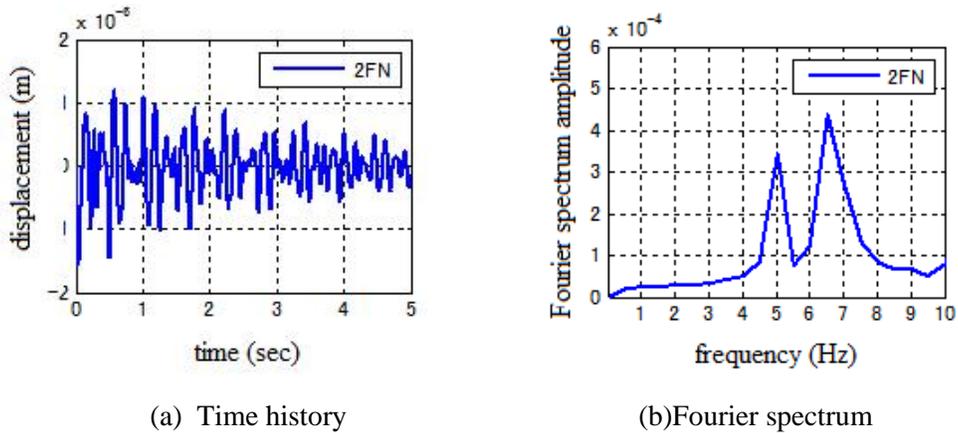
To obtain the natural frequencies in the analytical model, an impact acceleration of 100 gal was input to the building in the x and y directions separately, and the displacement response was computed at one point on the 2nd floor. The displacement history in the x direction when the impact acceleration was input in the x direction is shown in Fig. 5a. The Fourier spectrum is shown in Fig. 5b. The displacement history in the y direction when the impact acceleration was input in the y direction is shown in Fig. 6a. The Fourier spectrum is shown in Fig. 6b. From these figures, the Fourier spectra for the y direction has a peak ~4.0 Hz, which corresponds to the translational mode in the y direction of the first mode. The Fourier spectra in both x and y directions have their peak ~5.0 Hz, which can be considered the torsional mode of the second mode. The Fourier spectrum for the x direction has a peak ~6.6 Hz, which can be considered the translational mode in the x direction of the third mode. From this comparison between analytical results and microtremor observation, the analytical model expressed the vibration characteristics almost correctly, so the validity of that model was confirmed.

Fig. 5 – Displacement response in x direction when impact acceleration was input in x direction

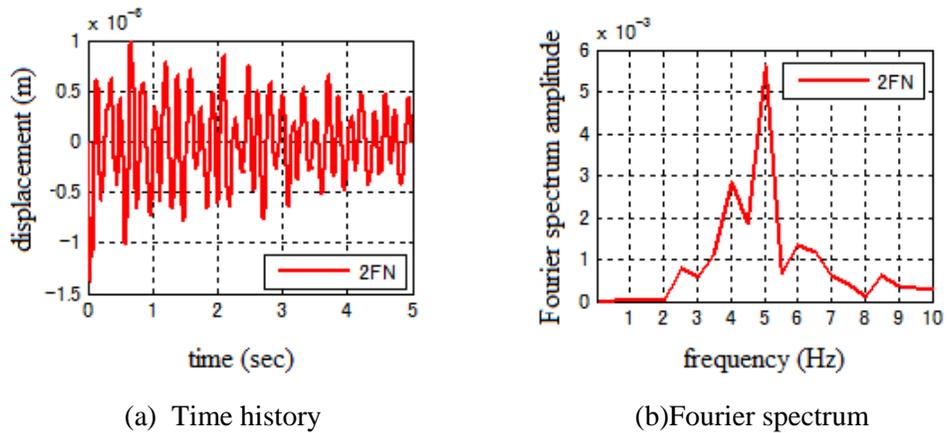
Fig.6 – Displacement response in y direction when impact acceleration was input in y direction

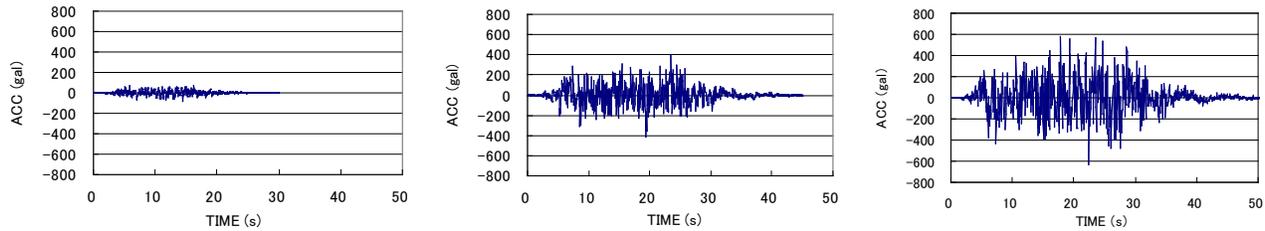
Numerical simulations were conducted by changing input ground motion. Input ground accelerations are shown in Fig. 7. These were estimated from Nepalese historic seismic data and active fault data using seismic hazard analysis [8]. Figure 7a shows acceleration with occurrence probability of 40% within 50 years (return period is 98 years) and a maximum acceleration of 84 gal. Figure 7b shows acceleration with occurrence probability of 10% within 50 years (return period is 475 years) and a maximum acceleration of 420 gal. Figure 7c shows acceleration with occurrence probability of 5% within 50 years (return period is 975 years) and a maximum acceleration of 630 gal. The analytical cases are shown in Table 3. There were six cases, with two directions and three occurrence probabilities.

(a) 40% (return period 98 year) (b) 10% (return period 475 year) (c) 5% (return period 975 year)

Fig. 7 – Input ground acceleration with various occurrence probabilities (%) within 50 years [8]

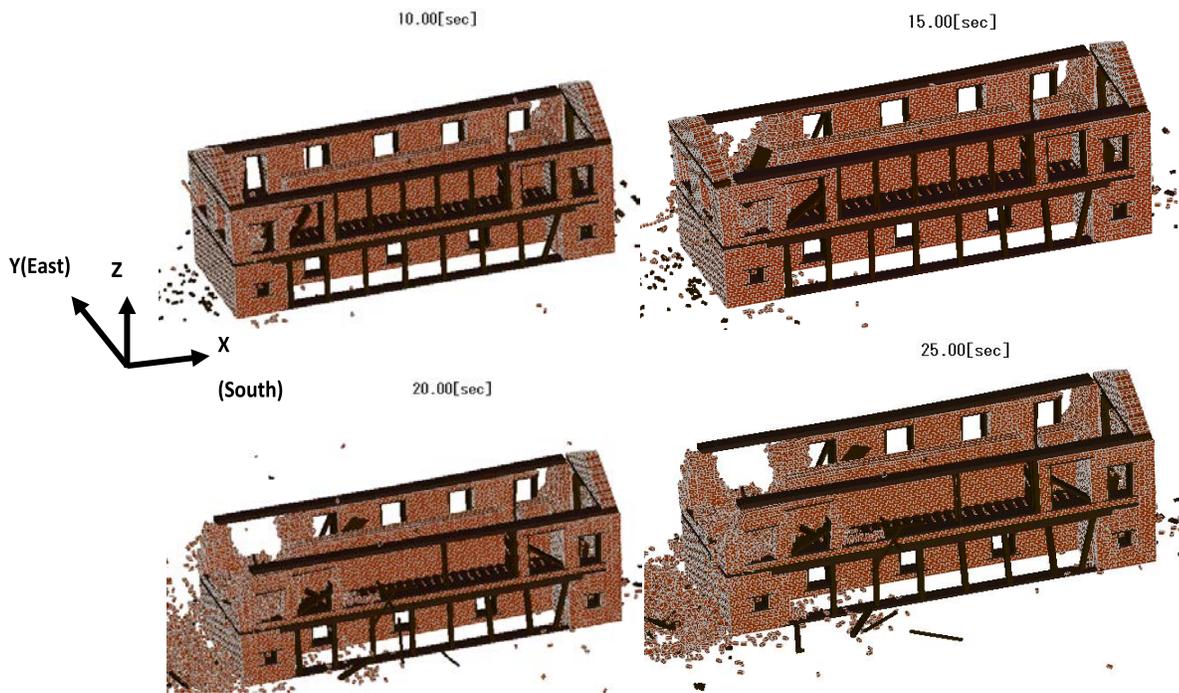
Looking at the triangle part on the shorter wall, the difference due to input ground motion directions cannot be seen. The northern wall completely collapsed and the southern wall partially collapsed. This is because the northern wall had larger openings on the second floor, which made that wall vibrate more.

When the input ground motion was input in the x direction (case 1X), more damage occurred to the wider wall compared to the case in which the input ground motion was input in the y direction (case 1Y). In case 1X, the northern part of the wall on the east side had severe damage. This is because ground motion in the x direction excited vibration of the shorter wall in the out-of-plane direction. The wall on the north side had larger openings on the 2nd floor, and was more likely to vibrate compared to the wall on the south side. Therefore, the upper part of the northern wall separated from the other part and collapsed, which caused failure of the eastern wall. The northern wall failed because of vibration in the out-of-plane direction, whereas the southern wall had slight damage. These observations show that the southern part with smaller openings on the 2nd floor had greater earthquake resistance than the northern wall. In case 1Y, both eastern and western walls were wide with larger openings, and vibrated readily in the out-of-plane direction. However, the western wall had less damage than the eastern wall. This is because columns in the western wall served as reinforcement and prevented its failure.

Fig. 8 – Seismic behavior in case 1X (ground motion input in x direction; 40% within 50 years)

The input ground motion with occurrence probability of 40% within 50 years was input in the x and y directions separately. Seismic behavior for these directions is shown in Figs. 8 and 9.

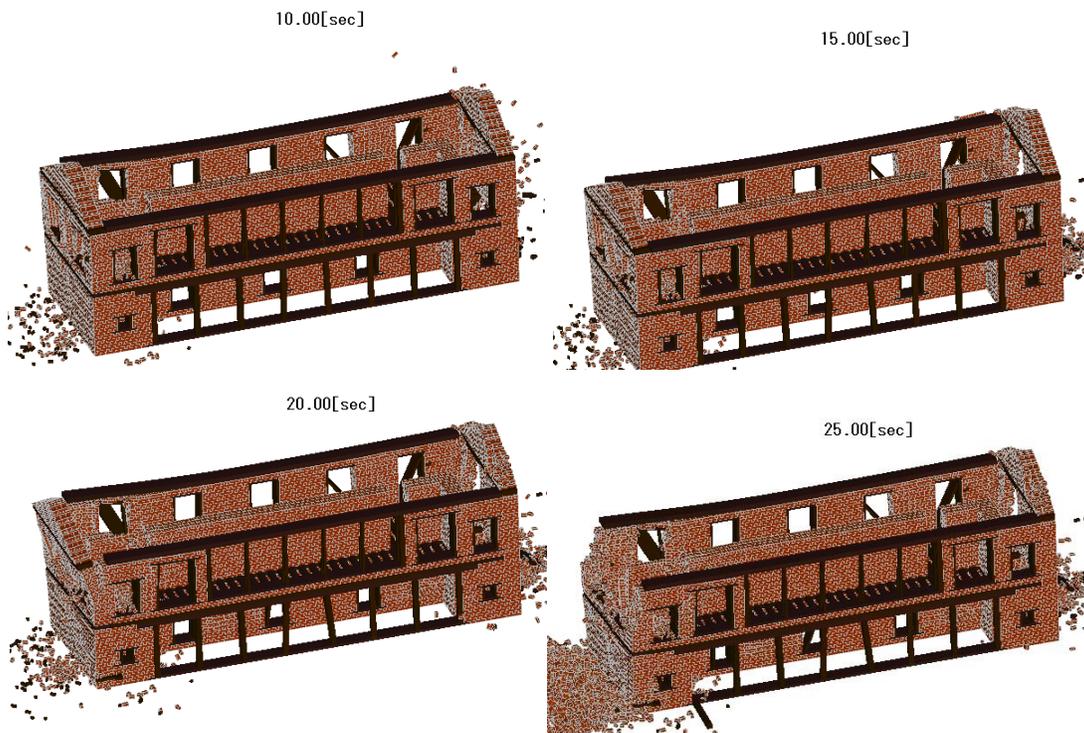
Fig. 9 – Seismic behavior in case 1Y (ground motion input in y direction; 40% within 50 years)

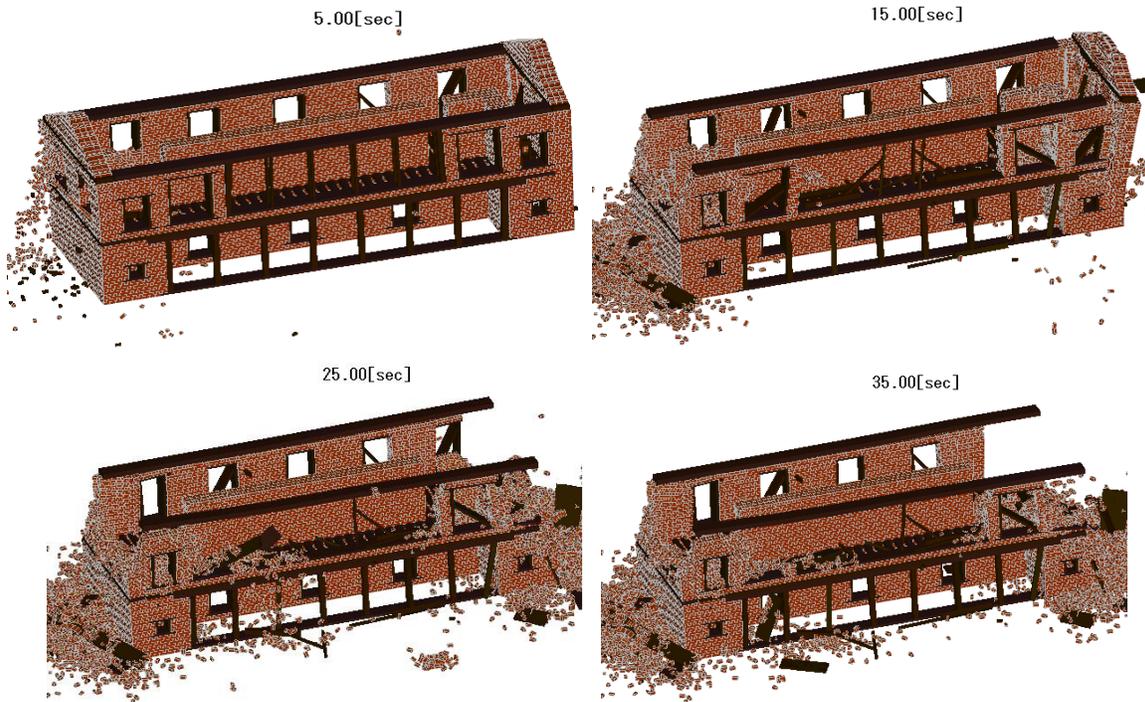
When the ground motion was input in the y direction, the building completely collapsed. The eastern wall first separated from the buildings and collapsed, then the shorter wall collapsed, and the western wall collapsed last. The reason why the western wall with the largest openings collapsed last is that the columns resisted tensile failure. When the ground motion was input in the x direction, both shorter walls were damaged on the 2nd floor, followed by failure of the 1st floor. This damaged southern parts of the eastern and western walls.

Fig. 10 – Seismic behavior in case 2X (ground motion input in x direction; 10% within 50 years)

Ground motion with occurrence probability of 10% within 50 years was input in the x and y directions separately. Seismic behavior for these directions is shown in Figs. 10 and 11.

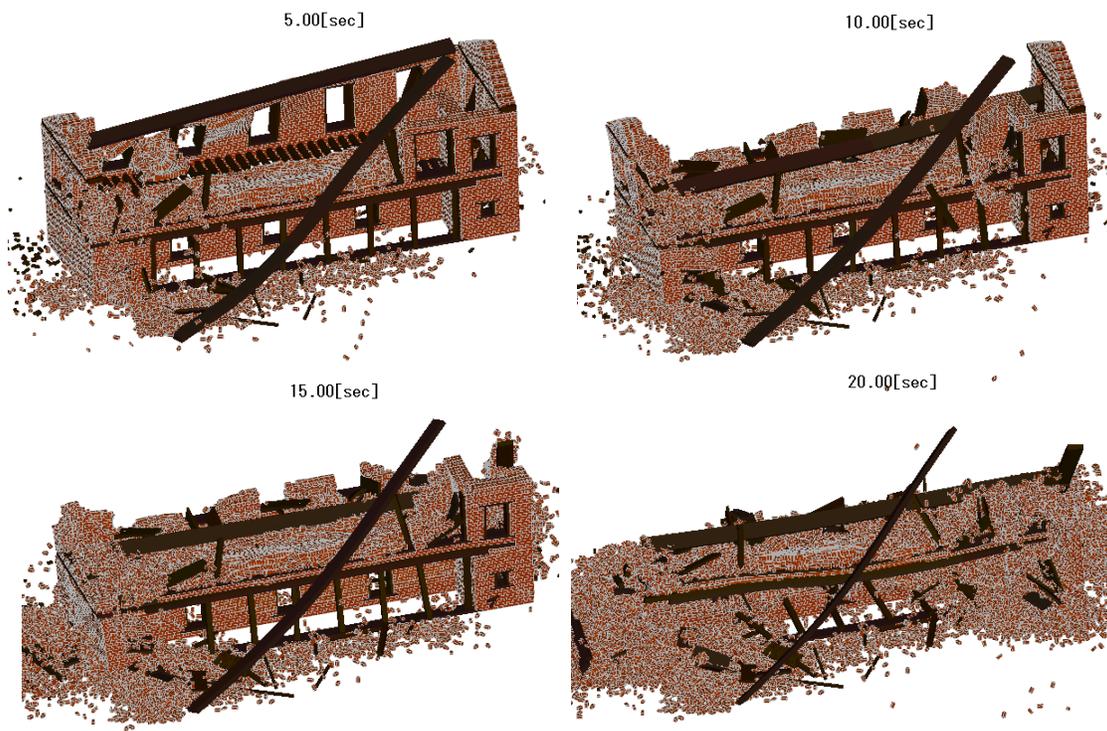
Fig. 11 – Seismic behavior in case 2Y (ground motion input in y direction; 10% within 50 years)

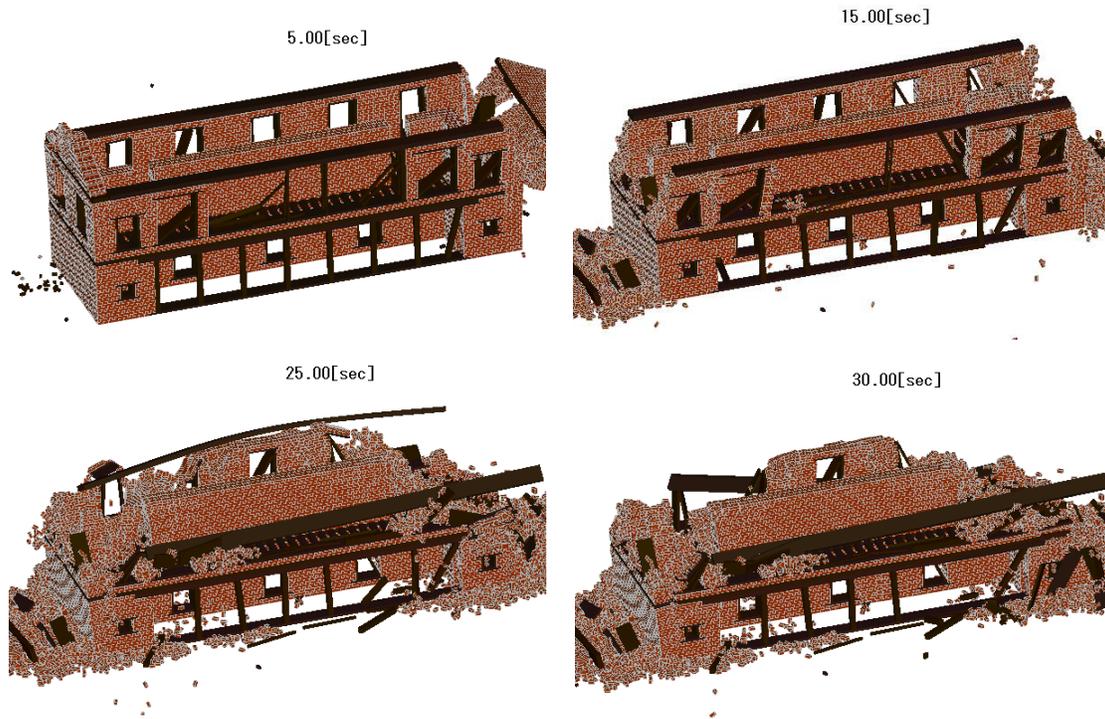
Finally, input ground motion with occurrence probability of 5% within 50 years was input in the x and y directions separately. Seismic behavior for these directions is shown in Figs. 12 and 13. Similar to the case with occurrence probability of 10%, the buildings collapsed when ground motion was input in the y direction. When that motion was input in the x direction, the 2nd floor collapsed but the 1st floor did not.

Fig. 12 – Seismic behavior in case 3X (ground motion input in x direction; 5% within 50 years)

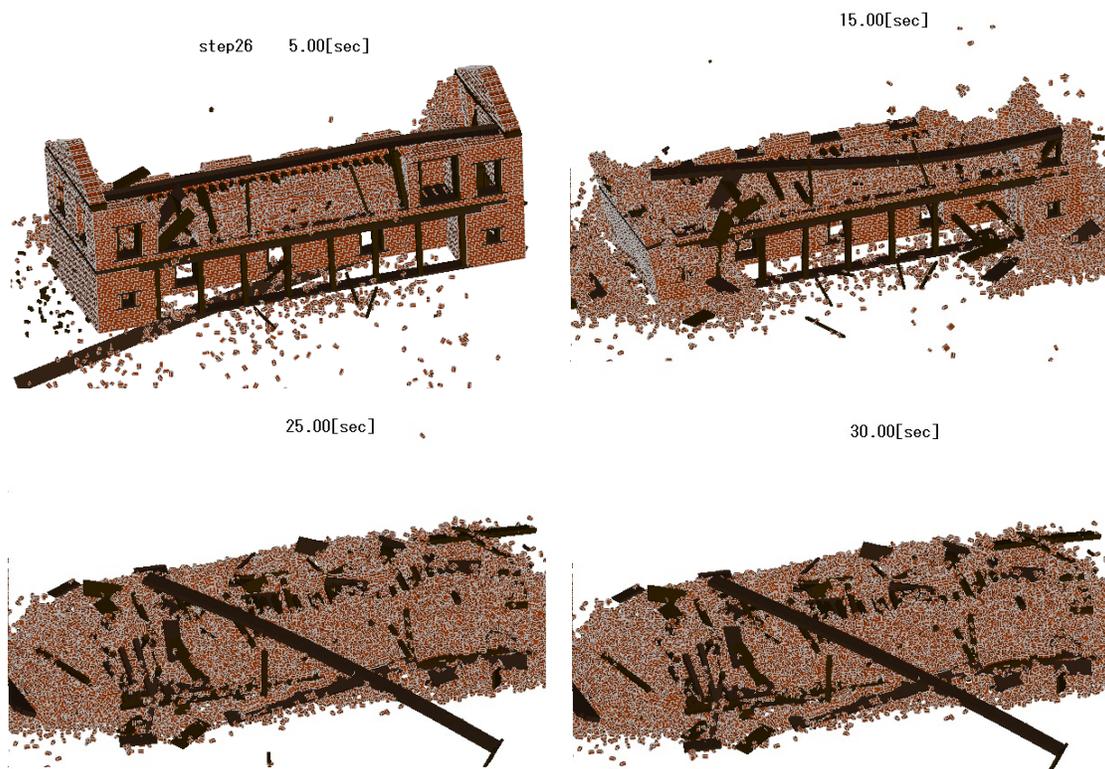
Fig. 13 – Seismic behavior in Case 3Y (ground motion input y direction; 5% within 50 years)
