## CYCLIC LOAD BEHAVIOR OF CONFINED MASONRY WALLS OF HORIZONTALLY-HOLLOW BRICKS RETROFITTED WITH WIRE MESHES

D. Quiun<sup>(1)</sup>, P. Mamani<sup>(2)</sup>

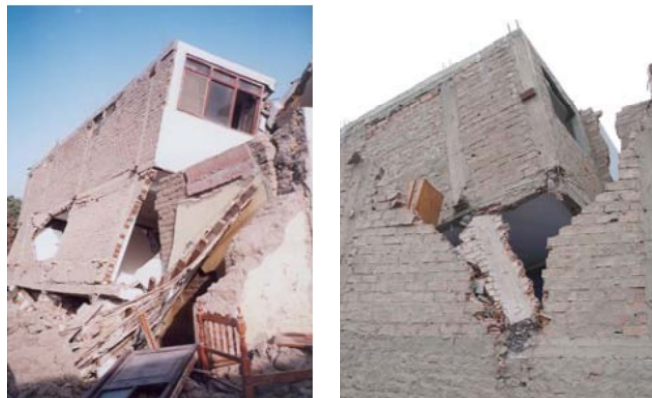
Fig. 1 – Masonry buildings that collapsed in 2007 Pisco earthquake [3].

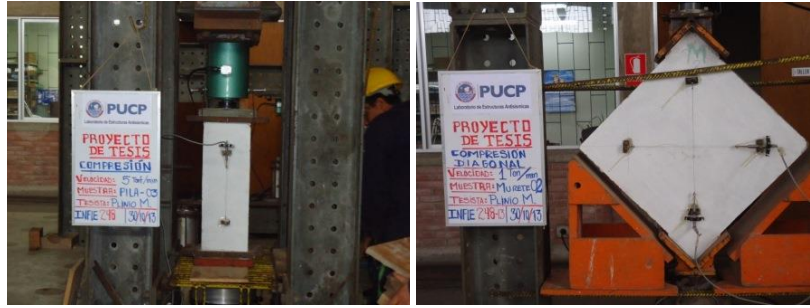
Three masonry prisms were built and reinforced using the wire mesh, with 220x160x620 mm overall dimensions. They were tested under axial compression, using a load velocity of 50 kN/min. The masonry compressive strength was calculated as  $f'_m=2.65$  MPa, and the elastic modulus was  $E_m=5835$  MPa (Fig. 4, left). Also, three masonry wallets of 160x620x620 mm overall dimensions were constructed and reinforced with the wire mesh. They were tested under diagonal compression using a load velocity of 10 kN/min. The shear masonry resistance was calculated as  $v'_m=0.88$  MPa, with a shear modulus of  $G_m=1275$  MPa (Fig. 4, right).

Fig. 4 – Masonry tests on axial compression (left) and diagonal compression (right).

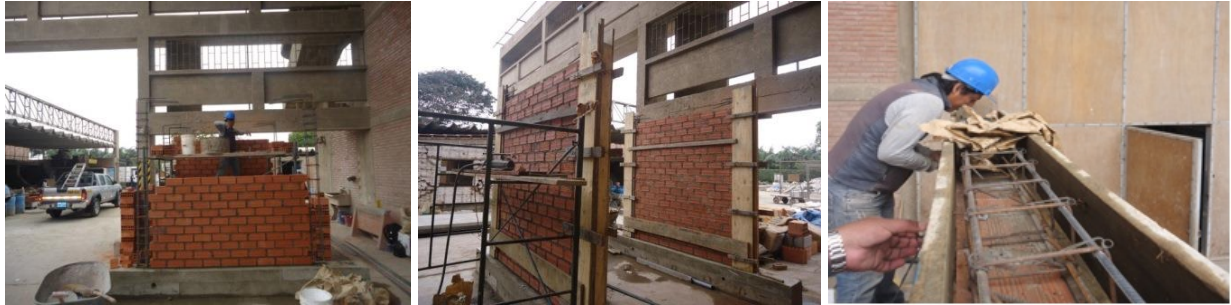
The two confined masonry walls were built in the traditional way, similar to the previous walls [6]. Afterwards, the welded wire mesh was added on both sides and covered with a cement-sand mortar. For both walls the same materials, same workmanship, and same kind of reinforcement in the confinement were used. The horizontal and vertical joints were 15 mm thick, using cement:sand mortar in a volume proportion of 1:4. The brick units were wetted for half an hour approximately 10 hours prior to their placement. The connection of the reinforced concrete tie-columns to the masonry wall was toothed. To prevent the concrete of the columns to enter the horizontal holes of the border bricks, pieces of paper were used to fill such holes. The masonry wall was constructed in two days, half of the height each day. After that, the column's formwork was set and the concrete was poured. The concrete used in the confinement elements had a resistance of 18.6 MPa, according to the samples taken during the construction. No holes were found in the tie-columns after the construction. Finally,

the concrete of the tie-beam was poured and the specimens were let to dry for 28 days. Figure 6 illustrates construction process.

Fig. 6 – Construction of the masonry walls (left), tie-columns (center) and tie-beam (right)

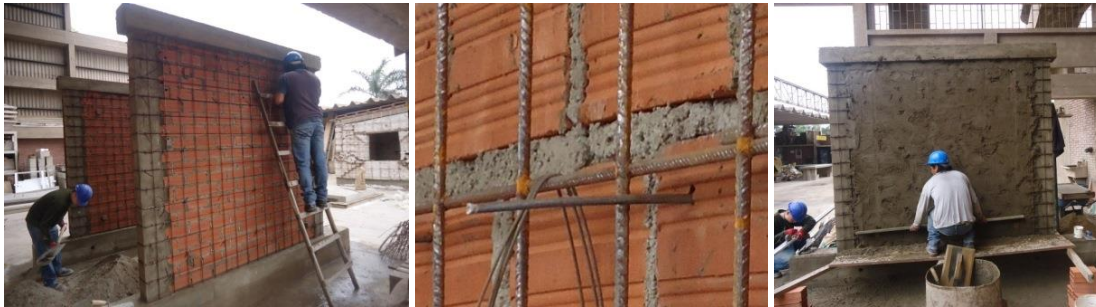
In the already built walls, the welded wire mesh was placed on both sides (Fig. 7, left). Some bricks were perforated with a 6 mm diameter steel bar and a hammer, every 450 mm, to allow a connecting wire to cross the masonry wall (Fig. 7, center). These connecting wires were bent in a 90° hook and tied to the wire mesh with smaller ties. Later, the perforations were filled with a cement grout in a proportion of cement and sand of 1:3. Finally, both sides of the wall were covered with cement-sand mortar in a proportion of 1:4 (Fig. 7, right).

Fig. 7 – Placement of the welded wire mesh (left), connecting wires (center), mortar cover (right)

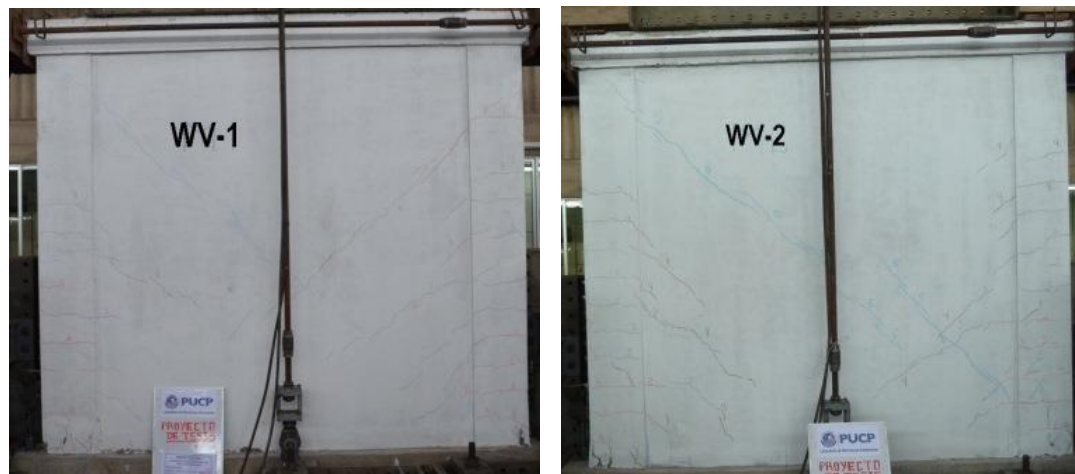
Fig. 9 – Wall WV-1 (left) and wall WV-2 (right), step 5.

Vertical load of 108 kN was applied to wall WV-1 and no cracks developed. In step 2, for a lateral load of 167 kN, the crack at the bottom of the column had a width of 0.05 mm. In steps 3 and 4, the cracks developed toward the wall center, having widths of 0.5 mm. The diagonal crack at the wall center appeared in step 5 with a maximum lateral load of 365 kN and a crack width of 0.7 mm. Finally, in step 6 the cover of the concrete columns spalled and cracked, and a shear friction failure occurred characterized by sliding at the wall base (Fig. 10, left).

Vertical load of 157 kN was applied to wall WV-2 without any cracks. In step 2, for a lateral load of 182 kN the crack at the bottom of the column had a width of 0.05 mm. In steps 3 and 4, the cracks developed toward the wall center. The diagonal crack at the wall center appeared in step 5 with a maximum lateral load of 414 kN and a crack width of 1.3 mm, and crushing of the concrete at the column base took place (Fig. 10, right). Finally, in step 6 the concrete columns base continued to crush until the shear friction failure occurred with sliding displacements of 15 mm at the wall base at the end of the test (Fig. 11).

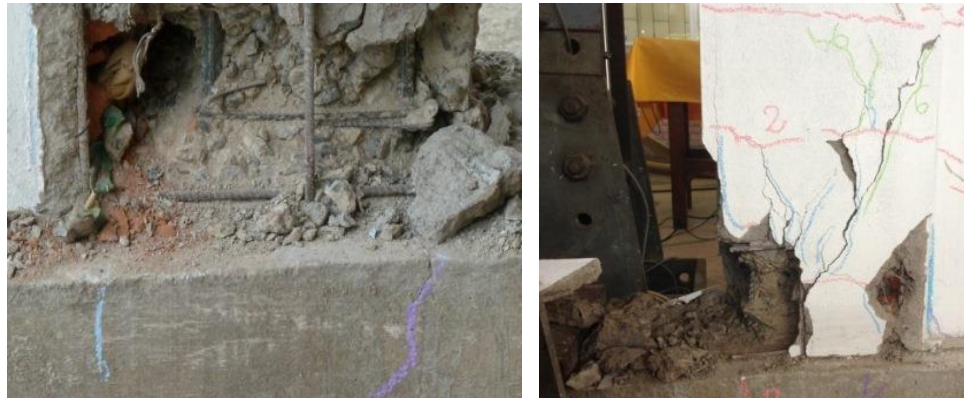
Fig. 10 – Crushing of the bottom of the columns for wall WV-1 (left) and wall WV-2 (right).
