## DAMAGE PROBABILITY MATRICES FOR EIGHT HISTORIC CENTERS AFTER THE 2009 L'AQUILA EARTHQUAKE

In this paper, the results of a damage reconnaissance activity carried out on eight minor historic centers of Abruzzi after the 6.3 Mw L'Aquila earthquake, occurred on the 6<sup>th</sup> of April 2009 in the central area of Italy, is presented.

The second part of the paper is focused on the occurred damage scenarios. The most frequent failure mechanisms of macro-elements are shown and the observed damage is classified according to the grades introduced by Grünthal for the definition of the EMS-98 European Macro-seismic scale.

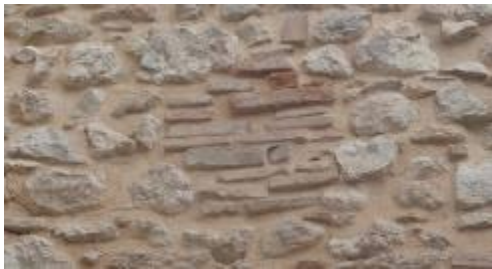
c)

Anti-seismic measures can be found in centers hit by past strong earthquakes. Iron ties were often inserted to prevent out-of-plane overturning of external walls and façades. These are characterized by different details, mostly of the anchor plates (Fig. 4a), depending on the period in which they were applied to the original walls of the buildings. Moreover, in some cases, the presence of buttresses is clearly evident (Fig. 4.b) while, for some specific buildings, “scuci and cuci” interventions can be read in the wall pattern (Fig. 4.c). Mortar injections and reinforced concrete plaster (fig. 4.d) have been applied only seldom.

Fig. 4. Anti-seismic strengthening interventions observed in some of the studied minor historic centers: (a) Iron ties with different type of anchor plates and (b) buttresses observed in San Benedetto in Perillis; (c) “Scuci and Cuci” intervention in Bazzano and (d) Reinforced plaster in Castelvechio Subequo

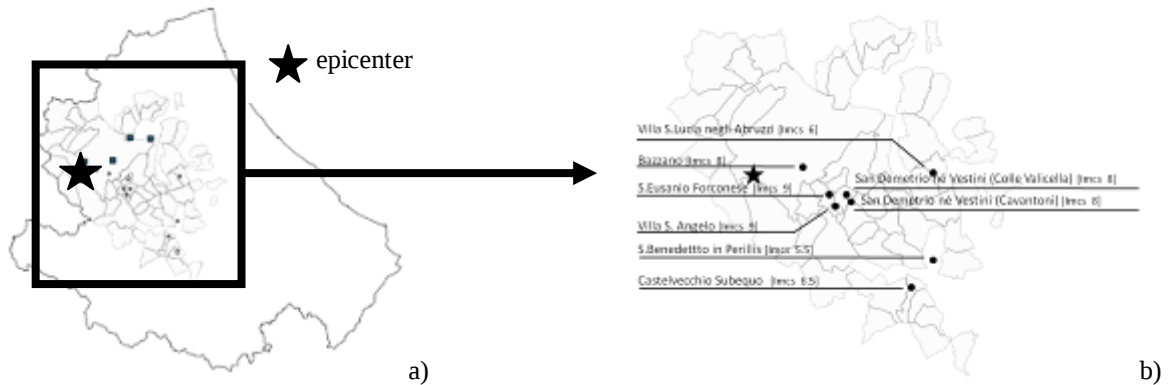
After the 2009 seismic event, a damage reconnaissance activity on more than 1000 buildings belonging to eight minor historic centers of the inner Abruzzi has been carried out. Namely, the minor centers inspected were: Sant'Eusanio Forconese, Villa Sant'Angelo, Bazzano, San Demetri né Vestini-Cavantoni, San Demetrio né Vestini-Colle Valicella, Villa Santa Lucia degli Abruzzi, Castelvechio Subequo, San Benedetto in Perillis. All these villages belonged to the so-called seismic crater, which is the area of Abruzzi region evidenced in Fig. 5a that was significantly stroke by the earthquake, so that the Italian Government funded its Reconstruction. In Fig. 5b an enlarged view of the area is proposed with the eight studied centers. For these the macro-seismic magnitude measured in the Mercalli-Cancani-Sieberg (MCS) and their position with respect to the epicenter is shown.

Fig. 5. a) Seismic crater of the 2009 L'Aquila earthquake; b) the eight studied historic centers

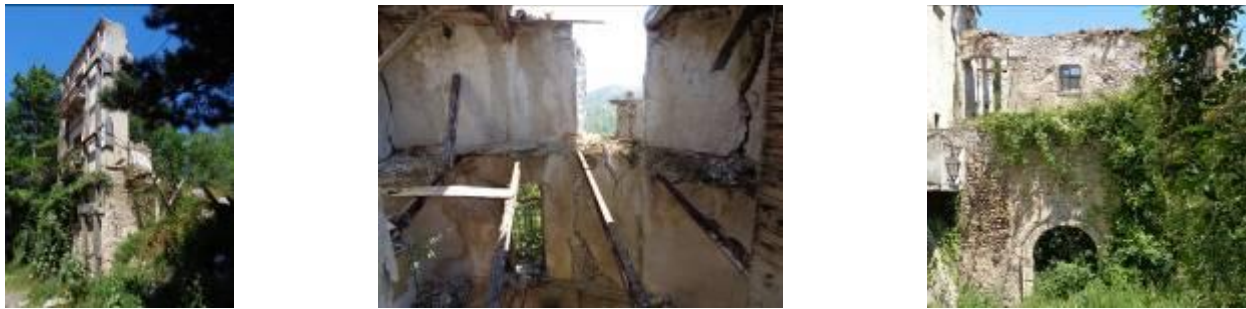
fact, for the center of San Benedetto in Perillis, we found several collapses that do not justify the assigned MCS intensity of 5.5 (Fig. 6).

Fig. 6. The observed buildings' collapses in San Benedetto in Perillis

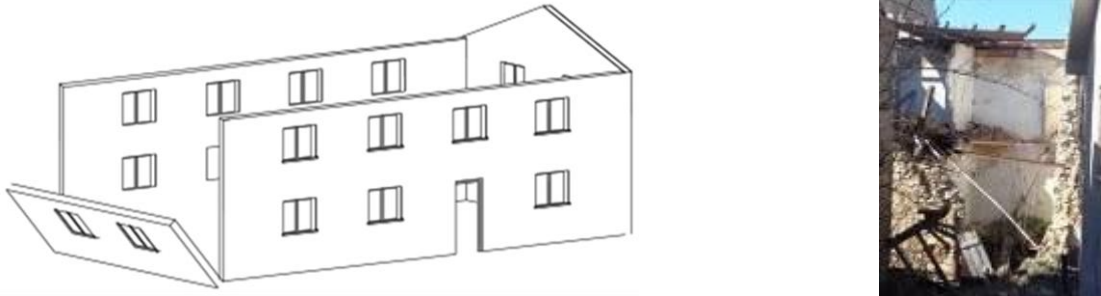
Many out of plane mechanisms were observed in case of lack of ant seismic devices able to restrain them, such as iron ties, or buttress or connection with transversal walls. In Fig. 8, one of the revealed complete overturning of one of the external walls is depicted. This was also favored by the slenderness of the masonry, as well as by the lack of floor or roof system able to act as a diaphragm.

Fig. 8. Complete overturning of a perimeter wall in Sant'Eusanio Forconese

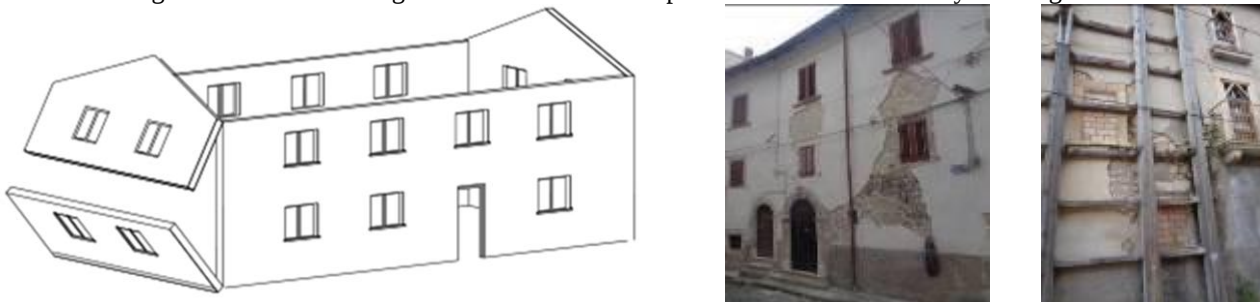
Fig. 10. Out-of-plane flexural mechanisms of the external leaf of a perimeter wall equipped with iron ties of a masonry building in Castelvechio Subequo

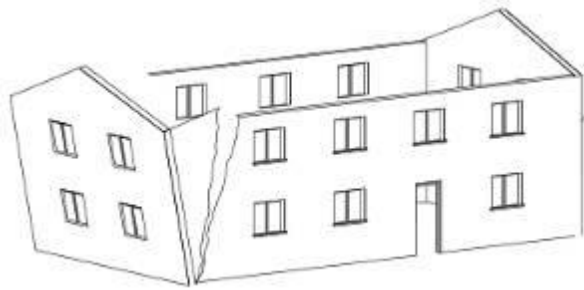
The presence of openings in the transversal walls favored overturning mechanisms also in case of good inter-connection of the tilted walls at their edges. An example is given in Fig. 11, where an “overturning with side wing” observed in Sant'Eusanio Forconese is shown.

Fig. 11. Partial overturning of the external leaf of a perimeter wall of a masonry building in Sant'Eusanio Forconese
