## PERFORMANCE OF REPAIRED SMA SHEAR WALL

### ***Abstract***

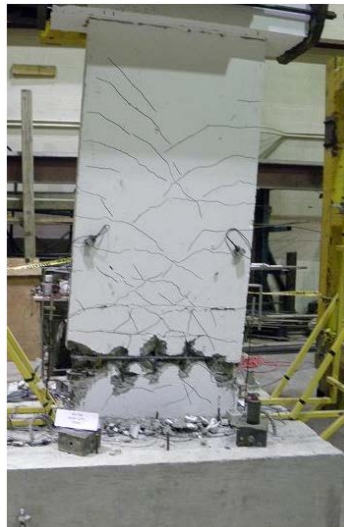
During the original testing, Wall W2-NR suffered extensive damage in the plastic hinge region. Few, but larger cracks surfaced on the wall. This was attributed to the smooth surface of the SMA bars. In addition, the wall experienced a major crack just above the termination of the starter bars, where most of the damage was experienced. This crack location controlled the behavior of the wall to failure. Spalling of the concrete in the boundary regions of the wall was also evident. Fig. 2 illustrates the state of Wall W2-NR prior to failure.

Fig. 2 – Condition of Wall W2-NR prior to failure (Abdulridha [1])

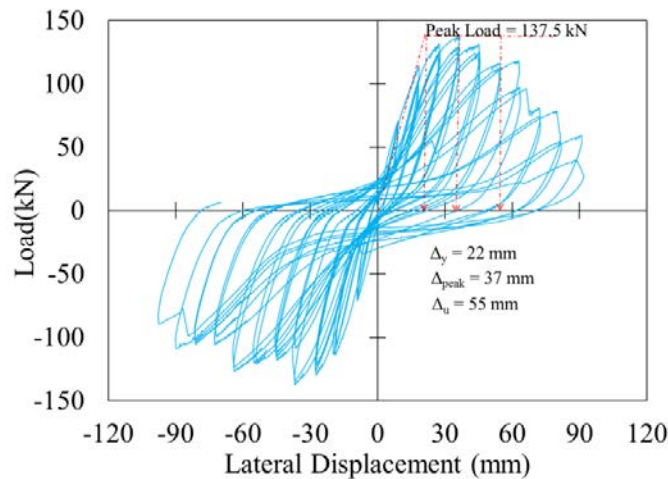
The lateral displacements recorded from DCT C1, located at the top of the wall, were used to generate the lateral load-lateral displacement hysteretic response for Wall RW2-NR, as illustrated in Fig. 8.

Fig. 8 – Lateral load-lateral displacement response of Wall RW2-NR

The response prior to yielding was linear, indicating elastic behaviour. After the first cycle, a reduction in strength was evident during the second and third repetitions of loading due to degradation in stiffness caused by reverse cyclic loading. Yielding of the wall was calculated using the equivalent elasto-plastic system with a secant stiffness passing through the load-displacement response at 75% of the average nominal strength (Park [4]). Yielding occurred at a displacement level of 22 mm, corresponding to a lateral load 119 kN. The peak lateral strength of 137 kN was recorded at a displacement of 37 mm. The ultimate displacement, corresponding to the displacement prior to the lateral load capacity of the wall dropping below 80% of the maximum load capacity (Park [4]) was 55 mm. The yield and ultimate lateral loads and displacements were based on the positive direction of loading.

In the post-peak regime, Wall RW2-NR experienced a significant degradation of strength of approximately 15% due to rupture of one SMA bar in the boundary zone while loading to a displacement level of 63 mm. Rupturing of the SMA bar affected the deformation recovery by 20% with respect to the first repetition of loading at a displacement level of 63 mm. During the subsequent loading stage to 72 mm of displacement in the positive direction, an additional SMA bar ruptured in the same boundary zone. This second fracture resulted in a significant reduction in the recovery capacity of the wall. Beyond this displacement level and up to failure of the wall, rupturing of the other SMA bars was evident. Rupturing of the SMA bars occurred along the plane where the sharp-end screws of the coupling system pierced through the SMA bars. Therefore, Wall RW2-NR did not realize its full lateral drift capacity. Future testing will investigate other coupling alternatives. Spalling of the concrete was first evident at a drift level of 1.5% (36 mm) in boundary zone at the location of coupler connecting the SMA bars to the new conventional reinforcing bar. Two probable reasons for spalling at a low drift level were: (1) reduced concrete cover caused by the presence of the mechanical couplers;

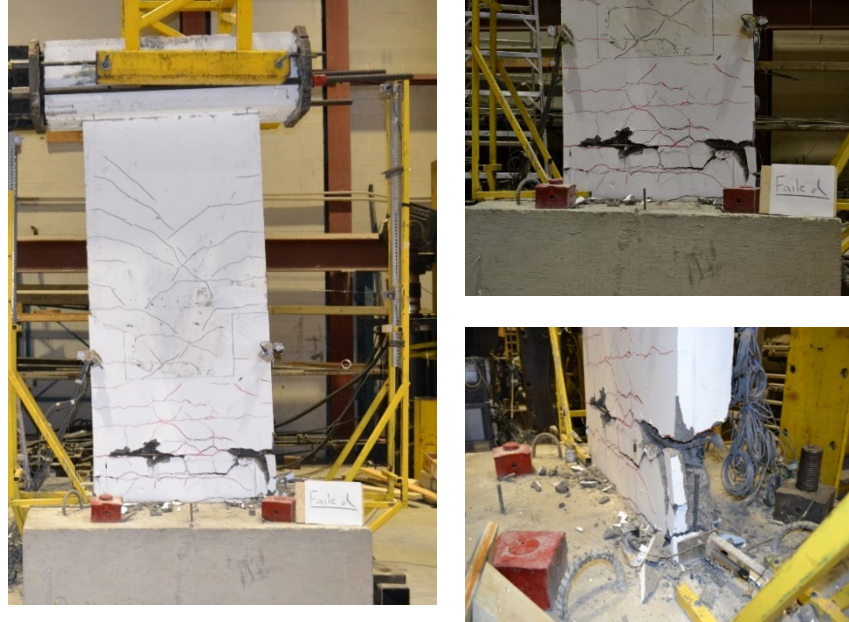
At the end of testing, damage was concentrated along a crack located at 260 mm from the base of the wall. No new cracks surfaced in the region above the plastic hinge zone that remained intact after the original test. However, existing cracks in this region re-opened during testing. Fig. 9 illustrates the damage state of the repaired wall after testing.

Fig. 9 – Damage state of Wall RW2-NR at the end of testing

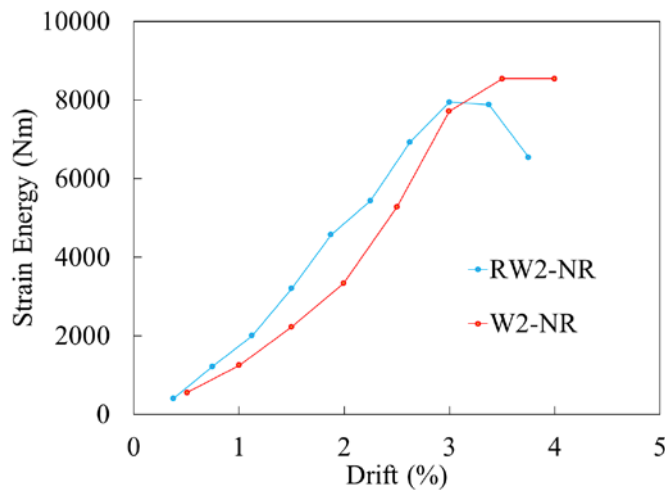
Fig. 13 provides the energy dissipated by the walls during the first repetition of loading at each drift level. Overall, RW2-NR dissipated more energy than W2-NR due to a reduction of pinching. The largest difference in energy dissipation in the walls was at 2% drift where RW2-NR dissipated 27% more energy than W2-NR. At 3% drift, both walls dissipated similar energy (approximately 7700 Nm). Beyond 3% drift, W2-NR dissipated more energy than RW2-NR due to a loss in lateral load capacity in RW2-NR after a number of the SMA bars had fractured.

Fig. 13 – Energy dissipation-drift response
