LARGE-SCALE TESTING OF A REPLACEABLE CONNECTION FOR CONCENTRICALLY BRACED FRAMES

D. Stevens⁽¹⁾, L. Wiebe⁽²⁾

Abstract

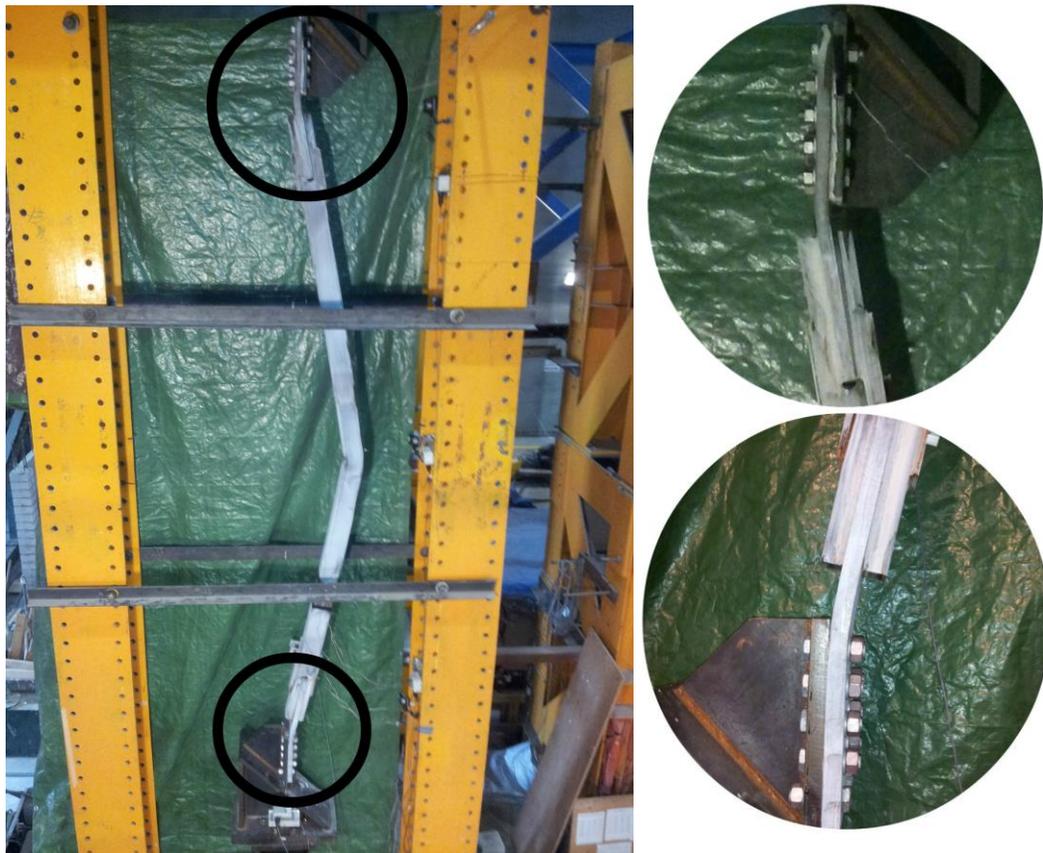
Fig. 9 – Rotation in the hinge plates under peak compressive displacement (Specimen #2)

All three tests experienced yielding and failure in the intended regions. The brace yielded in tension and buckled in compression with no undesirable buckling mode. Fig.9 shows the rotation of the hinge plates that occurs as the brace end buckles. Yielding in the top hinge plate was confined to the region between the brace end and the bottom of the support plate, as seen in Fig.10(a). Yielding in the bottom plate was spread over a larger area, with the largest yielding occurring along the centerline of the first row of bolts, as seen in Fig.10(b). No tears or major damage occurred in the hinge plates or the hinge to brace welds. Due to the thickness of the hinge plate, the bolt holes had no identifiable ovalization. All three tests failed due to fracture of the brace in the midspan. In all three tests, the brace experienced significant local buckling in the compression cycle and then tore in the following tension cycle, as seen in Fig.11. This is consistent with the brace failure sequence that is observed with more conventional connections [6].
