## UNSTABLE BEHAVIOR OF SUSPENDED CEILING DURING EARTHQUAKE

**Keywords:** *suspended ceiling, unstable behavior, seismic performance*

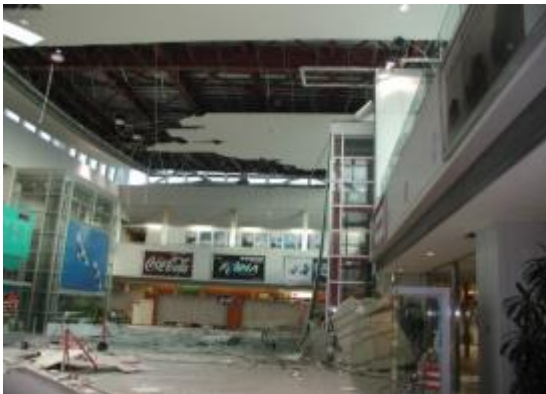
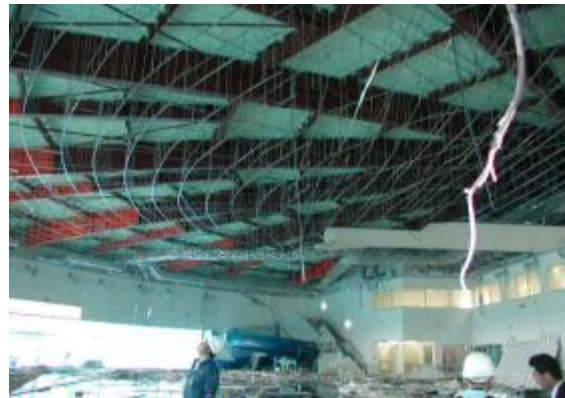
Photos.1 Damage of ceiling in earthquakes

(a) Kushiro Airport Terminal Building  
Maximum acceleration at the ground: 0.2G  
Tokachi-oki earthquake (2003)

(b) Sendai Indoor Swimming Pool  
Maximum acceleration at the ground: 0.2G  
Miyagi Prefecture Earthquake (2005)

In recent earthquakes, non-structural components such as ceilings were seriously damaged as shown in Photos. 1, while most structural frames of such buildings were not and the maximum acceleration values recorded at the site nearby were also comparatively small. It is no doubt that such failures of ceilings may kill residents and obstruct their daily lives owing to the malfunction of indoor space for a certain amount of time. The social problem was actualized in the Great East Japan Earthquake, in which the social system such as product lines and distribution systems had been shut down by the failure of non-structural components for a long time. Securing indoor space has been one of the most urgent issues to deal with. It should also be noted that such ceiling damages have been observed not only in Japan but also in other countries with earthquakes, where different construction methods for suspended ceilings were taken.

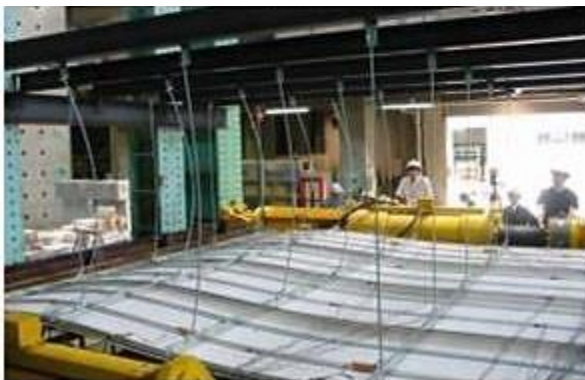
Photos.5 Deformed shape

(a) Experimental result

(b) Numerical result
