## LIQUEFACTION IN KATHMANDU VALLEY DURING 2015 GORKHA (NEPAL) EARTHQUAKE

M. Maharjan<sup>(1)</sup>

<sup>(1)</sup> Geotechnical Engineer, Atkins Ltd, UK, Formerly PhD Student at Tokyo Institute of Technology, [manika.maharjan@atkinsglobal.com](mailto:manika.maharjan@atkinsglobal.com)

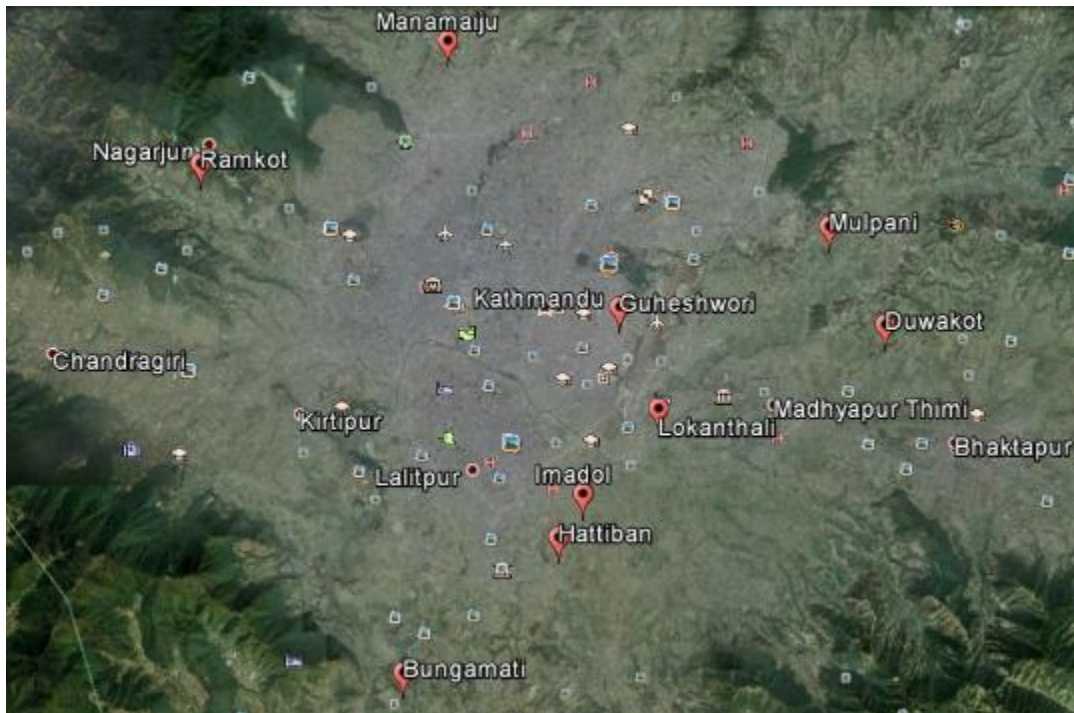
The reconnaissance survey visited as listed in Fig.7 and Table 1. Confirmation of liquefaction was based on clear evidence, such as sand boils, lateral spreading, upliftment and settlement of structures. The main evidence observed was sand boils. The degree of liquefaction does not have been sufficient to cause extensive settlement of structures.

Fig. 7 – Liquefaction sites in Kathmandu Valley visited during field survey from May 6 to May20, 2015

The location of liquefaction sites as shown in Fig.7 indicates that the location was limited to the valley sides (the basin edges) around the Kathmandu Valley after M7.8 Gorkha earthquake. This is due to the basin edge effects which resulted in ground motion amplification and change in the frequency content at the basin edge caused by the constructive interference of the direct shear waves propagating vertically through basin sediments and a horizontally propagating surface waves diffracted into basin. Such observation is relevant to the damage observed during 1994 Northridge and 1999 Kobe earthquake [21] [22].

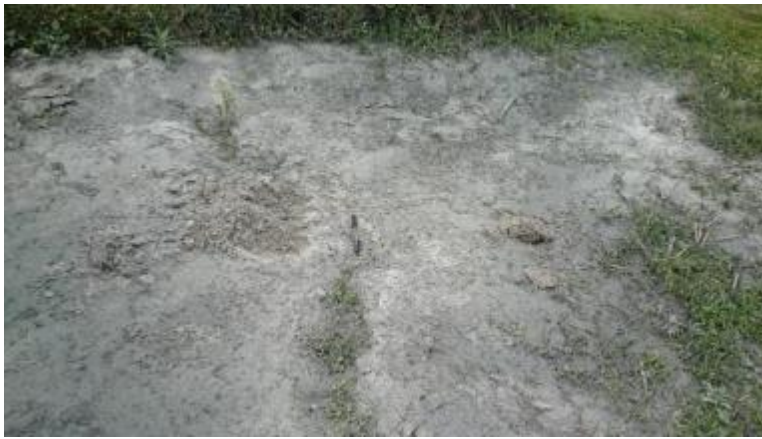
Sand boils were observed at all the liquefaction sites except Lokanthali as shown in Figs.8-10. Fig.8a shows sand boils on open ground at Duwakot, Bhaktapur on the eastern edge of the Kathmandu Valley. A number of sand boils were observed in this floodplain area about 300 m from the Manohara river as shown in Fig.8a. The ejected soil was silty clay found in the banks of the river. The liquefaction site near Mulpani is located about 1 km south east on the same floodplain of Duwakot. Significant sand boils were observed in a potato field with fissures of about 5 to 15 cm width extending for a length of about 200-300 m (Fig.8b). Numerous sand boils in cropfields were also observed at the Imadol, Lalitpur and Hattiban sites. Both Imadol and Hattiban sites are located on the floodplain of Manohara river. Similar to the Duwakot area, sand boils occurred on the floodplain about 200 m from the Bagmati river at Bungamati site (Fig.9a).

Fig. 8 – (a) Sand boils in Duwakot, Bhaktapur (b) Sand boils observed in the potato field with the fissures in Mulpani.

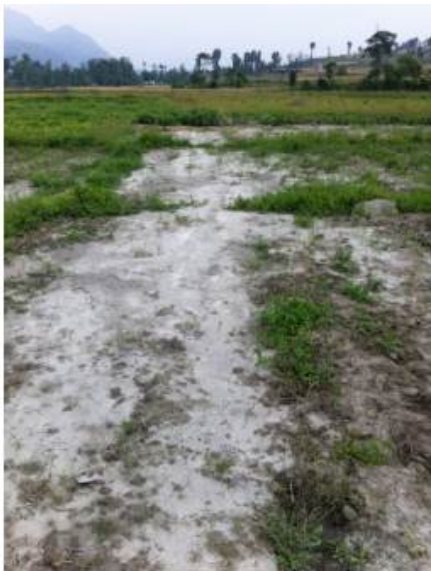
Fig. 9 – (a) Sand boils observed on the floodplain about 200 m from the Bagmati river at Bungamati site (Photo courtesy: Diwakar Khadka) (b) Massive sand boils observed at Ramkot site in sloping terrace

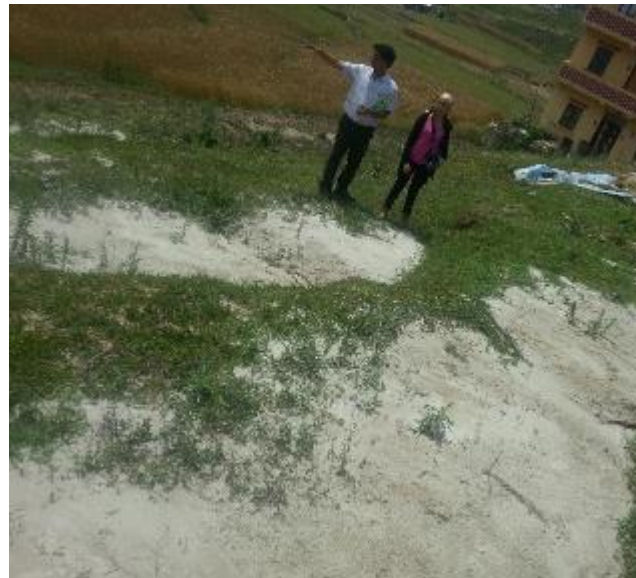
(b)

Massive sand boils were observed at the Ramkot site at the western edge of the Kathmandu Valley. The site is on a steep terrace where liquefaction of very fine material was observed (Fig.9b). The site is about 100m northeast of a meandering Manamati river. Large volume of fine materials was ejected to the ground surface.

However, no lateral deformation of terraces was found. According to locals, the boils were ejected upto a height of 2 m for about 2 hours following the M7.8 earthquake.

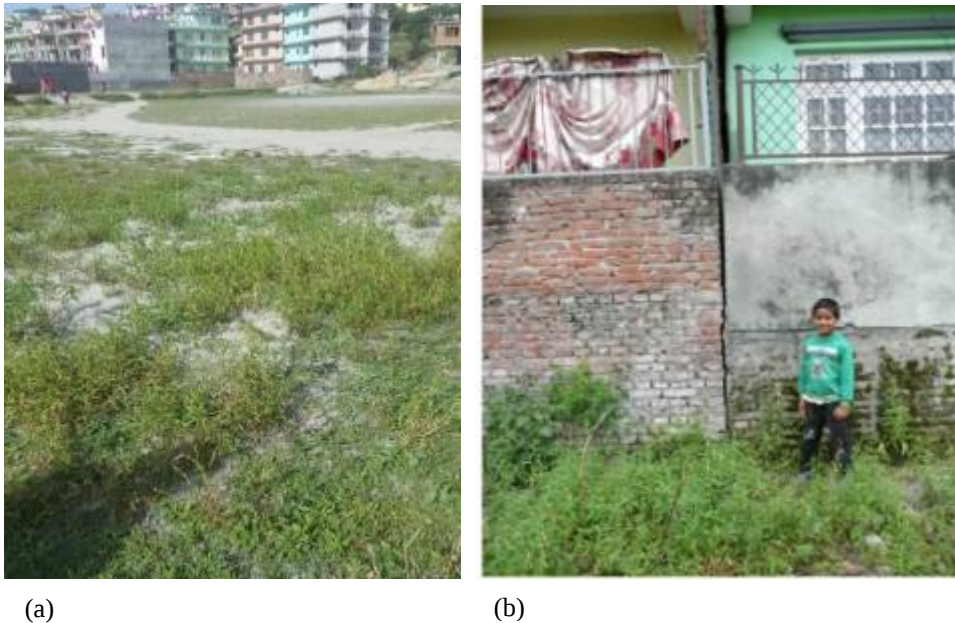
The evidence of liquefaction was observed both in the open ground and under building foundations at the Manamaiju site. Sand boils of fine sand were observed in the open ground and some minor tilting of building was observed which might be possibly due to the lateral spreading along a free end (Fig.10). A large area

Fig. 10 – (a) Large sand boils of fine sand in Manamaiju (b) Tilting of building due to lateral spreading in Manamaiju

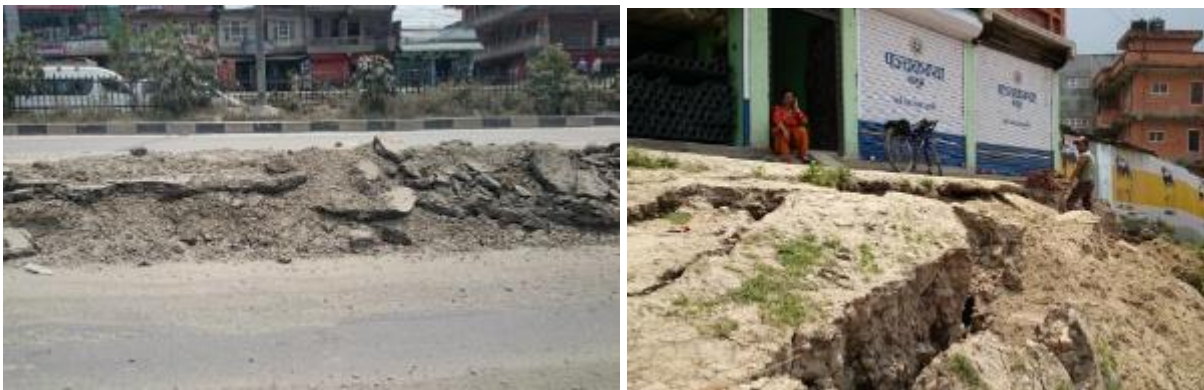
Lokanthali is the most interesting ground failure site from the earthquake which has drawn attention of researchers from all over the world. A section of the Araniko Highway extending from Lokanthali to Bhaktapur showed vertical offset. The section of highway which experienced failure was a newly constructed road embankment. This vertical dislocation ran across the highway diagonally but only extended a few meters away from the highway indicating failure to be localized. The vertical offset was approximately about 1m over about 200 m area (Fig.11). On the other hand, the horizontal offset extended over a large area (about 500 m). Large lateral cracks with 2-3 m deep fissures and width of 0.5m have occurred over a large area on or near sloping

Fig. 11 – Ground deformation with vertical and horizontal offsets of approximately 2 m and 0.5 m respectively observed in Lokanthali region

grounds. The surrounding buildings and appurtenant structures of the highway also experienced an excessive amount of settlement. One of the sections of vertical offset extended near to the overhead pedestrian bridge located at the Kaushaltar bus stop. The pedestrian bridge had experienced damage due to this ground failure and was closed for repair during the period of field survey. The conclusive remark on the cause of this vertical and horizontal offsets is difficult due to lack of detail information on the type of soil present and the depth of the ground water table. Based on the observations, the length of fissures, and the past earthquake site investigations, this vertical and horizontal offsets of highway might be attributed to mass movement of soil at lower depth. These mass movements might have occurred due to weakening or liquefaction of soil. This failure mechanism might be attributed to cyclic shear softening of silty clay lacustrine deposits allowing the movement of overlying soil and resulting in the vertical and horizontal offsets observed at the surface. This deformation was exhibited at localized areas as the weakening soil might have been localized and the deformation diminished after extending to certain length. Vertical offsets mainly existed on the both sides of slightly depressed zone of the highway, so the soil at this zone might have weakened allowing the movement of opposite hill slopes and causing the vertical offset on the surface. According to the locals, the displacements were rather small from the main Mw7.8 earthquake and the displacements increased due to the first Mw6.7 aftershock. This site was revisited after the occurrence of M7.3 aftershock and it was found that the width and depth of fissures had increased since the main

extent. This indicated that aftershocks can have pronounced effects on the deformation as suggested by Maharjan et al. [19].
