# ANALYTICAL AND EXPERIMENTAL CYCLIC RESPONSE OF RC WALLS WITH SETBACK DISCONTINUITIES

## Abstract

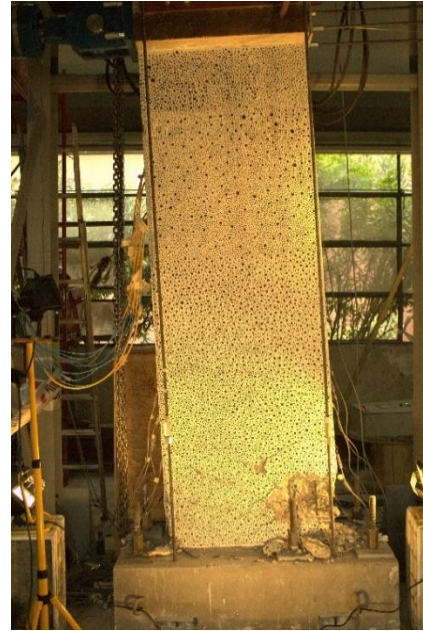
Fig. 5 - Lateral load vs top displacement and fracture Specimen 1

Figures 5, 6 and 7 show the response of the specimens tested under lateral cyclic loading, showing the lateral load versus lateral displacement. Lateral displacement was determined at the location of the actuator, and corrected by the pedestal sliding and rotation. For all tests cycles were started in the negative direction, where

*Specimen W1:* Initial stiffness of the wall is similar for both directions. The first cracks that can be distinguished on the wall occurred in the third cycle of 0.3% drift in the negative direction at the bottom of the wall. Further cycles, increase the number of cracks and widen them. In the first cycle of 3% drift in the negative direction, the wall begins to lose concrete cover at the wall boundaries, and diagonal cracks extended beyond half of the height of the wall. Finally strength degradation occurred in the third cycle of 4% drift in the positive direction, where the boundary bars present buckling and concrete at the wall edges is crushed. However, the test was pushed towards the 6% drift level in the negative direction, but was stopped at a drift of 4.5% since the specimen was unstable.

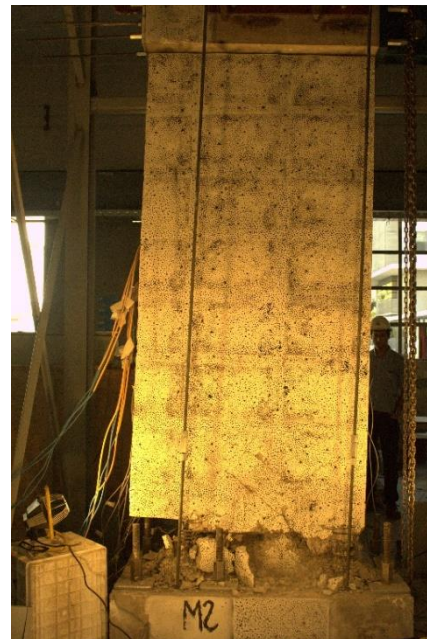
Fig. 6 - Lateral load vs top displacement and fracture Specimen 2

*Specimen W2:* Shows a similar behavior to the specimen W1, especially at the early stages. The first cracks that can be distinguished on the wall occur in the first cycle of 0.3%, which is earlier than in W1. In the first cycle of 3% drift in the negative direction, the wall begins to lose concrete cover, which is notably on the side of the discontinuity. Diagonal cracks are also extended over half the height of the wall, although concentrated at the wall bottom. Finally, strength degradation occurs during the third cycle of 4% drift in the positive direction, where the bars are exposed and suffer considerable buckling, while concrete at the wall edges has crushed. Also, edge reinforcement of positive side were fractured. Even though load was applied in the positive direction it was stopped since concrete and steel deterioration maintaining a degraded strength of the wall and further damage was observed, including bar fracture.

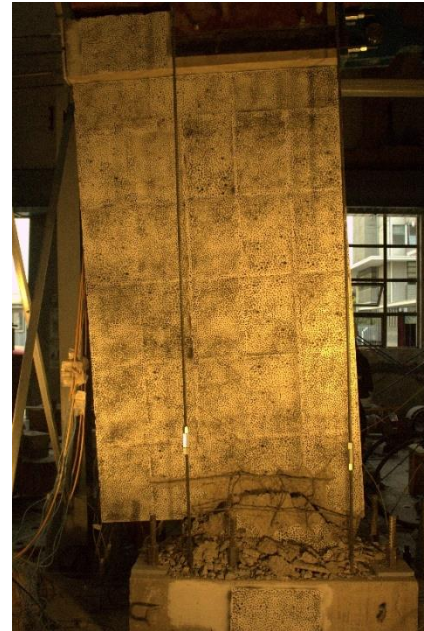
Fig. 7 - Lateral load vs Top displacement and fracture Specimen 3

*Specimen W3:* Similar behavior is observed in this specimen as with the other two. The first cracks that can be distinguished on the wall occur in the first cycle of 0.3% in the negative direction, concentrated at the bottom of the wall. Similar to the specimen W2, the first yield is achieved before the base case (W1) did. In the second cycle of 3% in the positive direction, the wall begins to lose concrete cover, mostly at the wall boundary near the discontinuity region. Diagonal crack are observed above half the wall height. Finally, strength degradation occurs in the second cycle of 4% drift in the positive direction, presenting longitudinal bar buckling and concrete crushing at wall ends. The second cycle at 4% was not completed since bars fracture and strength degraded rapidly.
