## SYSTEM IDENTIFICATION AND MODELING OF AN 18-STORY BUILDING IN NEPAL USING POST-EARTHQUAKE AMBIENT VIBRATION DATA

**Keywords:** 2015 Gorkha Nepal Earthquake; Post-earthquake performance assessment; System identification;

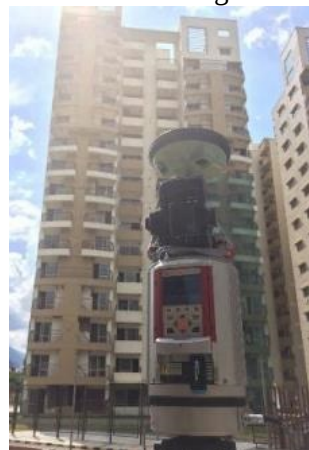
Fig. 2 – 18-story building

The structure is an 18-story (basement plus 17 stories above ground) high-rise reinforced concrete building as shown in Figure 2a. The floor plan is shown in Figure 2b. The location of the staircases and elevators can be seen to the right and left of the central lobby.

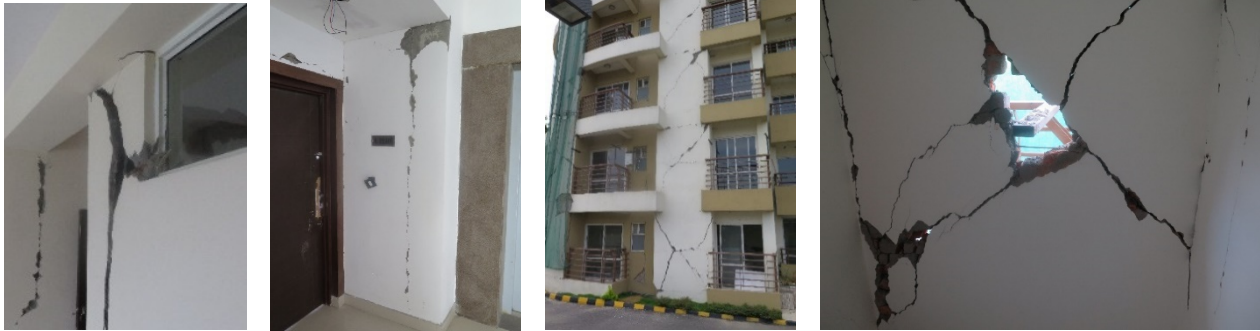
Extensive non-structural and minor structural damage was observed in the building in the aftermath of the earthquake. Beam-column joint cracks and shear cracks were visible in coupling beams and short beams. Additionally, flexural cracks on beams propagated to the 6 inch slabs, especially in the coupling beams connecting the elevator cores. Figure 3 shows the observed damage at different components of the building. It is worth noting that even though the building suffered mainly non-structural damage, the building was not used for shelter in place, and at the time of the visit, it was expected that it may take up to 18-months for the building to be repaired and for people to be able to return to their homes.

Fig. 3 – Observed damaged in (a) corner of infill wall, (b) beam corner, (c) exterior, d) interior/exterior wall
