## RE-LEVELLING & BASE ISOLATION RETROFIT OF THE CHRISTCHURCH ART GALLERY

F. Lanning<sup>(1)</sup>, S. Hogg<sup>(2)</sup>, G. Wilkinson<sup>(3)</sup>

**Keywords:** *Christchurch Art Gallery; in-ground re-levelling; base isolation retrofit; Christchurch Rebuild*

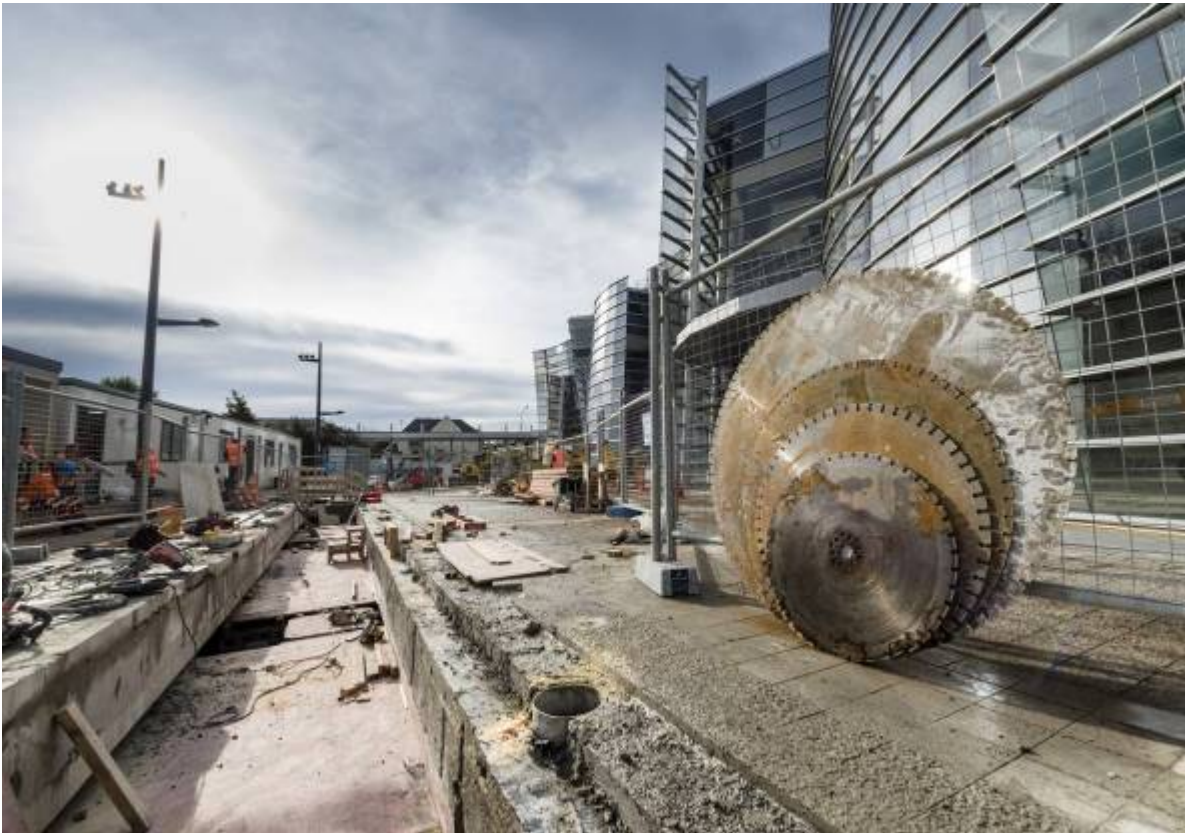
*Figure 1 - Seismic trench construction adjacent to the iconic western sculptural façade*

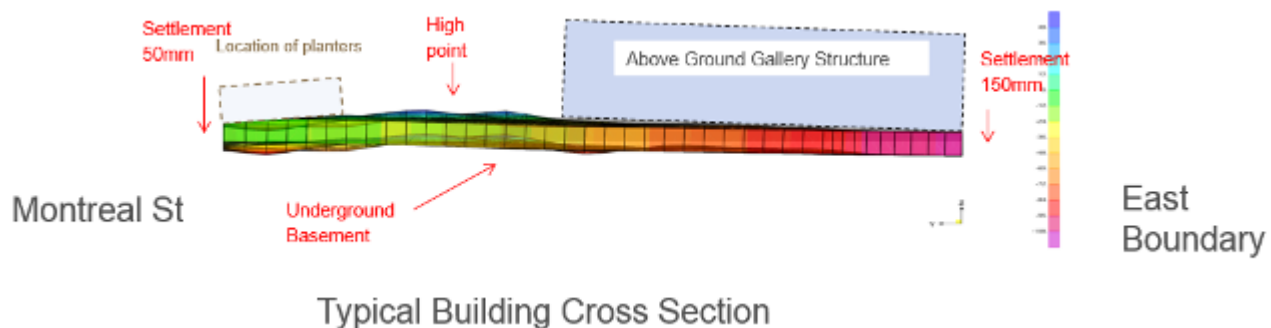
Figure 2 - Profile of the basement parking garage with differential settlement. (Figure Courtesy of Aurecon)

The Christchurch Art Gallery suffered differential settlement due to deep liquefaction which 'bent' the basement level parking garage structure. This bending induced stresses in the elevated ground floor slab. The greatest settlement occurred on the backside (east) of the Gallery structure with a displacement of 150mm (See Figure 2). A secondary low point was located on the Montreal Street (west) side of the basement with a displacement of 50mm. This created a relative high point in the middle of the gallery's forecourt. All viewing galleries in the building subsequently also had a slope to the floors.

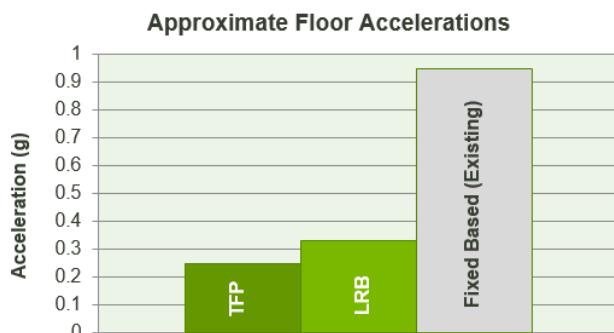
*Figure 3 - The graph depicts the preliminary floor accelerations the superstructure will experience with Triple Friction-Pendulum (TFP) isolators, Lead-Rubber Bearings (LRB) isolators and without any base isolation (fixed based). Later refinements in the design lowered the TFP to 0.17g.*

The most significant benefit of base isolation is the reduction in building floor accelerations induced by ground shaking. It is not only the structure that is protected but also the building contents. In the case of the Christchurch Art Gallery, the building accelerations are reduced from approximately 0.9g to 0.17g (See Figure 3). This is a significant reduction in transmitted seismic forces and enables the building structure, contents and fitout to ride out a major seismic event without significant risk to the building or its valuable contents.

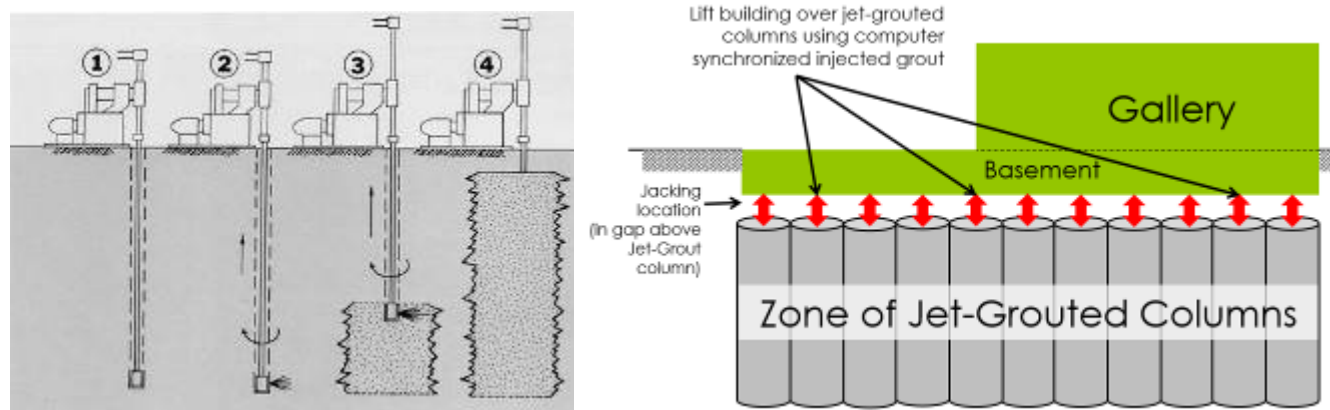
Figures 4 – The left figure (a) depicts the method of creating the grouted columns under the raft foundation which later served as a base to lift off from. The right figure (b) depicts the area where the lifting grout was injected which provided the actual lifting of the whole building. (Images courtesy of Aurecon)

Grouted columns were constructed by drilling a 4cm hole through the raft foundation inserting a high pressure grout jet. The jet would start at 7m below the foundation and shoot horizontally high pressure grout, displacing the soil. The jet would spin and slowly pulled up shooting grout in a helical path creating a 5m wide grouted column (see Figure 4a). 125 grouted columns were created in a grid pattern under the raft foundation.

Step three was the lifting of the building. The Mainmark / Chemical Grouting Company of Japan team used a computer-controlled grouting system to re-level the gallery by injecting grout over 44 days, which required 22 staff on an average day. The grout was pumped into the void between the top of the previously grouted columns and the bottom face of the raft foundation which pushed the foundation upward (see Figure 4b). There was no excavation or vibration. The system used high pressure, low volume grout pumps that delivered cementitious grout through 12mm lines to a number of grout monitors in a 'daisy chain' formation. Controlled to the millimeter, the gallery was lifted an average of 2mm per day, with lifts of up to 182mm required in some areas over the course of the job (see Figure 5).

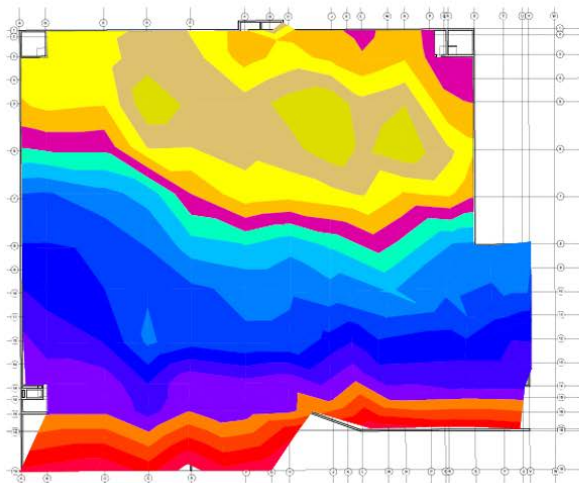
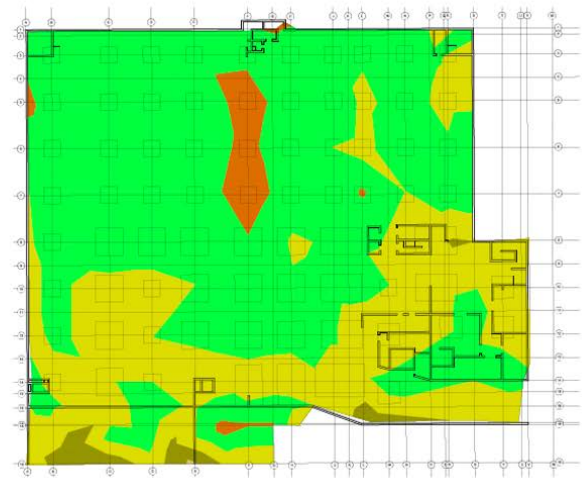
Figure 5 - Floor levels before and after the re-levelling process. (Figure courtesy of Aurecon)

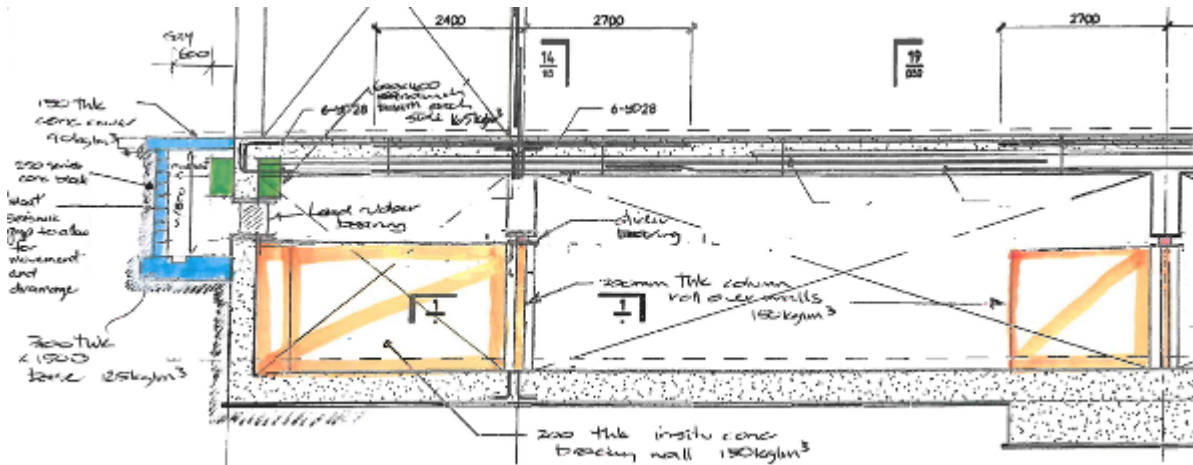
Figure 6 - Early feasibility and conceptual drawing of retrofitting base isolation in the basement which originally was calling out for lead-rubber isolators.

As the art gallery had an existing basement carpark below approximately 90% of the art gallery, there was already a substructure below capable of supporting loads from above the isolation plane. This meant that most of the retrofit works were limited to the basement, allowing repair and fit out works to the art gallery above to occur simultaneously, significantly reducing the project programme. Having the works limited to the basement also reduced the number of services and architectural finishes that would be affected during the strengthening works (see Figure 6).

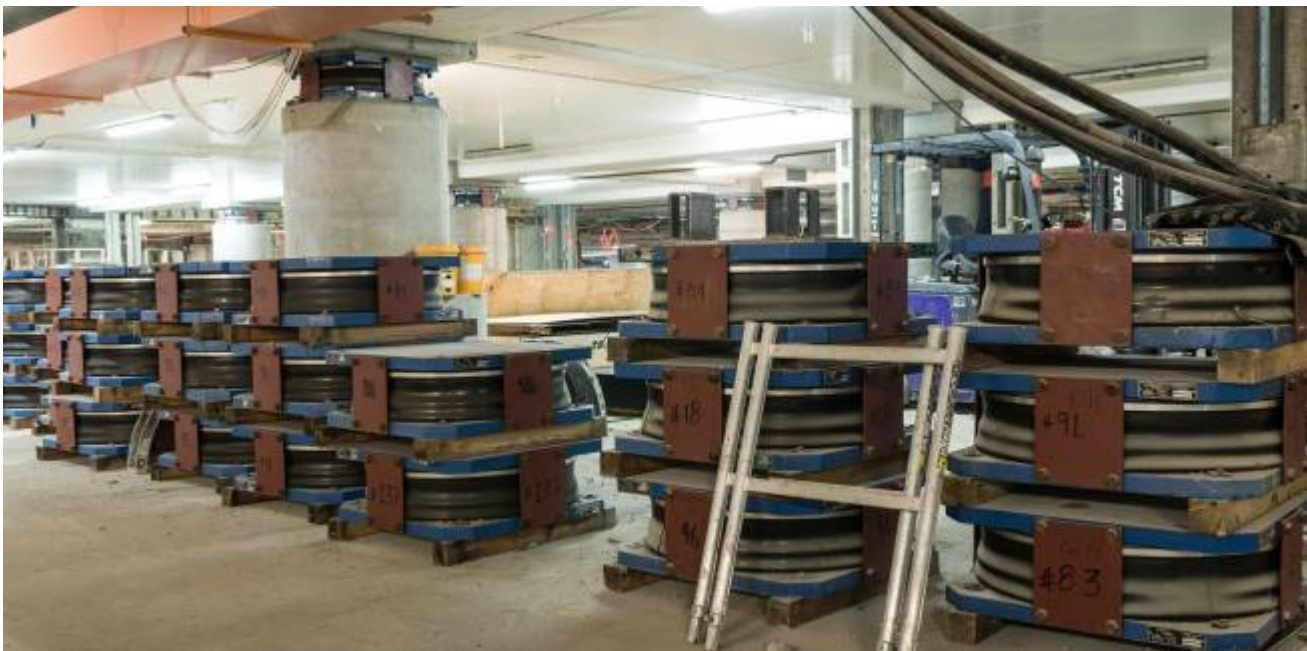
Figure 7: Triple curvature base isolation devices delivered to the Art Gallery basement for installation

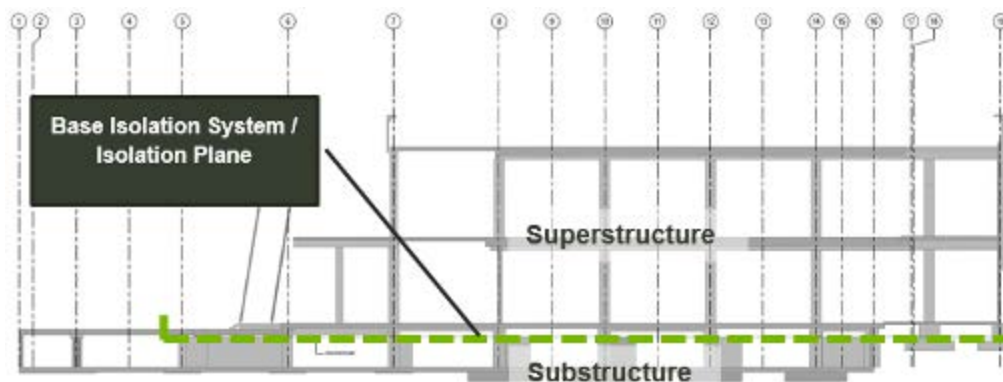
Figure 8 - Concept of the separation between the fixed basement and the isolated superstructure.

The original design of the basement foundations allowed for large reinforced pad footings to support columns and walls with heavy structural loads, while columns and walls with lighter loads were founded directly on the 400-500mm thick basement floor. For the retrofitted columns, which are subjected to vertical and horizontal loads from the base isolators, a structural assessment using the revised punching shear provisions introduced in the 2008 amendment of the reinforced concrete design standard NZS3101:2006(A2), indicated that the foundations would fail under retrofitted punching shear actions. Figure 8 conceptually shows where the building was split between the seismically isolated superstructure and fixed substructure/basement.

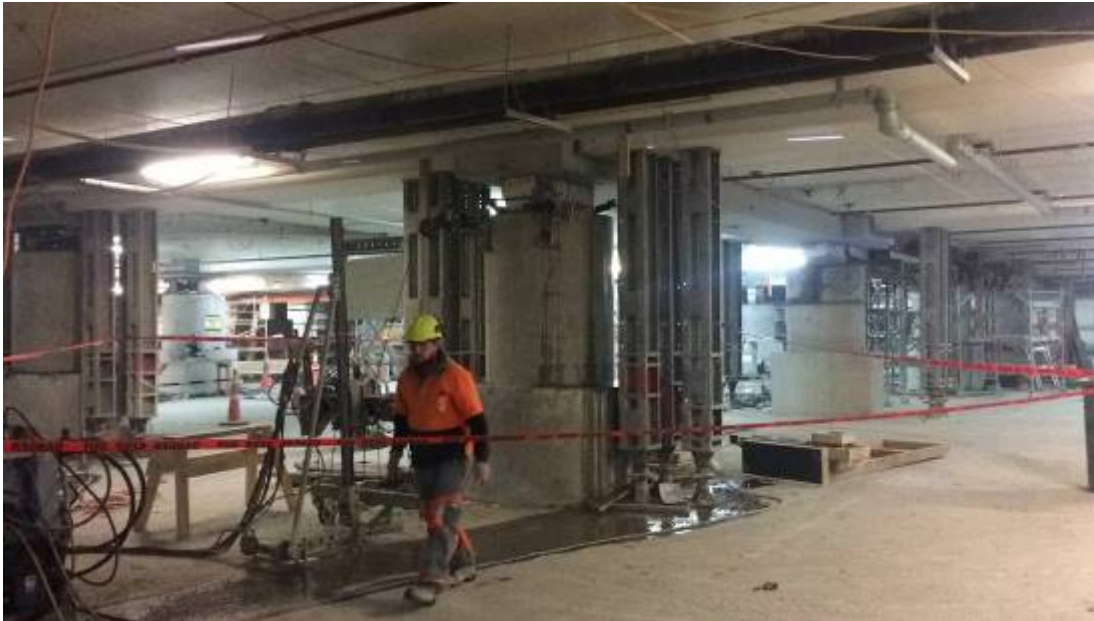
*Figure 9 - A basement column being cut at the top after the mid and lower sections were jacketed and retrofitted. Propping is placed on either side of the column to allow load transfer before cutting.*

Along with the specialized overhead casting of concrete, there was a large amount of specialised cutting and propping works required for the job. Propping was required in most isolator locations where the structure between the basement and ground floor was cut to allow the placement of the base isolators (see Figure 9). Ruamoko Solutions worked closely with Fulton Hogan to accommodate the propping requirements, integrating items such as cast-in steel plinth armouring or widened reinforced pads into the final structure. Precise monitoring was required during construction to ensure deflections under propping and transferring the loads to the isolators weren’t inducing adverse stresses in the existing superstructure.

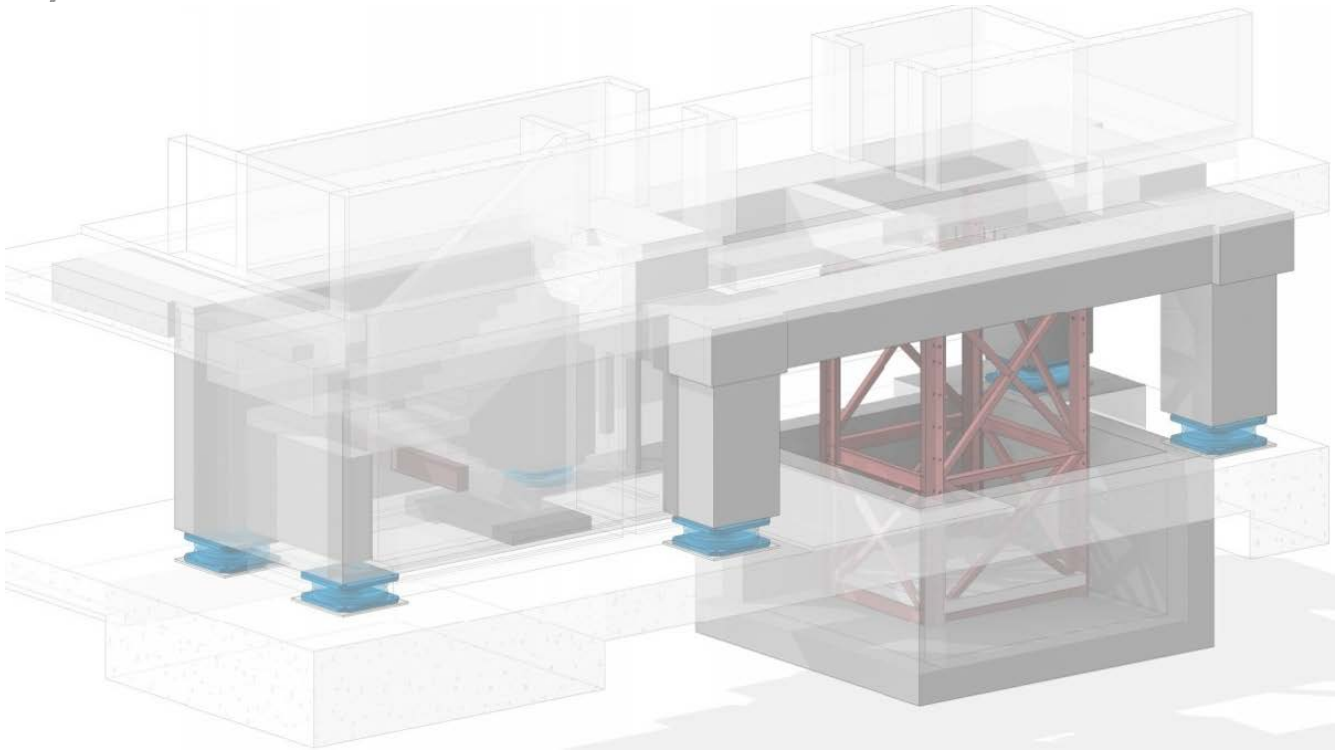
*Figure 10 –Lifts and stairwells servicing the basement were designed and constructed to laterally move along with the ground floor above during an earthquake.*

As illustrated in Figure 10, the stairs and lifts are generally suspended and braced below ground floor level to move within or above the basement level. Lift pits not servicing the basement have been designed to slide on plinths in the basement while the lift servicing the basement received a widened lift pit to accommodate the seismic movement of the suspended structure. Stairs generally slide at basement slab level or at mid-height landings. The mechanical platform was similarly suspended below the ground floor to significantly minimize the number of services that need to function whilst crossing the isolation plane. The isolation plane changed heights in many areas around the stairs, lifts and mechanical plant room which required careful design consideration and design of seismic jointing around the stepped isolation planes.

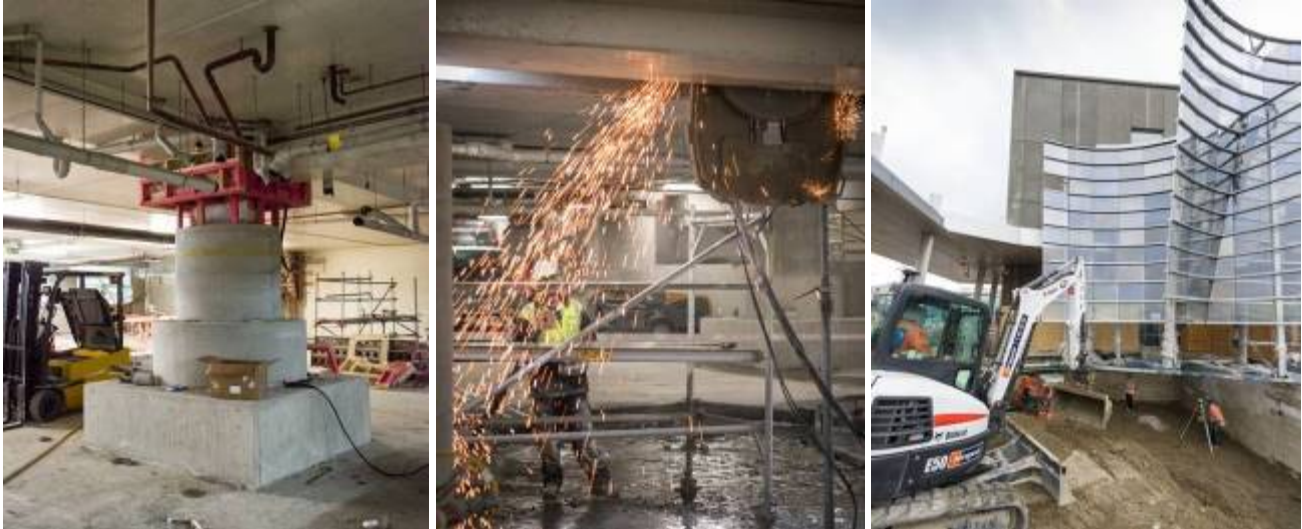
Figure 11 – a) Overhead work around columns (left), b) precision cutting works (centre) and c) temporary support works to the glazed sculptural façade (right)

The ramp presented complex challenges due to the intersection of the horizontal isolation plane and inclined ramp. Along the length of the ramp, pairs of new insitu and precast concrete ‘staple’ shaped portal frames extend above and below the isolation plane. The portal frames resist the existing gravity loads as well as the new seismic loads from the movement at the isolation joint. Maintaining head height and width for the ‘staple’ frames around the ramps were major constraining factors. Figure 11 shows some examples of the retrofitting works.
