# Factors Affecting Overturning of Buildings Induced by Tsunami Run-up in the 2011 Great Tohoku Earthquake

Two- and three-dimensional tsunami run-up analyses were conducted to investigate the mechanisms and differences in overturning failures of five buildings (Building A to E) in Onagawa during the 2011 Great Tohoku earthquake. Several buildings including Buildings A and D overturned landward, while Building C with spread foundation overturned seaward and Building E overturned almost parallel with the coastline. A simple pseudo-static analysis using the hydrodynamic force and buoyant force estimated from the 2D analysis was able only to predict the overturning directions of Buildings A to D, suggesting Building E unlikely overturned due to the tsunami-induced hydrodynamic force and buoyant force alone. The 3D tsunami analysis has shown that the major cause of the overturning of Building E was the collision impact on this building of the drifting right section of Building D.

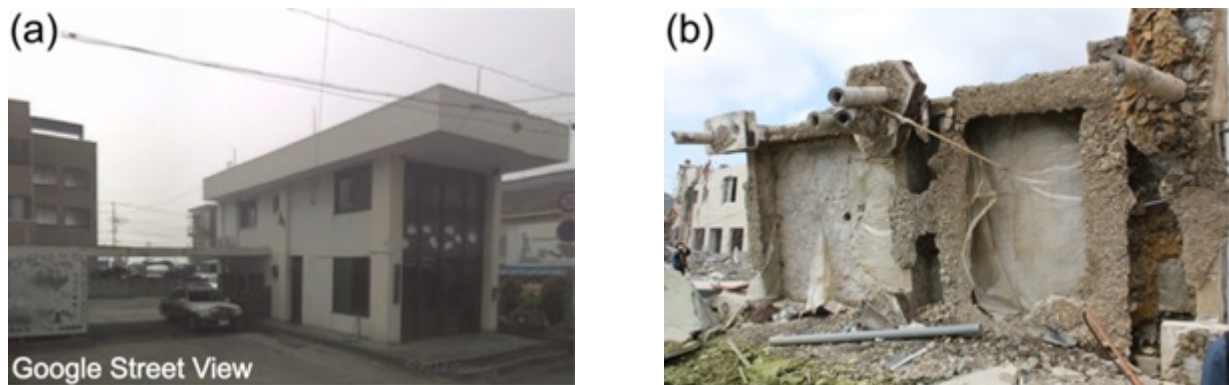
Fig. 8. Photos of Building E taken before and after the tsunami

Figure 8 shows Building E, a two-story RC building with pile foundation that toppled in parallel to the shoreline at its original location. The pile foundation had 14 PC piles 20m long and 300mm in diameter (NILIM, 2012), and failed at the pile head or 0.9m to 1.5m below the pile head, suggesting a tensile failure of pile. This indicates that the tensile strength of the pile was likely less than the pull-out resistance of the pile.

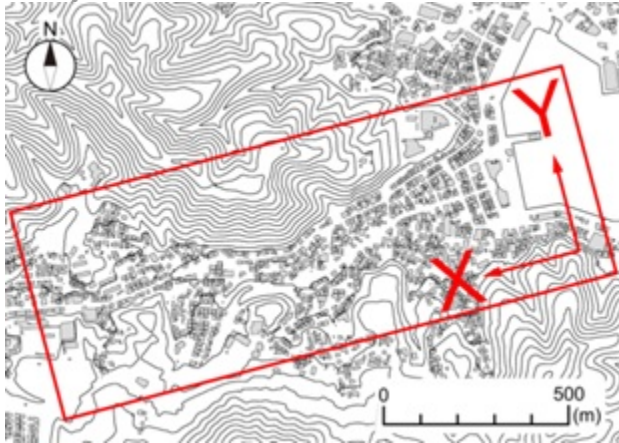
Fig. 9. Analyzed area for the 2D simulation

A 2D analysis of the tsunami run-up was conducted with a shallow water theory (Hirt and Richardson, 1999). The 2D area demarcated with red lines in Figure 9 is the concerned area for 2D analysis, which has a dimension of 1530m and 570m with uniform mesh of 10m by 10m. The terrain model using the 2D analysis was assigned according to the digital elevation model (DEM) provided by the GSI and General Ground Plan of Onagawa Port, Miyagi, available from Japan Center for Asian Historical Records (JACAR).
