## **DISPLACEMENT CAPACITY OF CONFINED MASONRY STRUCTURES REINFORCED WITH HORIZONTAL REINFORCEMENT: SHAKING TABLE TESTS**

### ***Abstract***

*Keywords: Shear strength; confined masonry; horizontal reinforcement; shaking table tests*

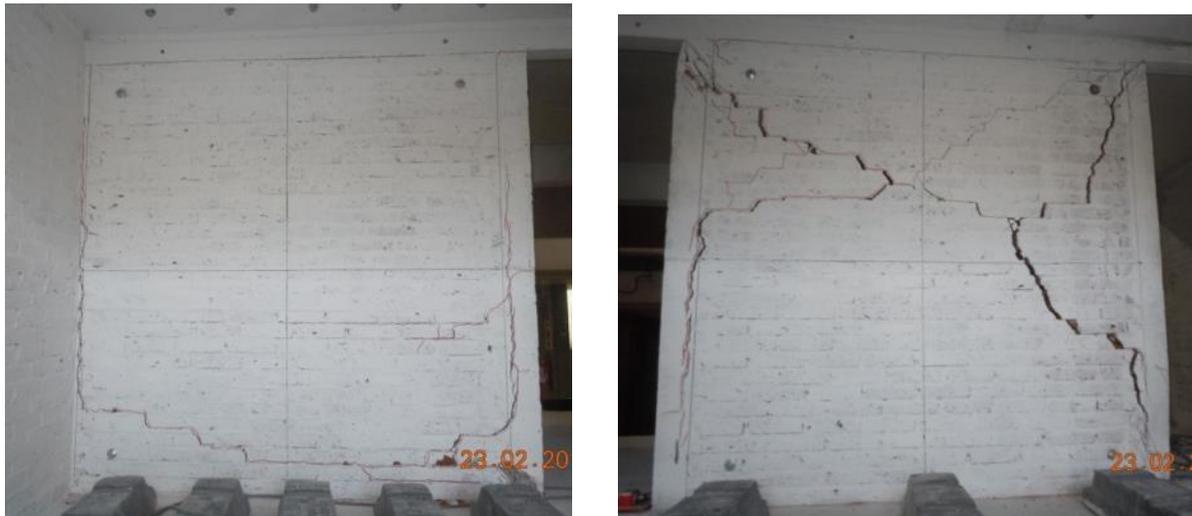
Fig. 8 – Final crack pattern in the Story 2 of specimen M3ND-0, test stage 200%

During the application of the ground shaking to 200% (factor of 2.0) the specimen came to its strength (maximum seismic forces) with damage characterized by severe inclined cracking pattern in the walls of Level 2 (intermediate floor). In Fig. 8 cracking in the specimen is shown, and the following figure shows details of the registered damage.

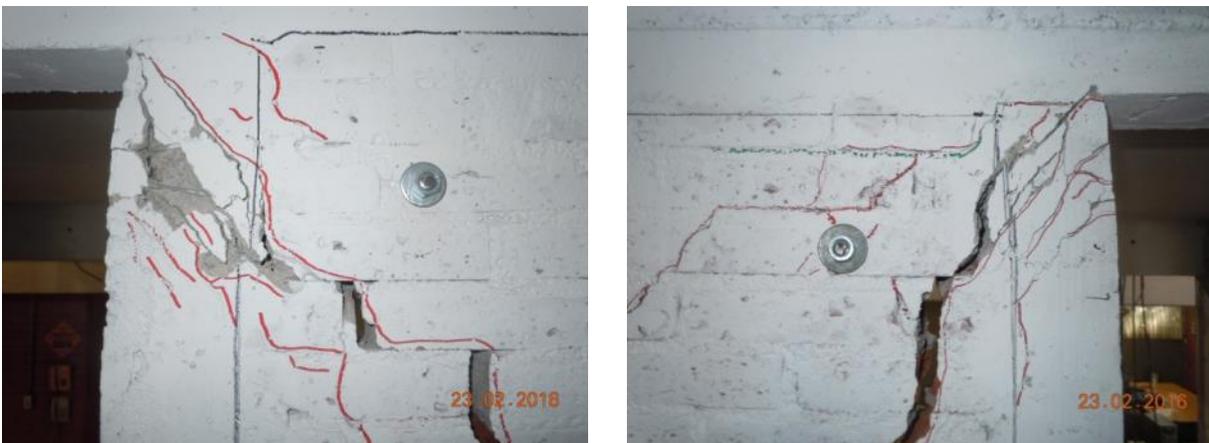
Fig. 9 – Final cracking detail and damage of tie-column at Story 2, specimen M3ND-0

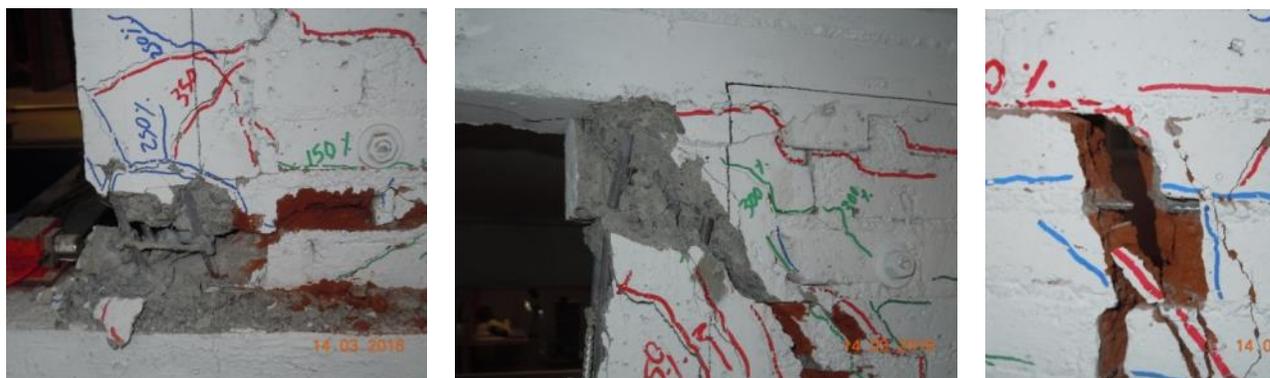
Fig. 11 – Final cracking pattern, detail of tie-column ends and the fracture of horizontal wire

Fig. 11 shows details of the final damage condition: dislocation of tie-columns no. 3 at its base, and tie-column no. 4 in its top; also breaking of one of the horizontal wires is shown.
