PRACTICES OF SEISMIC DAMAGE CONTROL DESIGN OF BRIDGES IN JAPAN AND SOME LESSONS FROM 2011 TOHOKU EARTHQUAKE

Y. Fujino⁽¹⁾, M. Abe⁽²⁾, Y. Takahashi⁽³⁾

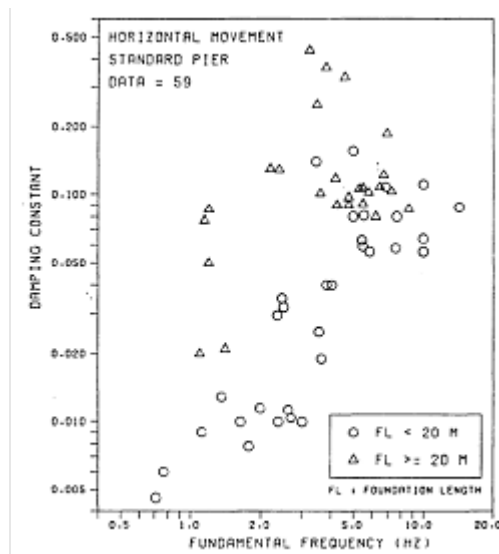
Fig. 2 Natural frequencies and damping ratios[2].

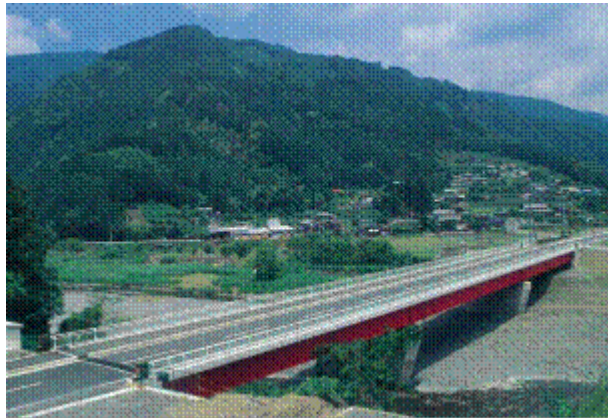
Fig.4 Miyagawa Bridge

Base-isolation design which employs rubber bearings fit to this two level design concept to reduce dynamic response for level 2 earthquake[5]. In 1989, “Guideline for seismic isolation of highway bridges” was published and first base-isolated bridge using lead rubber bearings was constructed in 1991, which is a three span continuous girder bridge, shown in Fig.4[6].

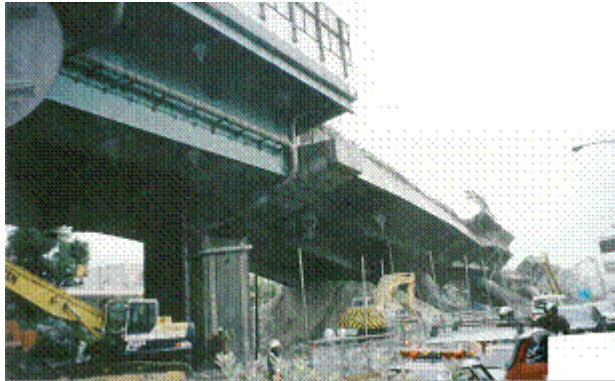
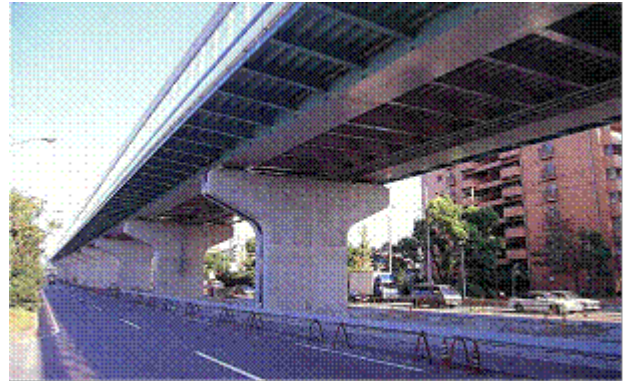
Fig.6 Fukae Viaduct at Hanshin Expressway

(a) at 1995 Kobe Earthquake

(b) reconstructed base-isolated bridge

Base-isolated bridges became particularly popular after Kobe Earthquake. Fig.6 shows the damage and reconstruction of Fukae Viaduct at Hanshin Expressway. The reconstructed bridge uses rubber bearings to

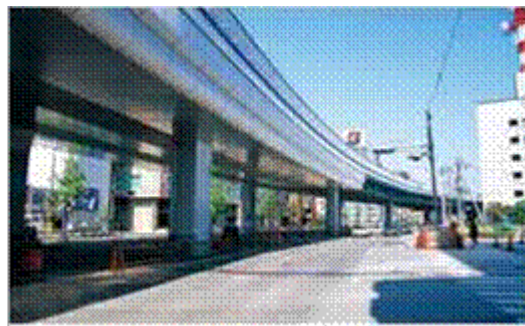
Fig.7 Benten Viaduct of Hanshin Expressway

isolate response between girders and piers. Fig.7 is reconstructed Benten viaduct which is isolated at the bottom of the columns by rubber bearings.

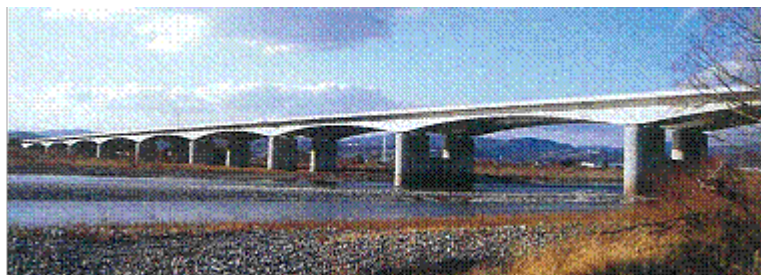
Fig. 8 Tenryu River Bridge

The base-isolation concept is extended and further applied to multi-span continuous bridges. Ohito Viaduct, constructed in 1998, is a 29 span continuous prestressed concrete girder bridge with total length of 725[m]. Fig. 8 is the longest base isolated multi-span bridge in Japan, Tenryu-River Bridge, with 23 span continuous prestressed concrete girder bridge with total length of 1585[m]. Seismic responses for mild earthquakes are recorded at Ohito Viaduct, and is shown to behave as expected as design by comparison with dynamic simulation[8].

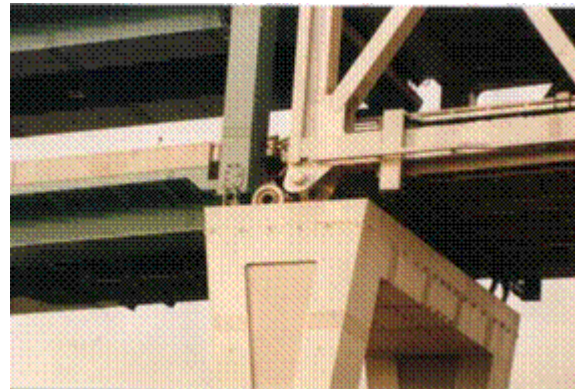
Fig. 9 Higashi Kobe Bridge

(a) overview

(b) damage at 1995 Kobe Earthquake

Higashi Kobe Bridge, shown in Fig.9 is an example. The girder is supported only by stay cables in longitudinal direction to reduce natural frequencies and eventually seismic load. In Kobe Earthquake, its bearing link systems connecting end girders and piers failed as shown in the Figure 9 (b), losing vertical support to prevent uplift. Failure of wind shoe, which was to prevent transverse motion of the girder, due to excessive transverse

motion of the girder end, lead to this failure of the link[16]. Although flexibility reduces seismic load, excessive motion may be induced. At Yokohama Bay Bridge, shown in Fig.10, the girder is supported by link from the main tower as shown in Fig.11 for isolation. In the same figure, measured response at 2011 Tohoku Earthquake is shown and spike like response indicating collisions are observed[17]. This is also unexpected response due to excessive motion. Treatment of excessive motion should be well considered for long span bridge isolation. Fig.12 shows uplift prevention restrainer attached to Yokohama Bay Bridge as a part of recent seismic retrofit. The restrainer is supposed to support uplift of girder even in case of excessive motion or unexpected damage.

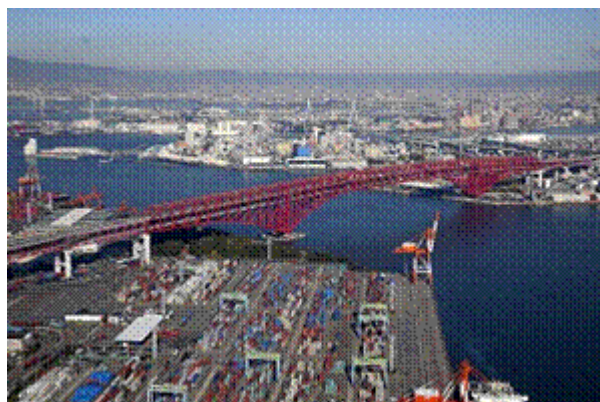
Fig.13 Minato Bridge

Natural extension of seismic response control is control and localization of damage. Retrofit of Minato Bridge, shown in Fig.13 is the first trial to apply damage control explicitly[18]. Isolation of heavy floor decks using sliding isolators was adopted to reduce the longitudinal inertia force. In addition, some of the truss members are replaced by buckling restrained braces to absorb seismic energy and to reduce the transverse response. Hence damage is localized to these replaced braces to increase seismic performance of the entire structure.

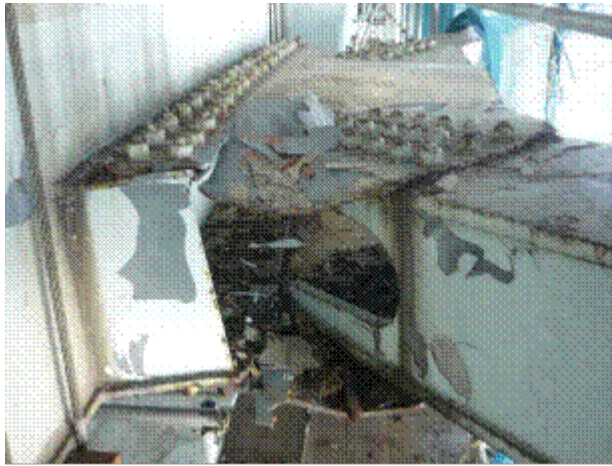
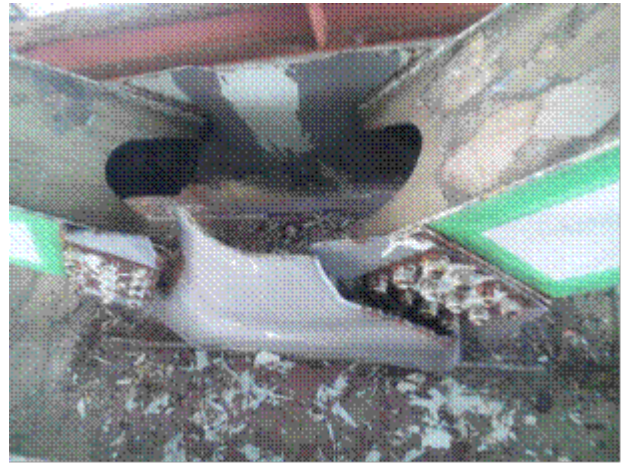
Fig.15 Damage at gusset plates of Arakawa Bay Side Bridge.

Arakawa Bay Side Bridge in Fig.14 is damaged by 2011 Tohoku Earthquake as shown in Fig.15. Several gusset plates were severely damaged though stability of the entire structure was not affected. Although this phenomena were not intentional, it indicates feasibility of damage localization and control.

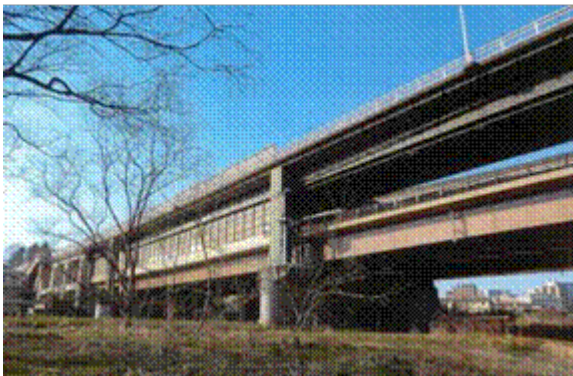
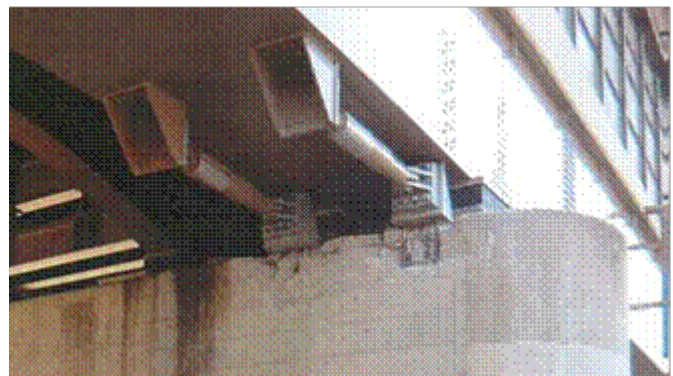
Fig.16 Nakanose Viaduct and observed damage of dampers

In 2011 Tohoku Earthquake, damage to vibration control devices are observed. Fig.16 shows an example of damage of dampers. Supports of dampers are observed to be vulnerable. Fig.17 shows an example of failure of rubber bearing at a cable stayed bridge. In 2016 Kumamoto Earthquake, complete failure of bearings are observed at a continuous steel girder bridge as shown in Fig.18. Unfortunately, none of these bridges were instrumented nor monitored continuously, and no record of response characteristics is available. Nevertheless, forensic investigation of these recent damage with remaining evidence would reveal challenges of seismic damage control of bridges.

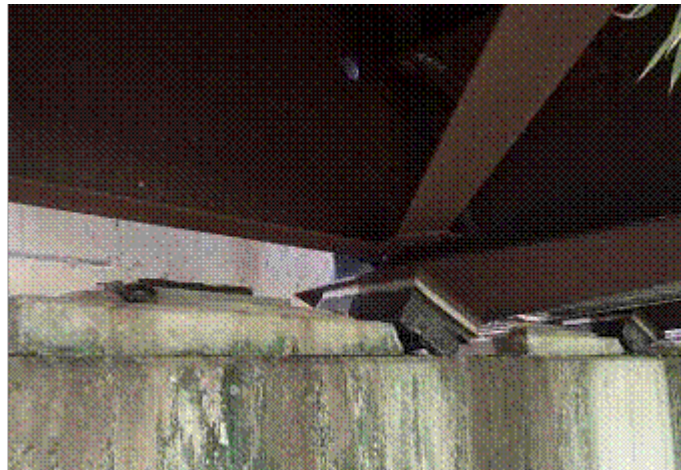
Fig.18 Bearing damage at Okirihata Bridge.
