STRUCTURAL PERFORMANCE EVALUATION OF R/C EXTERIOR/PARTITION FLAT WALLS MONOLITHICALLY CONSTRUCTED IN MOMENT RESISTING FRAMES

Keywords: nonstructural wall; reinforced concrete; seismic performance

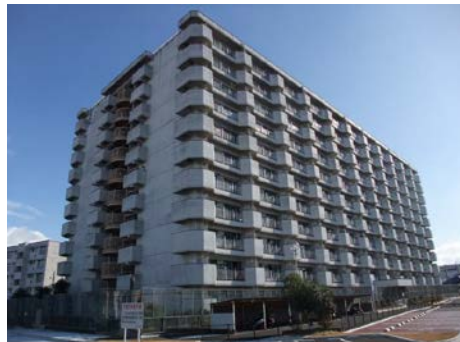
Fig. 1 – Northwest view of the investigated building

This study focuses on an 11-story steel reinforced concrete (SRC) residential building in Sendai city, which was damaged by the 2011 earthquake off the Pacific coast of Tohoku, as shown in Fig. 1. Figure 2 presents the ground floor plan. The building had an approximately symmetric regular plan with the dimensions of 71 m in the longitudinal direction and 27 m in the transverse direction, respectively. The structural systems in the longitudinal and transverse directions were SRC moment-resisting frames without and with structural walls, respectively. In particular, R/C nonstructural flat walls were implemented along the longitudinal direction as exterior/partition walls, as shown in Fig. 3 giving a typical exterior frame in the 10th story. The nonstructural walls were monolithically constructed with the beams, however, which were not considered in the structural design following the Japanese common practice. The nonstructural walls were reinforced with vertical and horizontal bars of #3, while additional bars of #5 were provided for vertical and diagonal bars reinforcing the wall edges and corners.

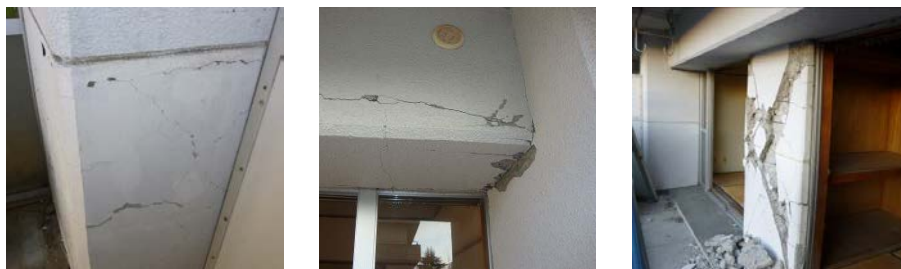
Fig. 4 – Typical damage to the columns, beams, and nonstructural walls

The building suffered earthquake damage mainly along the longitudinal direction. Damage data on all components in the west tower (Y3 and Y4 frames) were collected through the authors’ onsite inspection, as exemplified in Fig. 4, considering the symmetric plan of the building. Light damage was observed to the structural columns and beams, nevertheless, the nonstructural flat walls were severely damaged. The structural damage was mainly observed to the beam ends with the first-story column bottoms, as shown in Fig. 5; therefore, this building seemed to behave in a ductile manner during the earthquake. The maximum residual crack widths on the beams were approximately 1.0 mm, which indicated that the building could be recovered by typical schemes as cosmetic repair or epoxy injection in terms of the structural performance. In contrast, a large number of nonstructural walls needed to be replaced due to significant damage, as seen in Figs. 4 and 5. However, the effects of the nonstructural walls on the seismic performance of the building were quantitatively unclear.

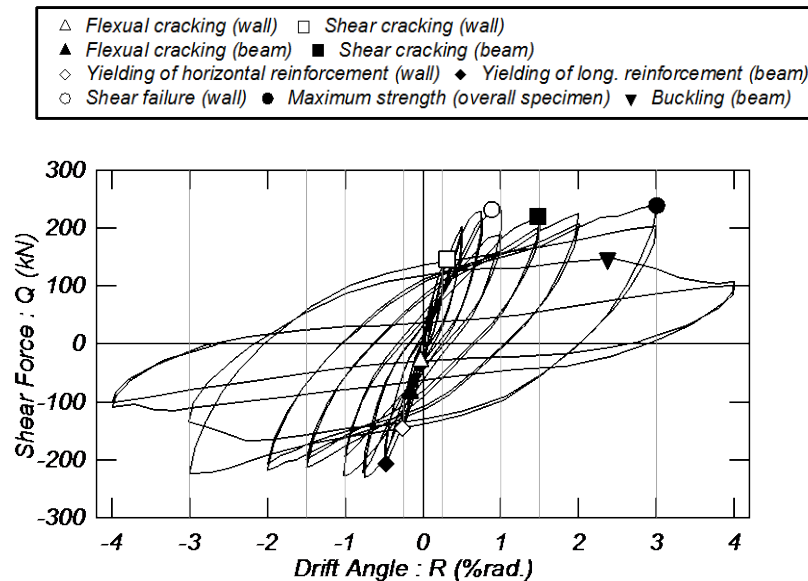
Fig. 8 – Story shear force vs. lateral drift ratio relationship of the specimen

Figures 8 and 9 present the shear force and lateral drift ratio relationship and the experimental damage development of the specimen. Flexural cracks initially occurred at the beam and wall ends during the first loading cycle. The vertical reinforcing bars in the nonstructural wall began to yield in the cycle to a 0.25% drift, which resulted in damage to the nonstructural wall exceeding a limitation for immediate occupancy, commonly defined as appearance of residual crack widths over 0.3 mm in Japan (Fig. 9(a)). The beams yielded in flexure in the cycle to a 0.75% drift. In the following cycle to a 1% drift, the nonstructural wall failed in shear (Fig. 9(b)); hence, the lateral strength of the specimen temporarily dropped, as shown in Fig. 8. A beam yielding mechanism was formed in the overall specimen with the shear failure of the wall. Spalling off of the concrete of the nonstructural wall was accelerated in the following cycle (Fig. 9(c)). The specimen finally deteriorated with buckling of beam longitudinal bars during the cycle to a 3% drift (Fig. 9(d)).

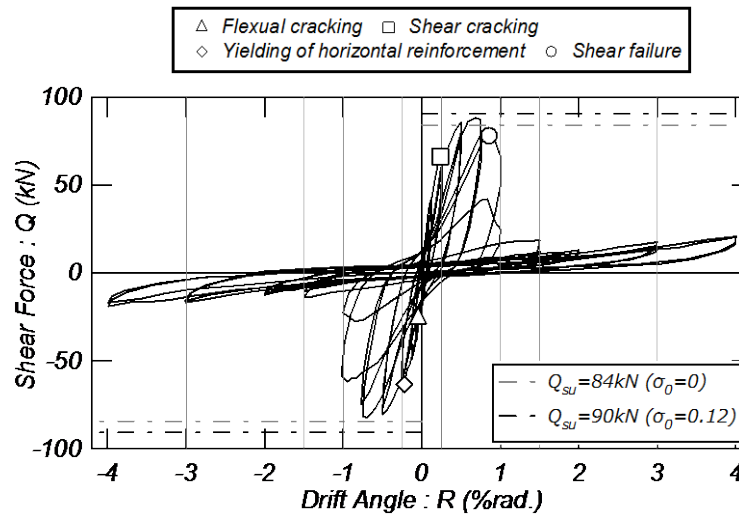
Fig. 10 – Shear force vs. lateral drift ratio relationship of the nonstructural wall

Figure 10 focuses on the shear force of the nonstructural wall which was obtained by subtracting the column shear forces, which were measured by the load cells implemented into both columns, from the story shear force. The nonstructural wall sustained the maximum shear force of 87 kN at a 0.75% drift, which was approximately equivalent to 1/3 of the total shear force, as compared with Fig. 8. This result indicates that this type of nonstructural wall significantly contributes the structural performance until the shear failure. Therefore, a mechanism of inducing such high shear is investigated in the following.

Figure 11 shows the axial compression on the nonstructural wall observed at every peak drift during the cyclic loading. The axial compression increased up to $\pm 0.75\%$ drifts where the maximum lateral strengths were observed, as shown in Fig. 10. Such increases of the axial compression were caused because the upper and lower beams constrained the wall axial elongations which resulted from nonlinear characteristics of concrete, as illustrated in Fig. 12 comparing idealized elastic (Fig. 12(a)) and inelastic (Fig. 12(b)) strain profiles along the depth and height of a wall under an antisymmetric deformation. As shown in the figure, no axial elongation occurs under the elastic behavior maintaining a constant neutral axis depth at the middle of the wall depth over the wall height. In contrast, an axial elongation δ_a is caused by higher tensile strains across the wall depth excepting the inflection point at the middle height, due to shifting of the neutral axis depth to the wall edge in compression. The elongation δ_a is represented by an integration of the strains along the wall height at certain wall depth, as shown in the figure. As a result of constraint to the wall elongations by the beams, the increases of the axial compression occurred and resulted in increasing of the wall flexural strengths; hence, the relatively high lateral resistances were exhibited, as mentioned above.

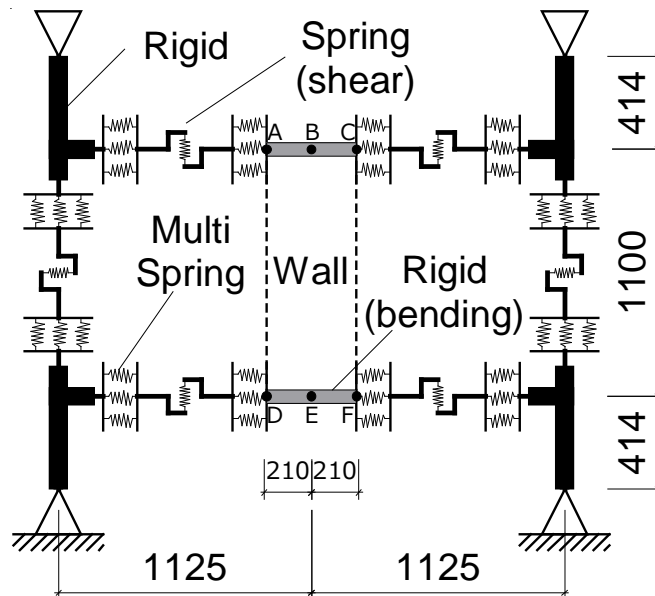
Fig. 13 – Modeling of the overall frame

Figure 13 shows an analytical model except for the nonstructural flat wall. The beams and columns were replaced by line elements with the MS models at both ends, to consider the axial-flexure interactions; however, rigid zones were provided from the pin supports at the column ends to the beam-column joints, as seen in the figure. The cross-sectional performance/behavior was represented by concrete and steel elements, as shown in Fig. 14. Concrete element was divided into ten layers considering core and cover concrete, steel shapes were divided into flanges and web with four layers, and reinforcing bars were placed according to the actual arrangement, as shown in the figure. The stress f_c -strain ε_c relationships of concrete was evaluated by the modified Kent and Park model [4], as shown in Fig. 15(a), in which the ascending curve was given by

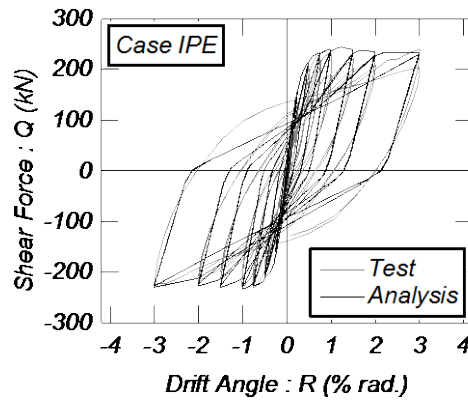
Fig. 17 – Comparisons of the story shear force vs. lateral drift ratio relationships

The analytical results are compared to the experimental ones in Figs. 17 to 19. Figure 17 compares the story shear force vs. lateral drift ratio relationships from the analysis with the experimental result up to a 3% drift, excluding the data after buckling of reinforcing bars was observed in the experiment, because the bar buckling was not addressed in the analyses. The analytical results well agreed with the test result. Figure 18 compares the shear force of the nonstructural flat wall vs. lateral drift ratio relationships between the analysis and the experiment in which the wall shear force was obtained as mentioned previously. The experimental nonstructural wall behavior including the deterioration after the shear failure could also be simulated by the IPE model, which indicate that the lateral performance/behavior of the nonstructural wall monolithically constructed in the moment-resisting frame can be evaluated by considering the axial-flexure-shear interactions. Moreover, the axial forces applied to the nonstructural wall in the analysis were compared with the experimental result, as shown in Fig. 19 presenting the axial force vs. lateral drift ratio relationships at every peak drift during the cyclic loading. The IPE model could simulate the loss of the axial resistance after the shear failure because of its consideration of the axial-flexure-shear interactions.

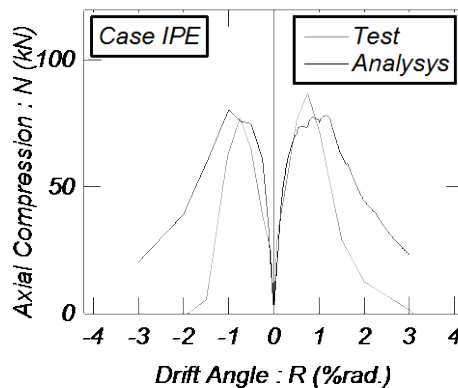
Fig. 19 – Comparisons of the wall axial force vs. lateral drift ratio relationships
