## RESEARCH, DESIGN AND APPLICATION OF HIGH PERFORMANCE EARTHQUAKE RESISTANT PRECAST STRUCTURE IN INDONESIA

High performance earthquake resistant precast concrete structures are innovations among emerging technologies capable of achieving high performance structural systems at low cost. There are two main components included in this technology, i.e., unbonded post tension tendon and mild reinforced concrete as energy dissipater. Unbonded post tension tendon may be provided at column-beam connection, and at connections of vertical components or connections of vertical and horizontal components. Unbonded post tension tendon is construed to provide re-centering effect so as to prevent residual deformations after earthquake event. Various technologies of this type have been developed and applied in California, Latin America, as well as in New Zealand. One structure using this kind of technology survived the 2010-2011 earthquake swarm in Christchurch, New Zealand. Since 2013, Indonesian precast and prestressed industry has been developing this kind of technology. This paper describes the significance of the research supporting the development of this emerging technology in Indonesia. T

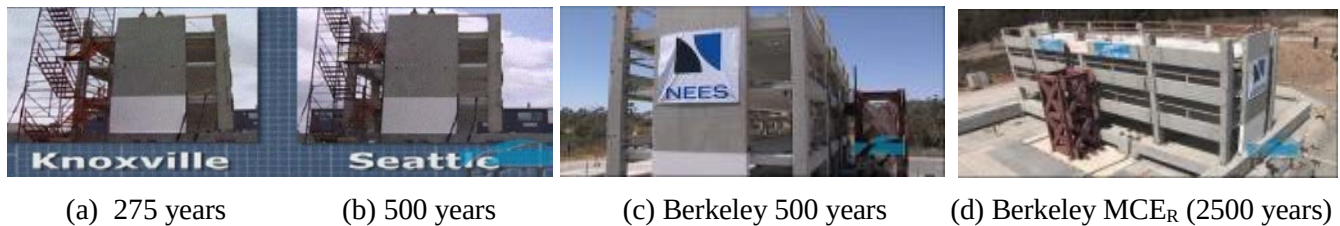
Fig.3 – Testing of high performance earthquake resistant structure with shaking table equipment [17]

The behavior of high performance earthquake resistant structure is more clearly demonstrated if testing conducted by shaking table, such as done in University of California at San Diego (2008) [17], as seen in Fig. 3. In the test scheme, full scale specimen of four-storey building which loaded by design earthquake record starts from Knoxville (275 years), Seattle (500 years), Berkeley (500 years), and the strongest ever MCE<sub>R</sub> Berkeley (2500 years) were considered. Amazingly post tension unbonded connection can restore the building back to its position even it has experienced rocking in extreme condition.

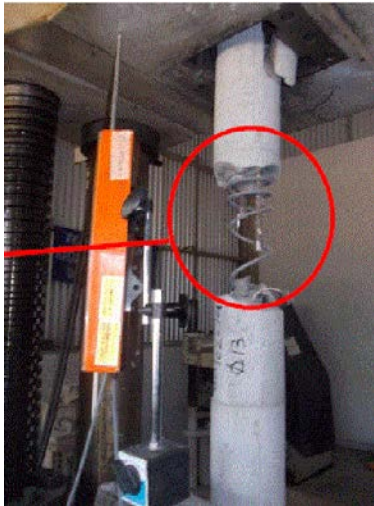
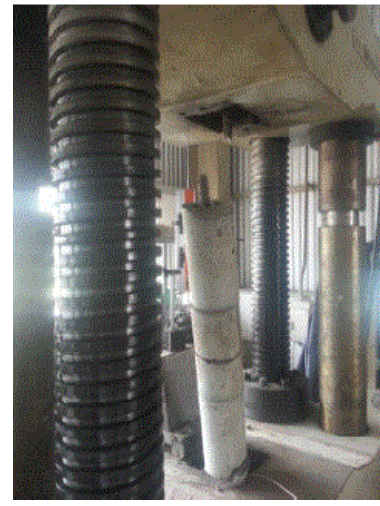
Fig. 10– Dissipater test result

(a) Dissipater  $A_s/A_s'=1.44$

(b) Dissipater  $A_s/A_s'=1.14$

(c) Strong connection  $A_s'/A_s = 1.06$

The dissipater test results [14] physically can be seen in Fig.10, wherein the first 10 (a) and 10 (b), yield occurs in connection bar. In Fig 10 (c), the yielding occurred at connected bars, because the third sample was designed as a strong connection.

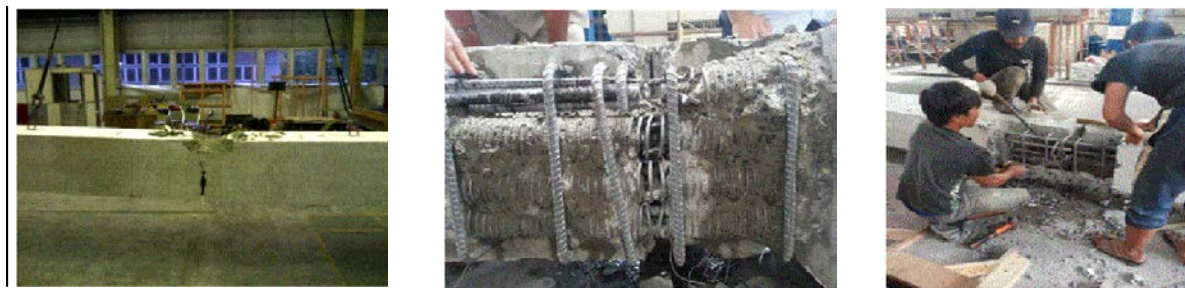
Fig. 14 – Repair of precast segmental hybrid beam and connected with new dissipater ( $A_s/A_s' = 1.14$ )

In addition to the damage in the gap position, there was no other damage occurred to the sample, including in the compression area of dissipater. So repair can be easily carried out in the connection area of dissipater, by replacing the first dissipater with a new one with the ratio of  $A_s/A_s' = 1.14$  as shown in Fig.14.

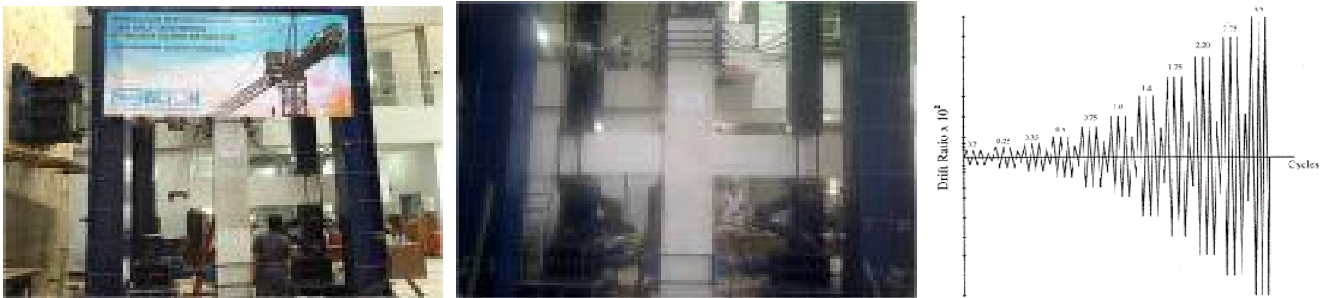
Fig. 16– Beam column joint test

The beam-column joint testing was done after some preliminary testing phases. Reinforcement of hybrid beam made according to preliminary test sample with a moment capacity ratio of dissipater bar to the probable moment capacity ( $M_s/M_{pr}$ ) approaching 0.5, in accordance with the recommendation of article 7.4.2 in ACI 550.3-13 [3]. Connected to connecting bar ratio was  $A_s/A_s' = 1.14$ . Joint and columns are designed in accordance with article 21.1.3, Article 21.6 and Article 21.7 of ACI 318-08 [2]. Loading scheme and acceptance test criteria are based on ACI 374-05 [1] as shown in Figure 15. In drift up to  $\Delta = 3.5\%$ , the specimen must meet three main criteria: strength, energy dissipation and rigidity in order to be categorized as Special Moment Resisting Frame (SMRF). Analysis of testing results [15] showed that the beam-column joint meets the criteria of ACI 374-05 [1] as shown in Fig. 17.

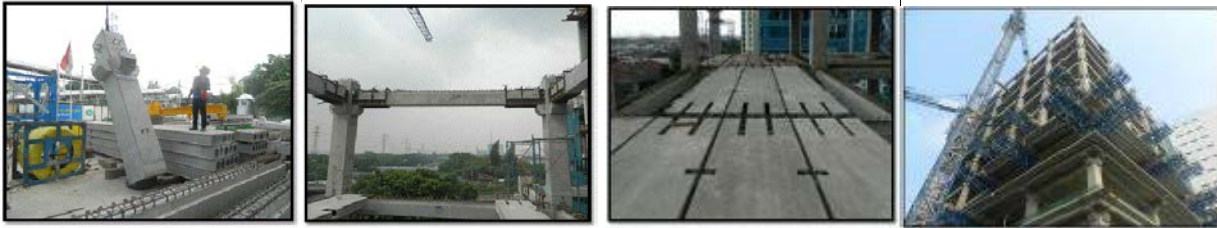
Fig.19 – Application in twelve storey office building in Jakarta

The system was applied to a twelve-storey office building in Jakarta, as shown in Fig. 19, and to some multi storey low cost housing in Jakarta, as shown in Fig. 20, High performance earthquake resistant precast system used in the columns, beams, and hollow core slab. The application proves resistant and can increase good quality construction with an easy, fast and economical.

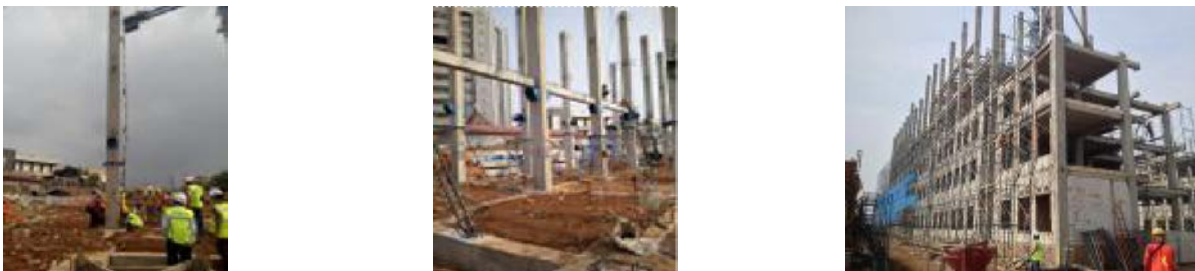
Fig.20 – Application in multistorey low cost housing in Jakarta
