## SHAKING TABLE TEST OF 6-STORY WALL FRAME BUILDING TO INVESTIGATE COLLAPSE PROCESS OF RC BUILDINGS

This paper describes the outline of experimental studies on collapse margin of reinforced concrete buildings. To reduce damages caused by large earthquakes, Special Project for Reducing Vulnerability for Urban Mega Earthquake Disasters has been conducted since 2012 by Ministry of Education, Culture, Sports, Science and Technology of Japan. In this special project, to quantify collapse margin of the buildings that are commonly seen in urban areas in Japan, shaking table test of a reinforced concrete building was conducted in *E-Defense*. The test specimen was a 1/3 scale model of a 6-story RC building designed according to the current Building Standard Law in Japan. The test specimen consisted of two moment-resisting frames in the longitudinal direction, and four frames with multi-story shear walls in the transverse direction, and the direction of main concern in this study was the latter. The two interior frames had shear walls and the others had nonstructural walls with openings from the second to the sixth stories. Recorded waves during the 1995 Hyogo-ken Nanbu Earthquake were us

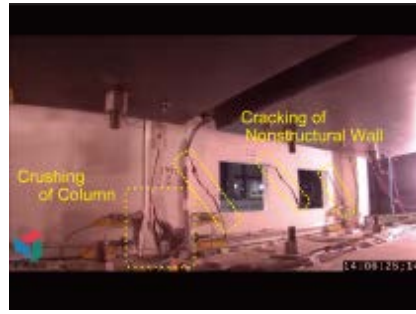
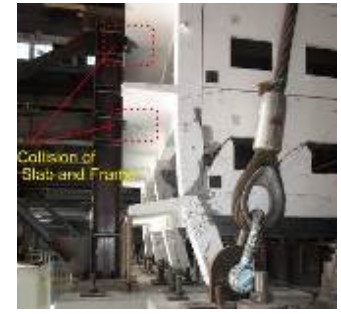
Fig.11 – Damage in Detail

Fig. 11(a) shows the cracking pattern of X1 frame after the 2nd day test. Joint bars fracture was observed in the 2nd and 3rd floors. Fig. 11(b) shows a captured photo from the recorded video at the 2nd floor during the test case #3-5. Collision of the nonstructural wall with the columns caused shear crack in the wall and crushing of the columns. Fig. 11(c) shows the collision of the cantilever slab and the steel frame.

(a) Crack patterns of X1 frame

(b) Captured photo in case #3-5

(c) Collision with steel frame
