## SHAKE TABLE TESTS ON 1100 kV GIS BUSHING-SUPPORT FRAME SYSTEMS

With the increase of the voltage, the substation equipment usually made of porcelain is more vulnerable subjected to severe earthquakes. In order to evaluate the seismic performance of the ultra-high voltage (UHV) gas insulated switchgear (GIS) bushing-support frame system, in this paper, shake table tests on a full-scale 1100kV GIS bushing with real support frame and canister for electrical device for alternating current (AC) was carried out. At the critical parts of the system, the dynamic responses were measured. The results indicate that the dynamic properties of the system were changed obviously under different levels of input ground motion with peak ground accelerations less than 0.15g. After retrofitting the frame, the system was retested under the input ground motion of which peak ground acceleration (PGA) is 0.4g and the dynamic properties of the system changed slightly. There wasn't any visible mechanical damage to the bushing. The damping ratio of the bushing-support frame system is small and the amplification factors of the supporting frame is larger than that specified in relevant specifications.

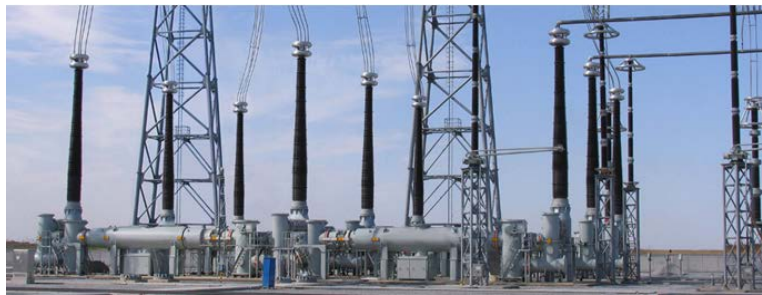
Fig. 1 – GIS used in substation

The electrical equipment such as circuit breakers, disconnecting switches, transformers and arresters are independent and they are connected by bus. In order to improve the degree of reliability of the circuits and to simplify the design of substations, the electrical equipment listed above was installed in metal tube which was filled with the insulating gas ( $\text{SF}_6$ ). The combination unit is called as gas insulated switchgears (GIS). The bushing installed on a GIS is called as GIS bushing. The GIS used in substations are showed in Figure 1.

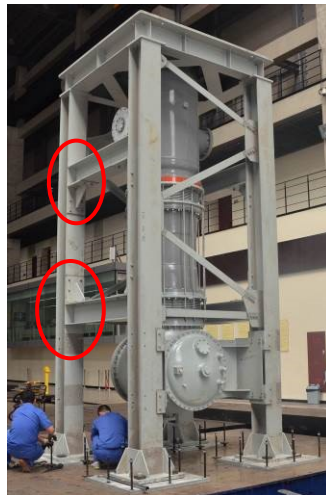
Steel was used to build the supporting frame. The columns of the supporting frame were made by wide flange H profiled bar (H 300×300×10×15 mm). In the main vibration direction, there were braces between

columns and the braces were made by angle (L 100×100×10×10 mm). In another direction of the supporting frame, beams were installed and the section of beam is same with columns. Because the metallic canister should be installed below the frame cover plate and between the columns of the frame, the supporting frame have dimensions of 2000×2000 mm at the bottom and the top. What's more, the height of the supporting frame was 5870 mm, which was design to accommodate the canister. The thickness of the cover plate on the supporting frame is 40 mm. A hole of which the diameter is 960 mm had been set through the cover plate to fix the bushing and the bushing was fixed on the frame by the flange.

The connections or the joints between beams and columns or braces and columns for the frame are bolted connections. For the convenience of the installation, the bolt holes is long and the bolt could slip in them, so the requirements for the installation accuracy could be lower and the supporting frame could be assembled in site. However, for the lack of the knowledge of structure mechanics, the manufacturer ignored the construction measures about the joints. The joints of beams and columns are showed in Figure 3 (a). There is only one ear plate connected the flange of column and beam, so the beams can't tie the columns fasten and lateral stiffness of the supporting frame is small, which may have negative impact on the porcelain bushing according to reference [5]. Between the flanges of the joints, there is no stiffeners, so the load transfer path is incomplete. The force from the beam can't transfer to the column directly. During the test, there were some problems about the frame, so the supporting frame was retrofitted after the test and retrofit measures will be introduced in the next section.

(a) The construction of Frame-O

Fig. 3 – Supporting frames and the joints of beams and columns

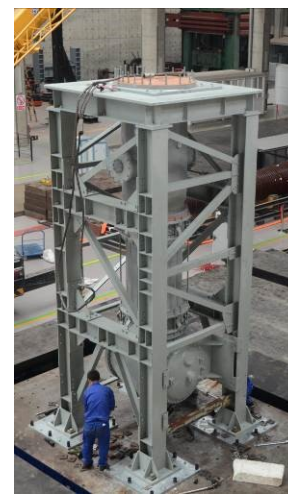
Firstly, the number of ear plate at the joints of beams and columns were increased. The stiffness of the joints increased and the lateral stiffness of the supporting frame increased. Secondly, the stiffeners at the joints was assembled, the force from beams or braces could transfer to columns directly and the local buckling of web or flange was suppressed. Finally, in the main vibration, the horizontal braces were assembled. In another direction, the braces were installed between beams. Figure 3 (b) presents the layout of the ear plates and stiffeners in Frame-R.

(b) The construction of Frame-R

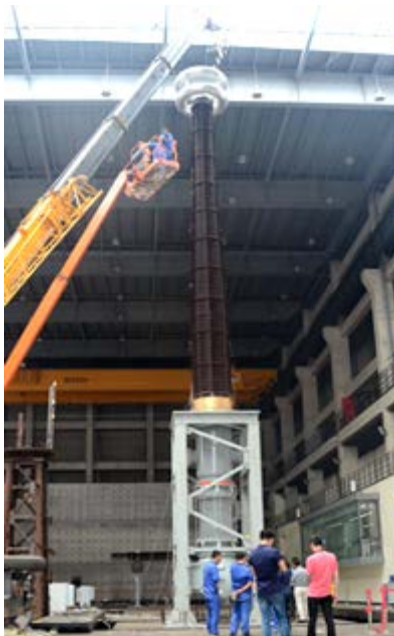
Fig. 6 – The installation of the specimen in laboratory

Table 1 and Table 2 summary the test conditions (TC) of the 2 tests with different supporting frames. The white noise was used for identifying the dynamic characteristics before the tests and for detecting whether there was any structure damage after the shake table tests. The destinations of TC 2, TC 3 and TC 4 for bushing with Frame-O or Frame-R were to optimize the table parameters and to minimize the tolerance between TRS and RRS. For some reasons which will be introduced in the following segments, the bushing with Frame-O couldn't be excited by the artificial time history of which the PGA is 0.4 g. TC 6 and TC 8 for bushing with Frame-R were carried out to evaluate the seismic performance of the GIS bushing. The installation of UHV GIS bushing with Frame-O is showed in Figure 6.
