## 3D Model Reconstruction Using Aerial Photos and Application to Detection of Buildings Damaged due to Earthquakes

M. Matsuoka<sup>(1)</sup>, H. Kawano<sup>(2)</sup>, T. Satoh<sup>(3)</sup>, H. Suzuki<sup>(4)</sup>, I. Sato<sup>(4)</sup>, and J. Miura<sup>(4)</sup>

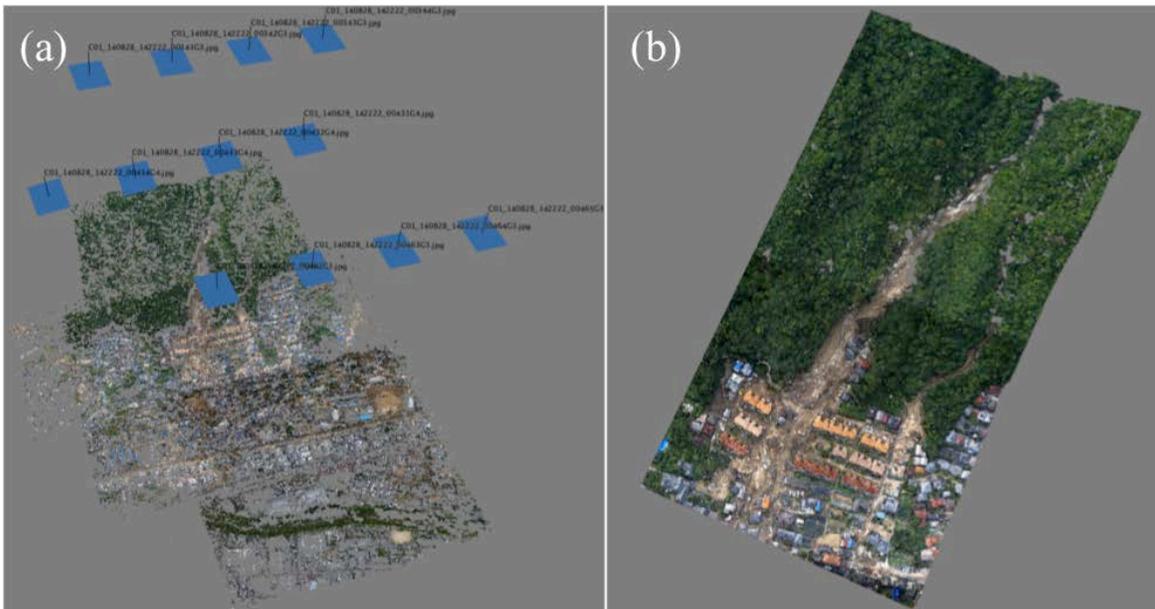
Fig. 1(a) – Estimated camera positions and postures, and the three-dimensional structure of the characteristic points; (b) – Dense three-dimensional model

Using  $A$ ,  $R$ , and  $T$ , the camera matrix ( $P$ ) is reconstructed by the SfM technology. As an example, Fig. 1(a) shows the three-dimensional replication of the estimated camera positions and postures and the common

characteristic points, using the aerial photographs of the site of the Hiroshima debris flow disaster as the input images. The figure shows that the replicated three-dimensional points are not dense.

The technique for obtaining a three-dimensional, high-density, and high-accuracy reproduction from photographs, with known camera matrices, is known as multi-view stereo (MVS). First, a depth image is generated for the input image group. The depth is the depth of the pixel of the image measured from the camera. By searching for corresponding pixels among images, using normalized cross-correlation, and defining the correlation values around the pixel-of-focus as a function of depth, the depth of the pixel-of-focus is defined when the function has the maximum value. The accurate depth information of an object is calculated by integrating the depth images [5], and as a result, a dense three-dimensional model is reproduced. Finally, the model is converted to real coordinates using GCPs (Ground Control Points). As an example, Fig. 1(b) shows a dense three-dimensional model for the site of the Hiroshima debris flow disaster.

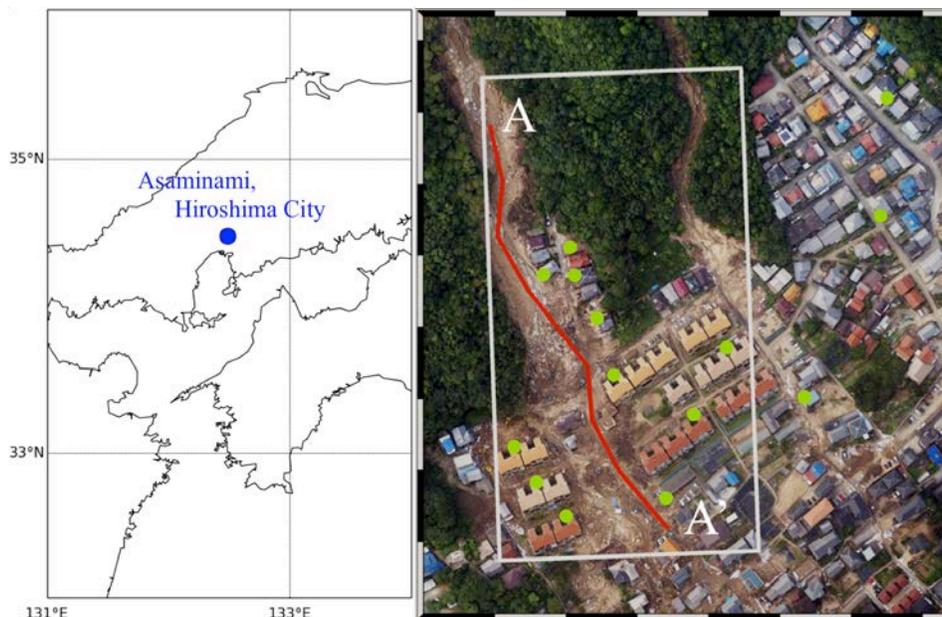
Fig. 2 – The whole observation area (white frame), the mudslide area (red line), and the GCP positions (green points); the background is an orthophotograph of the disaster area

We attempted to validate the altitude accuracy of the three-dimensional models for the Hiroshima debris flow disaster in 2014. Fig. 2 shows the whole observation area (white frame) and the mudslide area (red line) in Midorii, Asaminami-ku, Hiroshima City, where the damage was the heaviest. Twelve aerial photographs of the disaster area were taken on August 28, 2014 (after the disaster). Fig. 1(b) shows the constructed model (Model 1). The average density is 24 points/m<sup>2</sup>. Table 1 shows the image resolution and the replicated point cloud. For accuracy validation, we used the DSM (Digital Surface Model) constructed using the light detection and ranging (LiDAR) observation data (the first pulse) of that day (to be called the LiDAR model in the following sections). The average density of the LiDAR model is 9 points/m<sup>2</sup>, and the beam width is 0.19 m. The GCPs were chosen from the coordinates of the LiDAR data for the conversion to real coordinates.

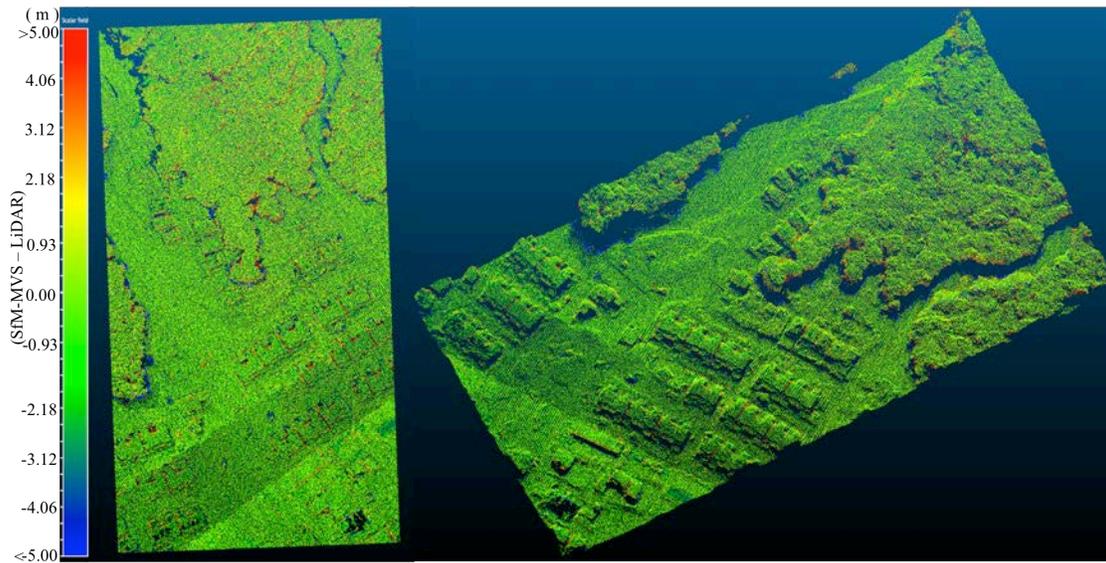
Fig. 3 – Difference in the whole observation area (Model 1 – LiDAR model)

The difference between Model 1 and the LiDAR model is calculated for the validation of the altitude accuracy. Because the models have different spatial resolutions, we searched for the maximum point of Model 1 located within a range of less than 0.1 m (the radius of the beam width) around a point in the LiDAR model to get the altitude difference. Fig. 3 shows the results for the whole observation area. The mudslide area was validated using the point cloud located within a buffer range of 0.1 m from the red line. The RMSE (Root Mean Square Error) of the difference value was 1.75 m in the whole observation area, and 0.17 m in the mudslide area (Model 1 in Table 2). The difference is large in the area with vegetation and around the outer perimeters of the buildings because the altitude accuracy of the replicated three-dimensional model is degraded in areas with large altitude differences.

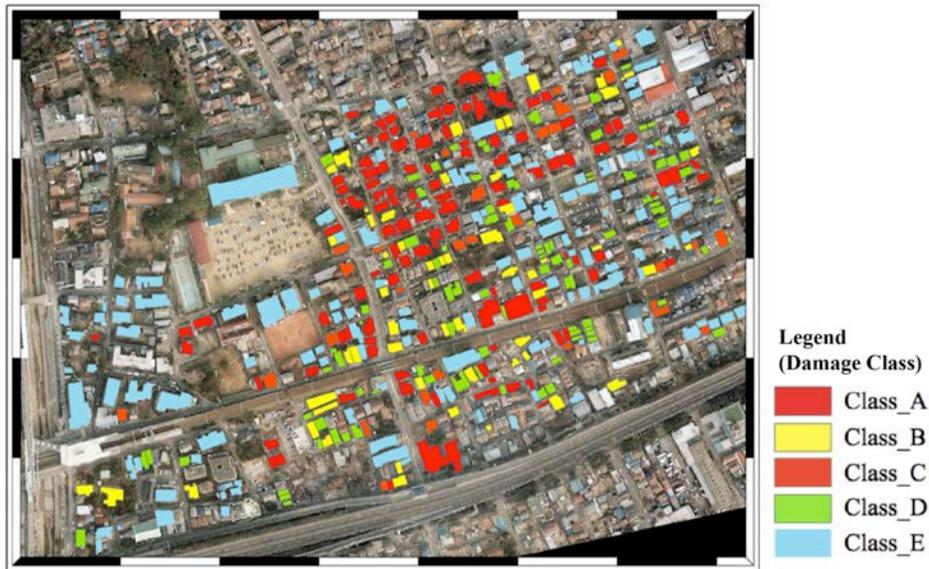
Fig. 4 – Classification of damage by visual interpretation

For the building damage data, in the verification process, we used the polygon data of the Building Research Institute [6], digitized by the Special Committee on Emergency Restoration of City from Earthquake using the results of assessing the degree of building damage. There are six degrees of building damage—complete destruction, major damage, minor damage, no damage, unexamined, and fire. Because there were clear differences in the damage degrees among the ‘completely destroyed’ buildings in this study, the ‘completely destroyed’ buildings were sub-classified by viewing the aerial photographs. Thereby, the combination of the two criteria—‘texture change in the roof’ and ‘altitude change of the building’—were used for the sub-classification into four types (A to D). In addition, another sub-class—no damage (E) was added. Table 3 shows the results of the sub-classification and the distributions are mapped in Fig. 4. The altitude change of a building was obtained from several photographs of the concerned building.

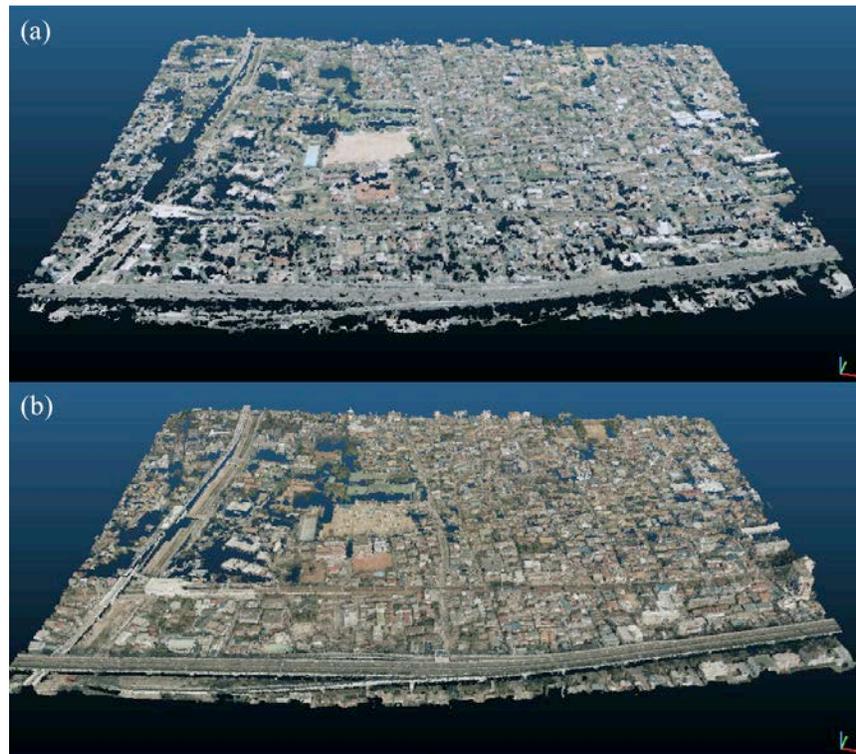
Fig. 5(a) – Three-dimensional model with the images taken at a vertical angle before the disaster; (b) – Model with the images taken at a vertical angle after the disaster

using different cameras, the three-dimensional model was developed using different focal lengths. The pre- and post-event three-dimensional models are shown in Figs. 5(a) and 5(b). Furthermore, the coordinates of the reference points established by Geospatial Information Authority of Japan (GSI) were used for the conversion to real coordinates. Although taken by different cameras, the two sets of photographs (taken after the earthquake) contain large numbers of images that are characterized by high spatial resolutions; hence, the buildings could be replicated quite well using a larger number of point cloud, when compared to the model before the earthquake.

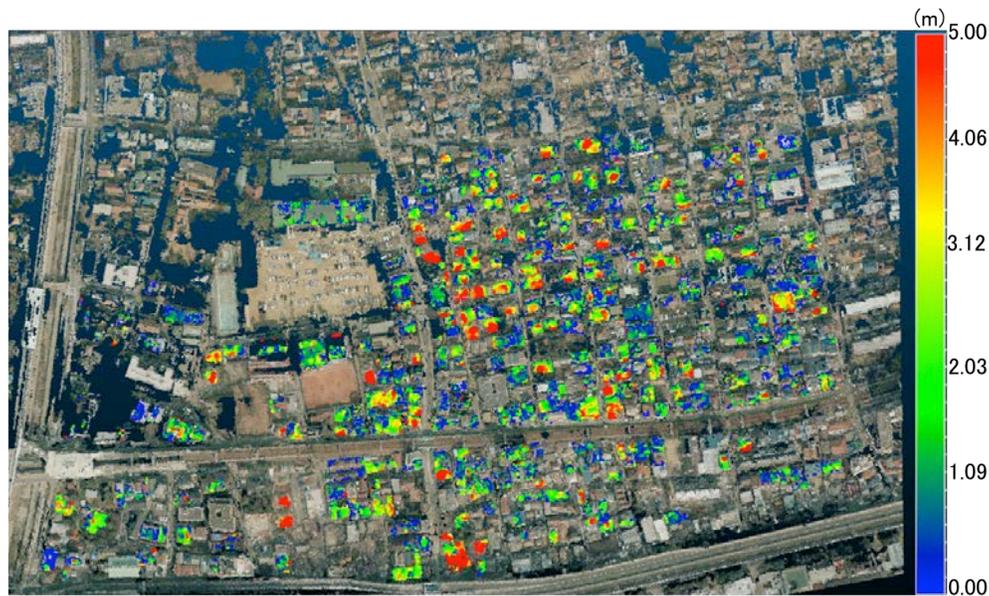
Fig. 6 – Altitude difference before and after the disaster (model before earthquake – model after earthquake)

For extracting the building damage, for which visual interpretation is somewhat difficult due to altitude changes, the altitude difference of the building was calculated from the models constructed from the images taken with a vertical angle before and after the earthquake. The point cloud in the building polygon was identified as building footprint, and the comparisons between the points, in the images before and after the earthquake, were made. First, as a preprocessing step, using the center of gravity composed of the focus point and its neighboring points, smoothing was done to remove the outliers such as noise from the point cloud on the building roofs with inferior resolutions in the images taken before the earthquake. In addition, the point cloud was extracted in several flat areas such as playgrounds, and the offset was calculated using the most frequent values of altitude for kriging—a spatial interpolation method—to revise the model before the earthquake. The altitude difference between the point cloud on the roofs in the models before and after the earthquake was calculated by subtracting the maximum altitude after the earthquake (within a range of 0.5 m) from the altitude before the earthquake. Fig. 6 shows the difference distribution calculated from the three-dimensional models.

The difference is found to be large in A and C with altitude changes. Large changes are not seen in B and D before and after the earthquake. Differences were found in the ‘no damage’ buildings E because the model after the earthquake replicated the building well, whereas the replication was insufficient in the model before the earthquake. An approximate regression equation was derived using the least-square method, from the RMSE values (in the lower part of Table 2) calculated for the accuracy verification in Section 3.2, to estimate the errors in the constructed model. The spatial resolution of the photographs before the earthquake was 0.517 m/pix, and the error estimated from the calculated regression equation was 2.361 m. Using this value as a threshold, the building was assessed as ‘damaged’ if at least 20% of the point cloud in the building footprint had differential values exceeding this threshold. The result is shown in Table 4.

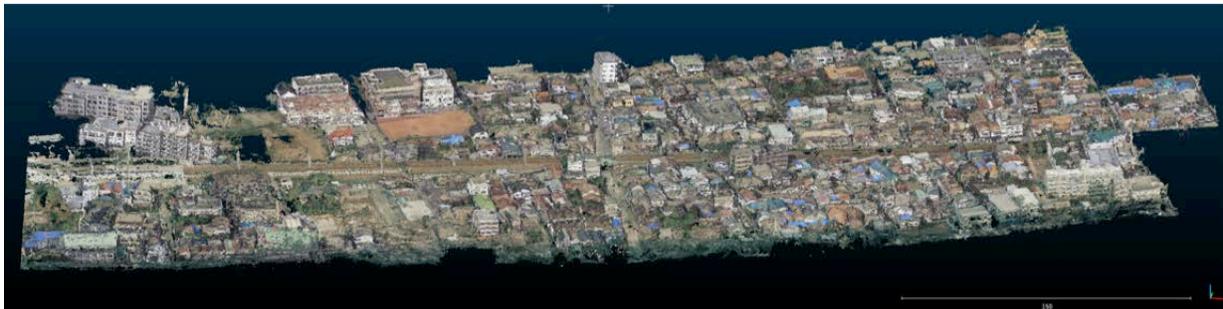
Fig. 7 – Three-dimensional model with the combined images taken at a vertical angle and at an obliquely downward angle

In order to verify the altitude changes and damages of building exterior wall, we re-constructed post-event three-dimensional model by adding oblique photographs taken from the helicopter. In the photographs, a streak-like noise was generated while creating still images. Therefore, to revise the images and construct a model, the noise was reduced by moving every pixel along the corresponding line by referring to the position of the building-wall surface in the image. In the model constructed from the images taken at an obliquely downward angle, there were no reference points within the image; therefore, the GCPs were chosen in flat areas such as playgrounds, and adjusted to the real coordinates using the laser measurement coordinates of the GSI. Then, using the iterative closest point algorithm (a position adjustment method for a point group model) [7], the model constructed from the aerial images taken at a vertical angle was integrated with the model constructed from the images taken at an obliquely downward angle. The results are shown in Fig. 7. It is shown that a three-dimensional model with information on building-wall surface can be constructed by incorporating the images taken at an obliquely downward angle. Using the three-dimensional model included the images taken at an obliquely downward angle (Fig. 7), we found that the visual interpretation of the building exterior wall damages was easy for even damage class ‘D’.
