## STRUCTURAL PERFORMANCE OF DAMAGED OPEN-WEB TYPE SRC BEAM-COLUMNS WITH BOLT-CONNECTED BATTEN STEEL PLATES AFTER RETROFITTING

T. Fujinaga<sup>(1)</sup>, Y. Sun<sup>(2)</sup>

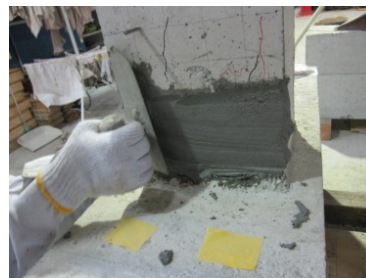
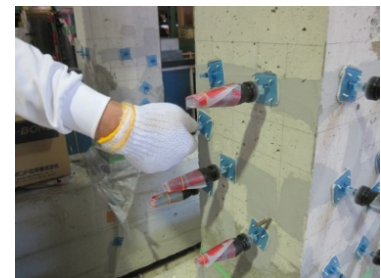
Photo 1 – Method of retrofitting.

(a) Rebuilding of damaged cross section with PCM

(b) Injection of epoxy resin

The main retrofitting method includes the injection of epoxy resin into the observed cracks. The cross sections were rebuilt using polymer cement mortar (see Picture 1) before injecting the epoxy resin because the damage was heavy and the cover concrete was partially exfoliated. After removing the fragile portion of concrete, the

primary resin was coated onto the surface to improve adhesiveness with the existing concrete. Then the section was rebuilt with polymer cement mortar.

Injection of the epoxy resin into cracks was conducted using the internal pressure of the rubber tube swollen by resin for injection. After removing surface dust, rubber tube attachments were put on the cracks with large width or the point where two cracks were crossed. The other cracked portions were caulked. Then rubber tubes were set and epoxy resin was injected. The surface was ground after the resin hardened.
