SEISMIC STRENGTHENING OF RECTANGULAR RC COLUMNS USING PRESTRESSED CFRP WRAP

A. Anžlin ⁽¹⁾, T. Isaković ⁽²⁾

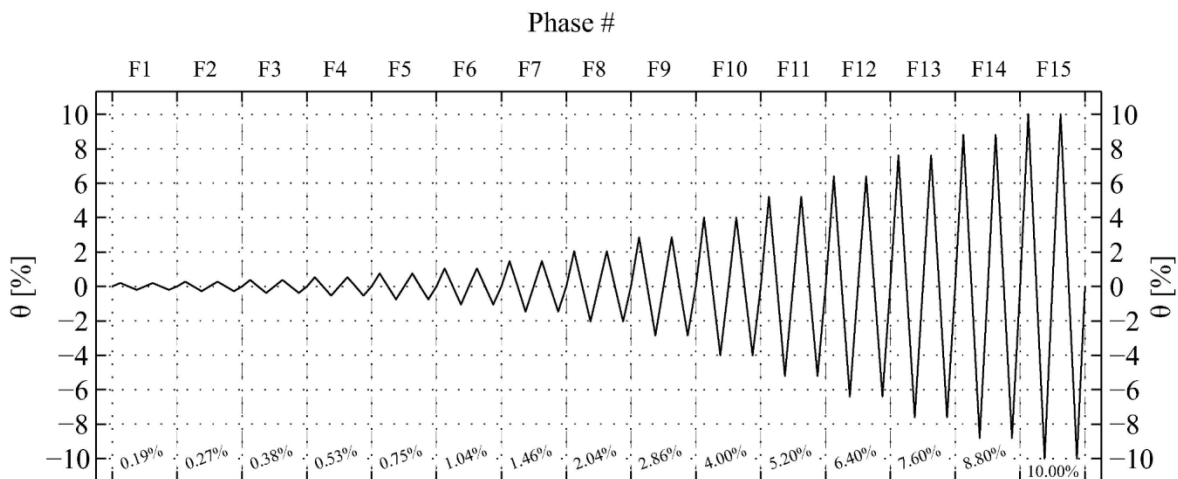
Fig. 1 – Loading protocol used for non-strengthened and strengthened column

Both specimens were tested cyclically under constant axial force provided by two vertical jacks. The displacements were imposed according to loading protocol (see Fig. 1 for details) proposed by FEMA 461 [2] with actuator of maximum load and displacement capacity of 250 kN and ± 200 mm, respectively. Both specimens were loaded at the height 1.8 m from the column base.

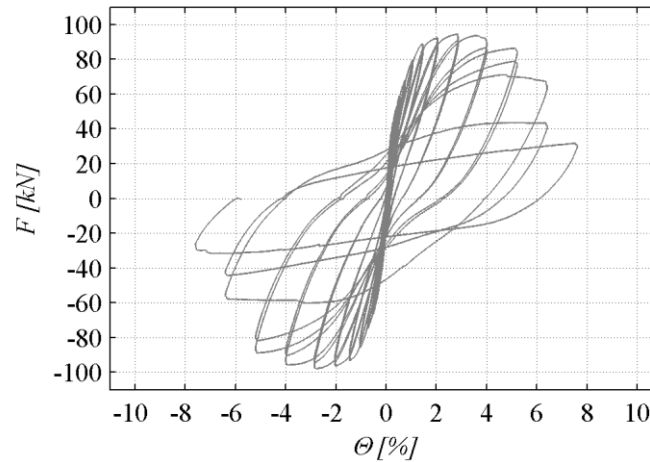
Fig. 3 – The cyclic response of the non-strengthened column

The relationship between the lateral force F and the rotation θ recorded during the experiment is presented in Fig. 3. The maximum lateral resistance was achieved at 2.9% drift. At that drift amplitude flexural cracks were detected at the heights 12 cm and 25 cm from the column base in the vicinity of lateral reinforcement.

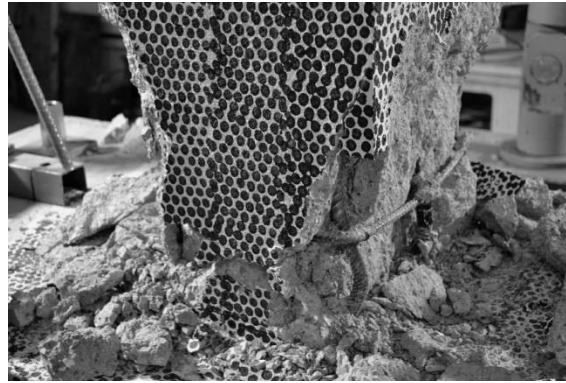
Fig. 5 – Significant damage of the concrete core and global buckling of longitudinal reinforcement after the second cycle at 6.40% drift amplitude

In the first cycle at 6.4% drift amplitude the strength was considerably reduced to about 70% of the maximum observed strength. In the second cycle the strength was further considerably decreased (to about 60% of F_{max}), due to the considerable damage of the concrete core and buckling of the longitudinal bars (see Fig. 5). The stirrups without hooks were opened and were not able to support longitudinal bars.

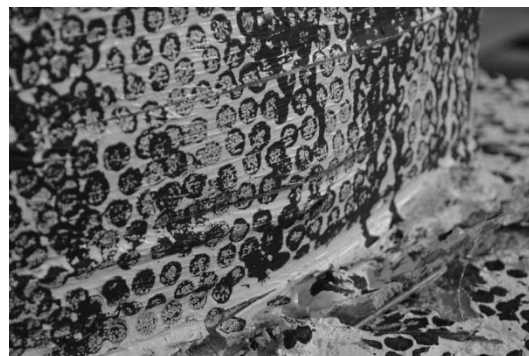
Fig. 11 – Modest rupture of CFRP wrap at 7.60% drift amplitude

At 7.60% drift amplitude deformations of the CFRP sheets were further increased and modest rupture occurred (see Fig. 11). However, this had no significant influence to the strength of the column. The CFRP sheets were ruptured and deboned from the column in the last phase of the test at 9.7% drift amplitude (see Fig. 12). Three longitudinal reinforcing bars were ruptured after the significant local buckling. The strength of the column before the failure was about 70% of the maximal observed strength. After the test the jacket was removed. Only local buckling of the longitudinal bars was observed on both sides of the column. The integrity of the concrete core was remarkably preserved (see Fig. 13).

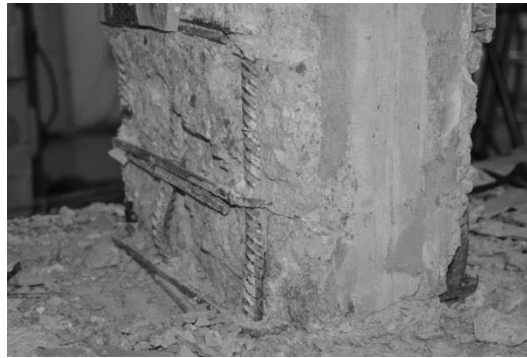
Fig. 13 – The damage of the specimen after the CFRP wrap was removed
