# COLLAPSE OF BAIHUA BRIDGE DURING THE 2008 WENCHUAN EARTHQUAKE: FINITE ELEMENT ANALYSIS WITH A MULTI-SCALE MODEL

H. Li<sup>(1)</sup>, G. Sun<sup>(2)</sup>, R. Luo<sup>(3)</sup>

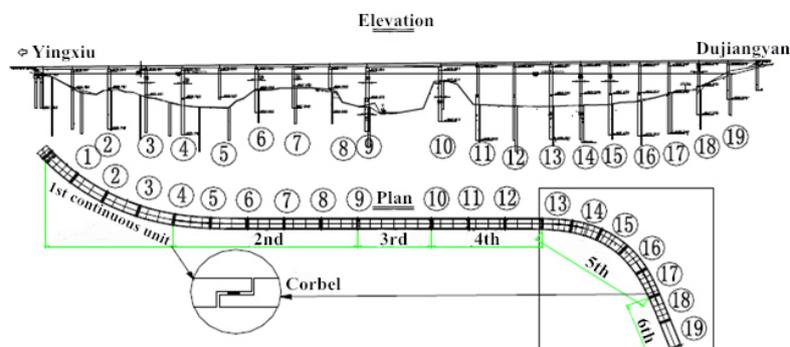
Fig. 2 – General plan and elevation

Baihua Bridge is a prestressed concrete girder bridge with total 495.6 m in length and 8 m in width, and completed in 2004. The superstructure is composed of 6 units with a span distribution of  $4 \times 25\text{m} + 5 \times 25\text{m} + 1 \times 50\text{m} + 3 \times 25\text{m} + 5 \times 20\text{m} + 2 \times 20\text{m}$  (as shown in Fig.2), and supported by twin-column piers connected together by collar beams. The highest and shortest piers are respectively 30.3 m and 7.1 m. The continuous girders with box section are adopted for all the units except the third unit in which a T-shaped simply supported beam is used. The first unit is within a 150 m radial circular curve by left side while the fifth unit 66 m right side from a bird's eye view.

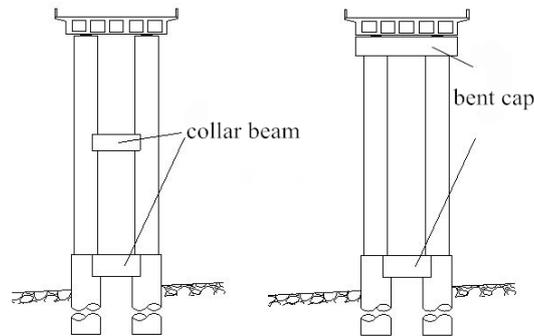
(a) Without bent cap      (b) With bent cap  
Fig. 3 – Twin-column pier of Baihua Bridge

The piers of Baihua Bridge includes two types of structures, as shown in Fig.3. Most have no bent caps and only collar beams set in the middle part of the columns but transition piers between the second and third units, the third and fourth units, and the fourth and fifth units.

The pot rubber bearings are set on the top of all the fixed piers (2, 7, 12, 16 and 19 piers), while the bi-directional sliding bearings on the transition piers (including the brackets), in which lateral displacement of the girders is limited relying on stop blocks, and laminated rubber bearings on the rest of piers.

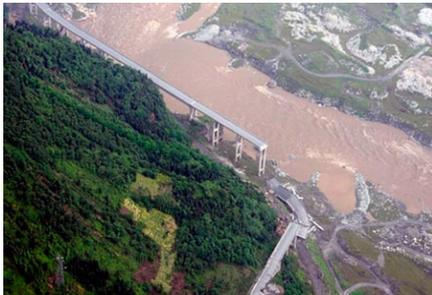
Fig. 4 – Aerial view of collapse of the bridge

Baihua Bridge suffered major damage during the Wenchuan earthquake. As shown in Fig.4 and Fig.5, the whole five spans (spans 14, 15, 16, 17 and 18) in unit 5 collapsed completely, all twin-columns from pier 14 to pier 17 suffered shear cracking, crushing of concrete, destroying of collar beams. It may be observed that pier 17 toppled backwards while other piers, i.e., piers 14, 15 and 16 to opposite direction. The deck of the bridge fell off in unit 5. Seismic damages of collapsed piers mainly include pier breaking, concrete crushing, collar beam destruction and shear failure, etc. Seismic damages of piers not collapsed include concrete crushing, collar beam cracking, stop block destruction and superstructure shifting, etc., as shown in Fig.6.

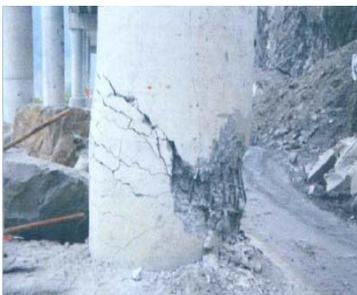
(a) Concrete crushing

Fig. 6 – Seismic damages of piers not collapsed

Furthermore, seismic damage investigation shows that the first to fourth continuous units are basically intact. Earthquake damages are mainly presented as overall transverse movement, plane rotation and transverse stress damage in substructure. The seismic damages of substructure of the fifth and sixth continuous units are mainly presented as longitudinal stress damage. Transverse relative slipping occurred between some bridge piers and girders. For piers installed with laminated rubber bearings, the relative displacement between girder and pier is large but damage of pier is slight. However, piers installed with fixed bearings are all damaged seriously.

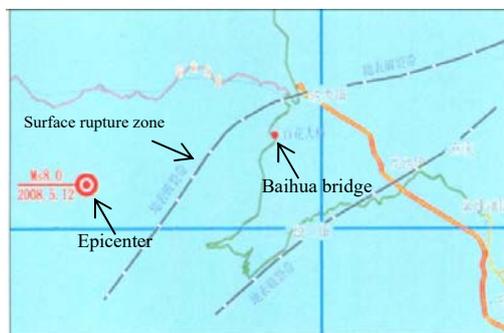
Fig. 7 – Relationship of bridge site, microscopic epicenter and surface rupture zone

The site of Baihua Bridge is about 10.6 km away from epicenter and the closest distance between bridge and surface rupture zone is about 1.5 km. The relationship of bridge site, microscopic epicenter and surface rupture zone is shown in Fig.7 and the relationship between bridge site and principal direction of ground motion is shown in Fig.1.

It can be seen from Fig.1 and Fig.7 that ground motion input of the first to fourth continuous units is mainly transverse action, however, the ground motion input of the fifth and sixth continuous units is mainly longitudinal action. In addition, because Baihua Bridge is near to fault zone, the vertical earthquake input is also considerable. Therefore, a three component accelerogram of ground motion is considered as ground motion input for bridge model in this paper.

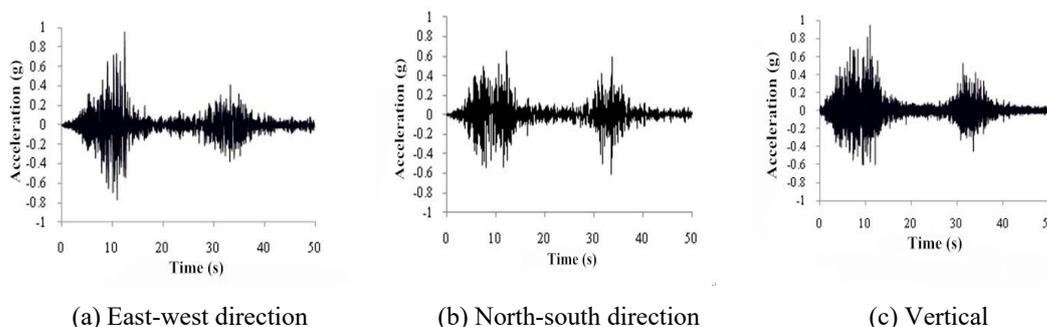
Fig. 8 – Time history of earthquake ground motion acceleration (Wolong seismic wave)

Therefore, the acceleration record obtained at Wenchuan wolong seismic station in Wenchuan earthquake (called Wolong seismic wave) is determined as the ground motion input for bridge model, as shown in Fig.8.

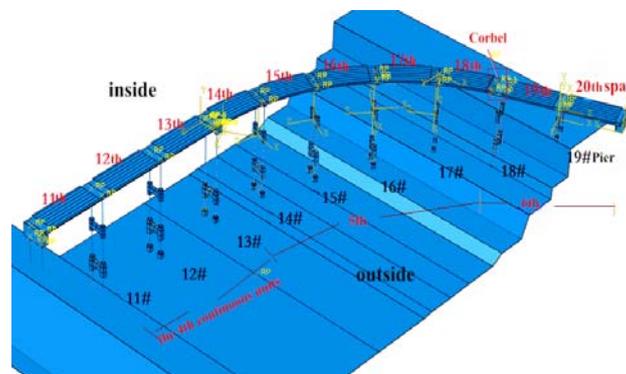
Fig. 9 – Multi-scale finite element model of Baihua Bridge

In order to improve computation efficiency of numerical simulation and accurately reflect the damage process and failure mechanism of structure, the finite element microstructure model of Baihua Bridge is established considering the following effective measures:

(1) Only the rightmost three continuous units (from the fourth to sixth continuous units) of Baihua Bridge is modeled and the influence of other parts are considered as boundary conditions.

(2) In order to simultaneously analyze the whole mechanical behavior and local damage process of structure and to fatherly reveal the properties and failure mechanism of structure, different-scale model are chosen according to the complex degree and nonlinear behavior of structural components or joints.

Therefore, the finite element model of Baihua Bridge established in this paper is shown in Fig.9.

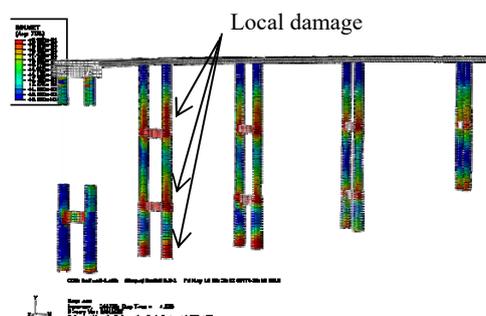
Fig. 10 – Numerical simulation result of bridge pier damage using solid element model

According to the seismic damage investigation and the numerical simulation result using solid element model, the main damaged parts mostly locate in the collar beam, collar beam-pier joint and pier bottom of bridge, as shown in Fig.10.

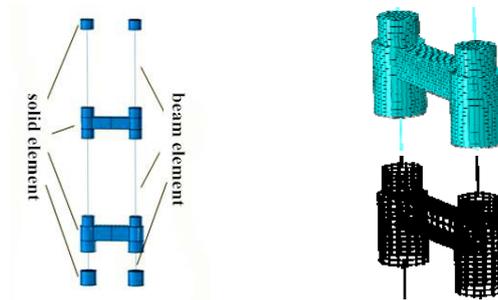
Fig. 11 – Multi-scale model of bridge pier

Therefore, the damaged parts of bridge pier are modeled by solid element and others are modeled by beam element. The multi-scale finite element of pier is shown as Fig.11. In the bridge model, the material of beam element is assumed to be elastic and the reinforce concrete of solid element is simulated by a separate plastic model. The Jeeho Lee plastic damage model of concrete (see references [10]) and bilinear model considering strength degradation of steel bar (see references [11]) are applied respectively. The treatment scheme with force equilibrium condition is applied to deal with the coupling problem at the interface between solid model and beam model (see references [12]).

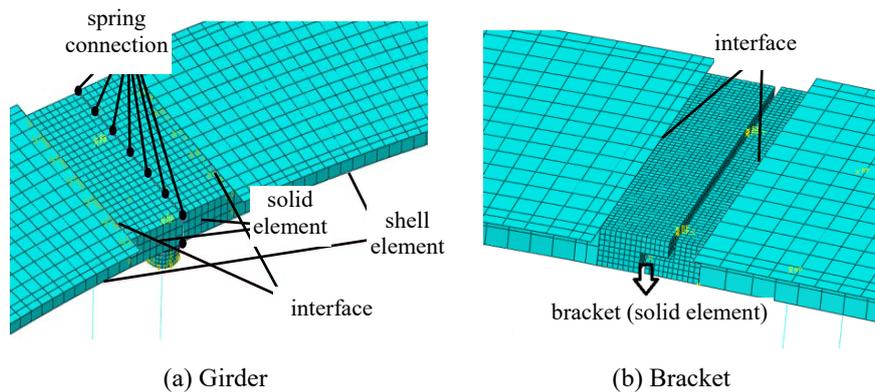
Fig. 12 – Multi-scale finite element model of girder

According to the seismic damage investigation, the damaged parts of superstructure mainly locate in the girder on top of bearing due to collision and unseating. Therefore, the girder model is divided into two parts, the parts on the top of bearing are modeled by solid element and others are modeled by shell element, as shown in Fig.12(a). The plastic damage constitutive relation is adopted in solid model and the elastic constitutive relation is adopted in shell model respectively. The tensile and compressive effects of steel bar in girder are simulated by nonlinear spring. The treatment scheme with force equilibrium condition is applied to deal with the interface coupling the between solid model and shell model.

In addition, the collision occurred at the bracket connection of girder during earthquake, so the bracket is modeled also by solid element and local mesh refinement is applied, as shown in Fig.12(b).

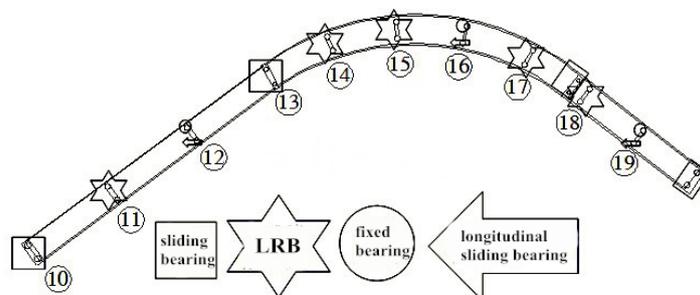
Fig. 13 – Bearing arrangement

Bearings of Baihua Bridge include laminated rubber bearing, fixed bearing, bi-directional sliding bearing and unidirectional (longitudinal) sliding bearing as shown in Fig.13. Bearing is simulated by the link element and contact friction element as shown in Fig.14.

Only one fixed bearing is set at outside of the 16th pier and longitudinal sliding bearing is set at inside of the 16th pier. Other piers are all installed with sliding bearings or laminated rubber bearings. Under the bi-directions horizontal earthquake action, in-plane rotation of girder around the fixed bearing occurred in curved segment, leading to longitudinal-transverse coupling displacement at expansion joint, as shown in Fig.21. The longitudinal-transverse coupling displacement results in extrusion and pounding of adjacent girders, leading to larger relative displacement and unseating eventually, which is consistent with the actual bracket damage as shown in Fig.17. In addition, horizontal seismic action of superstructure of the fifth continuous unit was totally bear by the 16th pier due to fixed bearing arrangement, leading to the pier destroyed rapidly.

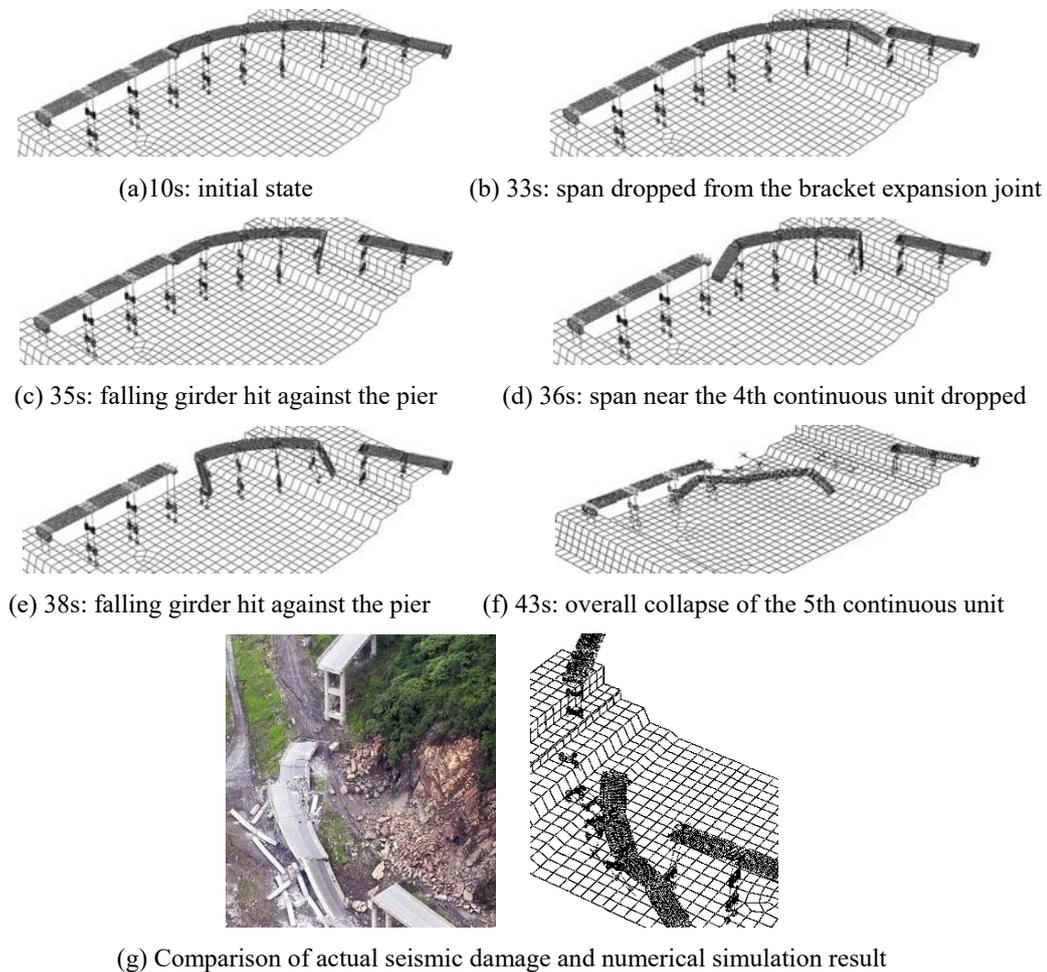
Fig. 15 –Progressive collapse process numerical simulation of Baihua Bridge

Numerical simulation results of progressive collapse process of Baihua Bridge are shown in Fig.15. It can be seen from results that bridge collapse process is as follows.

(1) One side of the 18th girder of the fifth continuous span dropped first from the bracket expansion joint due to excessive movement, as shown in Fig.15(b).

(2) The 18th falling girder hit against the 17th pier, as shown in Fig.15(c).

(3) One side of the 14th girder of the fifth continuous span dropped from the 13th transition pier due to excessive movement, as shown in Fig.15(d).

(4) The 14th falling girder hit against the 14th pier, as shown in Fig.15(e).

(5) The 14th and 17th piers collapsed and led to overall collapse of the fifth continuous unit including the 14th to 18th span and the 14th to 17th pier, as shown in Fig.15(f).

From Fig.15(f), it can be seen that the actual seismic damage and collapse process can be simulated accurately according to the multi-scale modeling in this paper.

(2) The numerical results show that one side of the girder of the fifth continuous span dropped first from the bracket expansion joint due to excessive movement, and the falling girder hit against the pier. This leads to further damages and final collapse of the pier, then overall progressive collapse of the fifth continuous span.

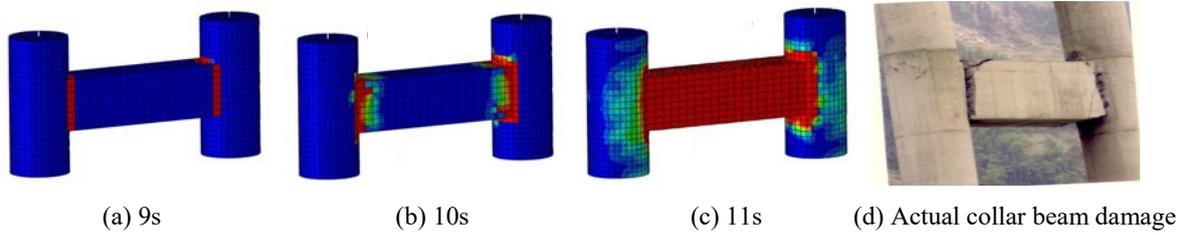
Fig. 16 – Pier and collar beam damage process

In addition, numerical simulation results of local damage process by tension of connection part of collar beam and pier is shown in Fig.16, and the numerical simulation result of longitudinal-transverse coupling displacement of curved girders between bracket expansion is shown in Fig.17.

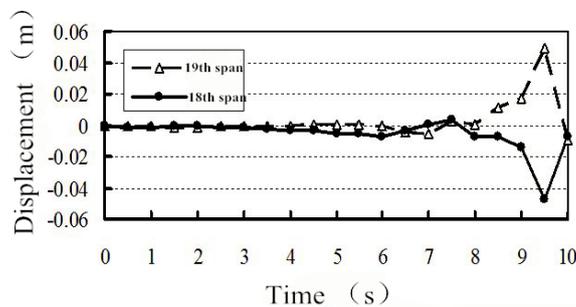
Fig. 18 – Displacement of girders at bracket expansion

There is a great difference between pier height of the fifth and sixth continuous unit. The height difference of fixed pier is about four times, i.e., the 16th pier is 26.9m in height and the 19th pier is only 7.1m in height. According to the numerical simulation results, the longitudinal natural frequency of the fifth and sixth continuous unit is 0.45Hz and 0.64Hz respectively. The displacement of girders at bracket expansion is shown in Fig.18, it is indicated that movement in an opposite direction of the fifth and sixth continuous unit occurred at about 9.5s during earthquake, leading to the excessive relative displacement and collision between bracket expansion.

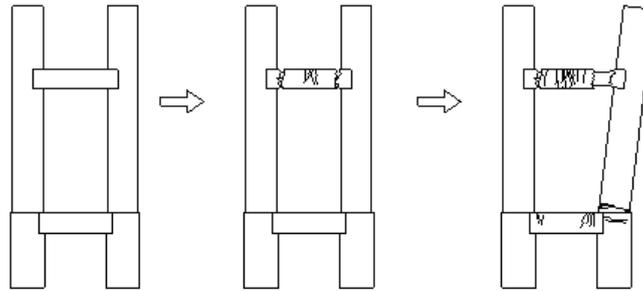
Fig. 19 – Seismic damage process of bridge pier without bent cap

Because most bridge pier have no bent cap and vertical earthquake action amplifies bend-torsion coupling effect of curved bridge, the connection part of collar beam and pier is easy to failure and can not work as a whole as shown in Fig.19. For example, the displacements of fixed pier top of the fifth and sixth continuous unit are shown in Fig.20. The results show that after peak acceleration of earthquake (t is about 12.25s) is reached, there will be a larger displacement difference between outside and inside of the 16th pier and the 19th pier respectively. It indicates that serious damage occurred in connection part of collar beam and pier, leading to greater relative horizontal displacement between the fifth and sixth continuous unit.

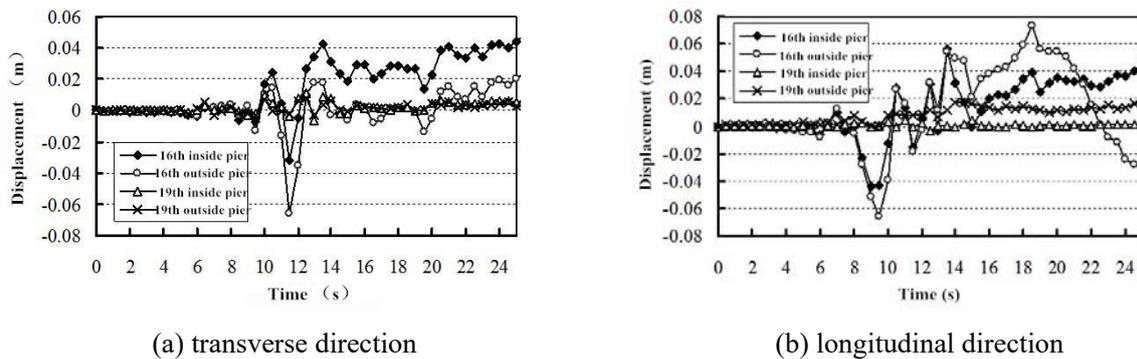
Fig. 20 – Displacement of fixed pier top

(a) transverse direction

(b) longitudinal direction

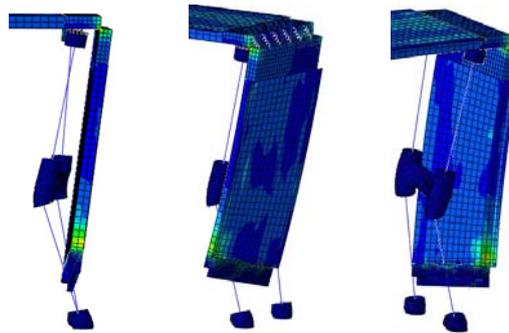
Fig. 22 – Pounding between girder and pier

The pounding effect between the 14th girder and the 13th girder, and the pounding effect between the 18th girder and 19th girder affect unseating obviously. Furthermore, the pounding effect between girder and pier aggravates the collapse failure. For example, the numerical simulation results of pounding effect between the 18th span and 17th pier is shown in Fig.22. It is indicated that the falling girder hit against the pier, leading to further damages and final collapse of the pier.
