STRENGTHENING METHOD AND RELIABILITY TESTING OF PRECAST CONCRETE STRUCTURES

Abstract

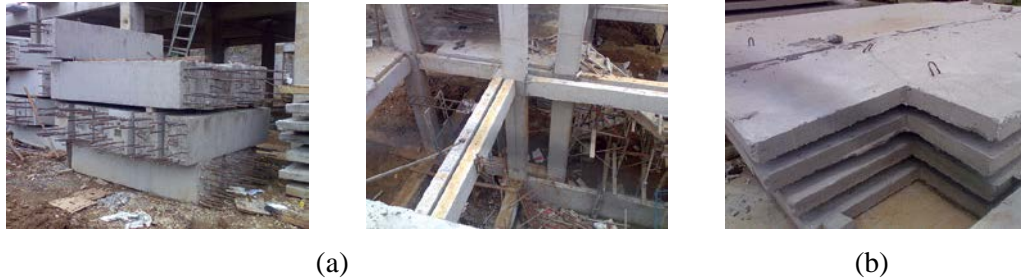
Figure 3 – Condition of beam and column components

1. The quality of concrete of columns and beams considered to be good. See Figure 3a.
2. The quality of concrete of plates is not good, cracks were found at some location as shown in Figure 3b.

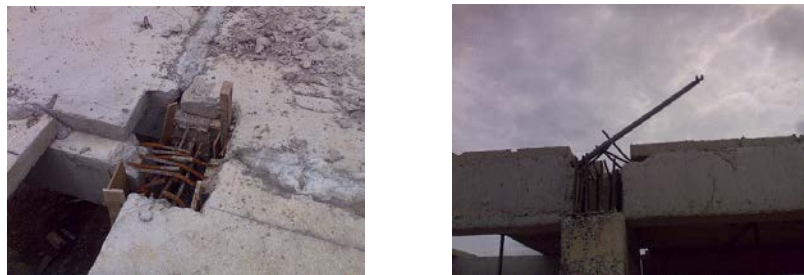
Figure. 4 –Precision of the components

3. Precision of component dimensions was not good so that repositioning and edge cutting were necessary to be carried out to position the components at place. Damages and imperfection occurred at joints as shown in Figure 4.

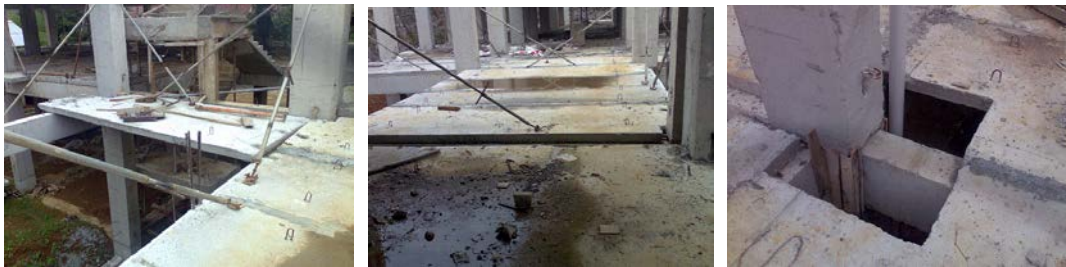
Figure 6 – Beam-slab joint condition at field

6. Detail plate and beam connection does not represent rigid floor diaphragm as shown in Figure 6.

Additional reinforcing bars were provided to withstand negative moments at plate supports. Plates were replaced with newly designed components to limit deflection to the allowable limitation. See Figure 11.

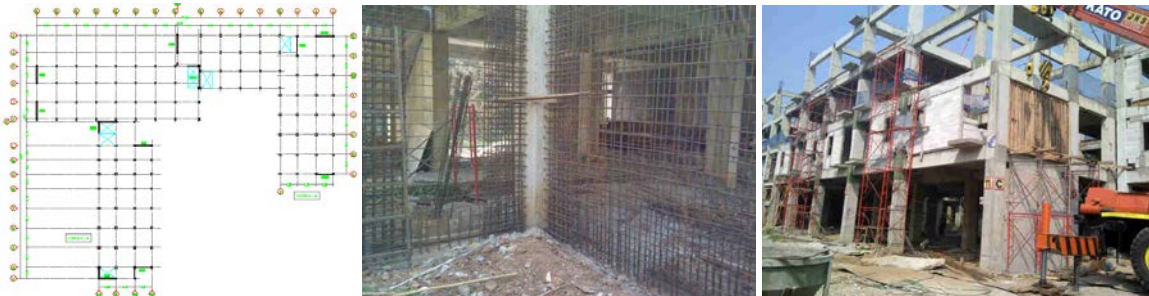
Figure. 9 – Location and reinforcement of shear wall

To prevent soft storey effect and to stiffen the structure, shear walls were added at locations from lower floor up to the second floor. The shear wall thickness was 30 cm. See Figure 9 for explanation.

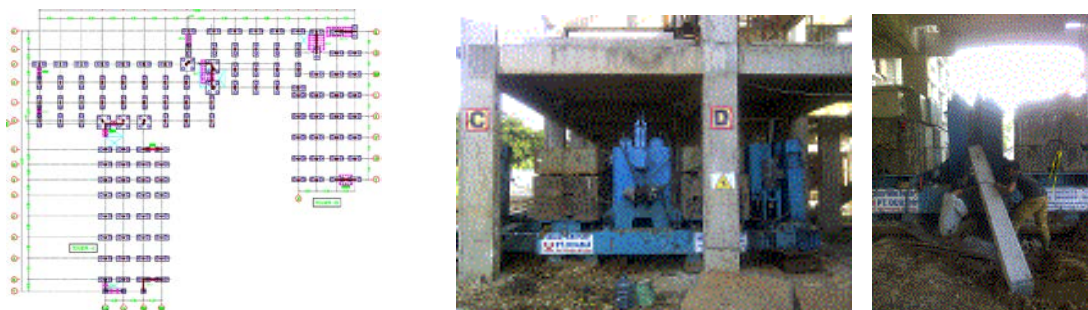
Figure 10 – Additional foundation at shear wall base

The addition of shear wall requires the addition of foundations to withstand forces exerted at shear wall bases. Underpinning technique was used to place and construct the additional foundations. See Figure 10.

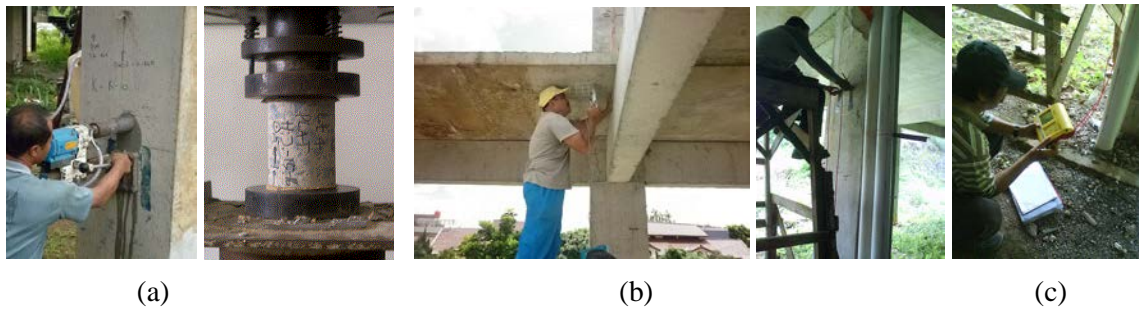
Figure 12 – Material testing: (a) core drill, (b) Schmidt hammer, (c) Ultrasonic Pulse Velocity

Material testing consisted of core drill test, Schmidt hammer test and Ultrasonic Pulse Velocity (UPV) test, as shown in Figure 12. The most worrying finding was that the core drill test showed that the concrete compression strength was only around 20 MPa, less than the specified value of 41 MPa. UPV test showed that the concrete was less uniform. Components tested were column, beam, and plate. The test results were used to evaluate the performance of the structural system.

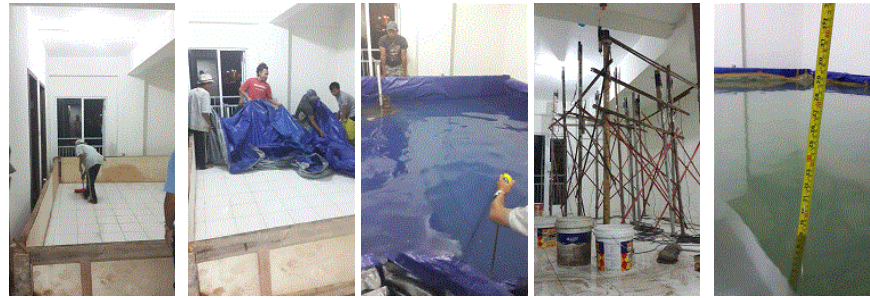
Figure 16 – Gravity load testing

Gravity loading test performed on a part of beam-slab strengthened by rigid floor diaphragm is shown in Figure 16 [8]. Loading test was carried out in accordance with Sections 20.3 up to 20.5 of ACI 318-08 [1]. The loading test level was $1.15 \text{ DL} + 1.5 \text{ LL} = 4.05 \text{ kN/m}^2$ applied as water. After reaching peak level, the load was then sustained for 24 hours, and then removed. The deflection were observed at all time of the testing.
