## DYNGMIC TESTING ON CIRCULAR RC BRIDGE COLUMNS RETROFITTED AND REPAIRED WITH SHAPE MEMORY ALLOYS

### **Abstract**

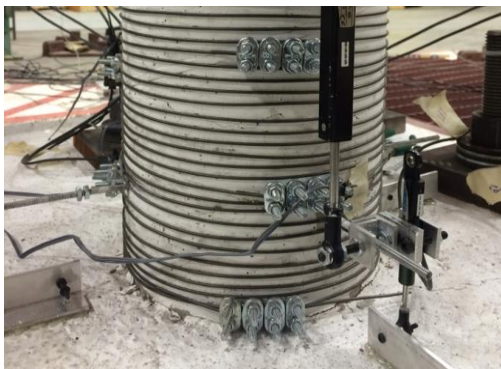
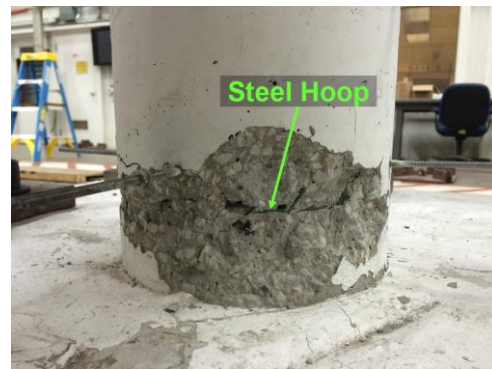
(a) COL-1

(b) COL-2

Fig. 6 – Damage conditions of test specimens after test run 3

The elastic level earthquake loading was applied during test run 1 in phase 1. Both test specimens showed quite similar dynamic responses globally and no signs of major damages were observed. Only hairline cracks at the interface with the footing and the column were commonly seen for both columns, which were quite negligible. The initially reported damage was minor spalling of cover concrete on the east side of COL-2 near the base when recording the maximum drift of 3.65% in the lateral (east) direction during test run 2. Several hairline cracks newly formed on the west side of COL-2. Under test run 3, more severe concrete spalling occurred on the northeast side of COL-2 near the base. COL-2 lost cover concrete and exposed steel hoop in the damaged area ranging about 101.6 mm and 279.4 mm in height and width, respectively. After test run 3, COL-2 was slightly tilted in the lateral (east) direction with a residual drift of 0.89% caused by the elongation of the longitudinal reinforcing bars. The damage condition of COL-1 was closely monitored however only several hairline cracks in the concrete were observed without any significant damage even after test run 3. The maximum and residual drifts of COL-1, were 3.76% and 0.22% in the lateral (east) direction in phase 1. The maximum drift of COL-1 was quite similar to that of COL-2 but large discrepancies existed in the local damage conditions and the residual drifts between the two specimens. The damage conditions of the specimens in the plastic hinge zones after test run 3 are shown in Fig. 6. The large elongation of the reinforcing bars of COL-2 is expected to be caused by the loss of concrete in the plastic hinge zone shown in Fig. 6.b, which in turn reduced the lever arm for the bending acting on the circular section and imposed higher demand on the bars. The time history of the relative column drifts are shown in Fig. 7.

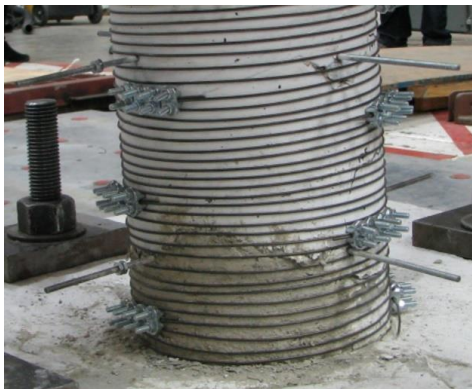
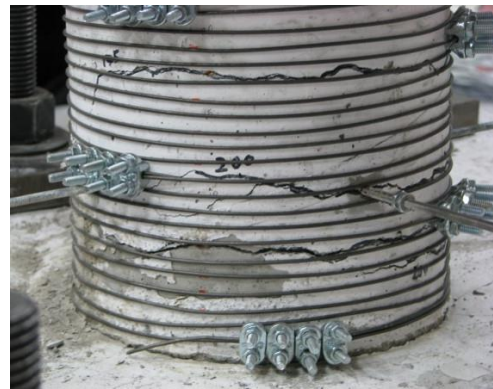
(a) Northeast side

(b) Northwest side

Fig. 8 – Damage condition of COL-2 in the plastic hinge zone after test run 6

Phase 2 of the dynamic testing started from the design earthquake (227% of the Loma Prieta record) after the repair process was completed. In test run 4, both COL-1 and COL-2 successfully survived the design earthquake considered as the main shock. Only small concrete flakes were observed in the plastic hinge zones of both columns. In the global responses, both COL-1 and COL-2 had the maximum column drifts of about 4% in the lateral direction. The residual drift of COL-2 increased to about 1.27% in the lateral (east) direction, tilting further in the east direction because of the damage accumulation in the longitudinal reinforcing bars while COL-1 had a residual drift of 0.39% in the east direction. In test run 5, the aftershock motions, 80% of the design earthquake (-182% of the Loma Prieta record), were applied in the opposite directions to control the undesirable residual drift of the specimens as mentioned earlier. No further damages were reported for both columns in the plastic hinge zones. Due to the opposite directions of the applied test motions, the residual drift of both columns did not increase further. In test run 6, test motions equal to 1.25 times the design earthquake (284% of the Loma

Prieta record) were applied. The damage observations of the confined regions of both columns were similar to what had been reported in previous tests in phase 2. More concrete flakes were generated in the confined regions of the columns without serious concrete damages. The concrete damages in both columns were effectively minimized by the SMA confinement. However, the global responses of the column specimens exhibited differences, compared to the previous test runs. COL-1 and COL-2 recorded the maximum column drifts of 6.4% and 7.3% in the lateral direction, respectively, much greater than the 4% column drifts recorded in test run 4. Especially, the residual drifts of COL-1 and COL-2, 2.1% and 5.2%, respectively, in the lateral direction, increased significantly from 0.39% and 1.27% recorded in test run 4. The dramatic changes in the column drifts in test run 6 can be mainly attributed to the low cycle fatigue behaviors of the reinforcing bars as a direct consequence of the large number of inelastic strain reversals experienced by the bars under the repeated dynamic loading in phase 1 and 2. The time history of the relative column drifts in the lateral direction for both columns are presented in Fig. 7. Fig. 8 shows the damage condition of COL-2 after test run 6 in the confined region. The cracks developed on the west side of COL-2 opened further in Fig. 8.b due to elongation of the reinforcing bars. Fig. 9 clearly shows the residual drifts of COL-1 (captured from the south) and COL-2 (captured from the north) in the lateral direction after test run 6.
