PROGRESSIVE COLLAPSE ANALYSIS OF EXISTING BUILDINGS A PERFORMANCE BASED APPROACH

I. Prionas⁽¹⁾, J. Jing⁽²⁾, M. Seifi⁽³⁾, J. Tahir⁽⁴⁾

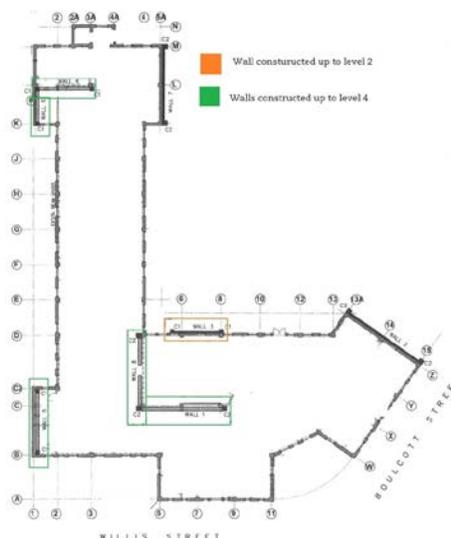
Fig. 5 – Typical Plan of Partial Seismic Strengthening

The earlier strengthening scheme which involved adding 8 RC shear walls to the building was only partially completed. Walls 2 and 7 are the only walls extended full height while wall 3 terminates after level 1, and walls 1,4,5,6 and 8 are built up to level 4 (Fig. 5).

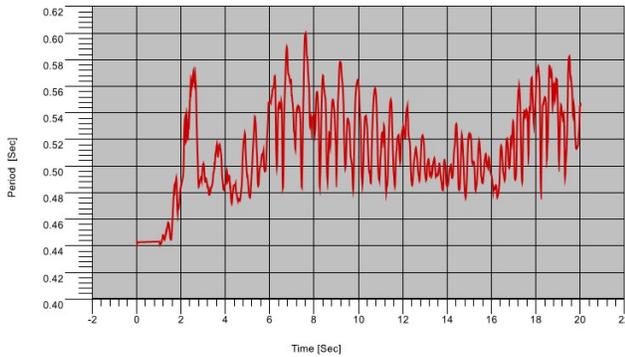
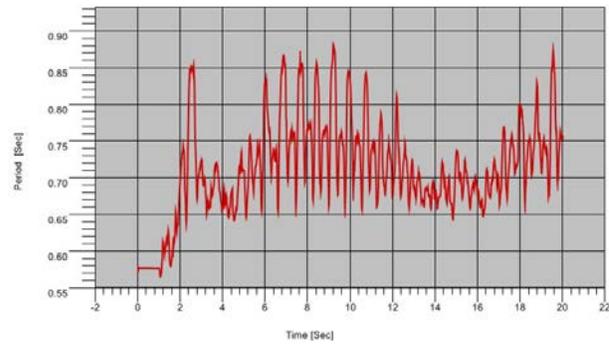
Fig. 11 – Structure period vs. time in the X (left) and Y (right) directions (34% cases)

In addition, it was found that the structure period was initially constant and then elongated due to concrete cracking and reinforcement yielding in all the analysis cases considered. Following each analysis, the period was obtained as a function of time. Fig. 11 and 12 show the structure period against time for the X and Y directions in the 34% and 67% cases respectively.
