DAMAGE ASSESSMENT AND SEISMIC RETROFIT OF TRADITIONAL AND MODERN MIDRISE BUILDINGS IN THE AFTERMATH OF 2015 NEPAL EARTHQUAKE

H. Kit Miyamoto (1) and Amir SJ Gilani (2)

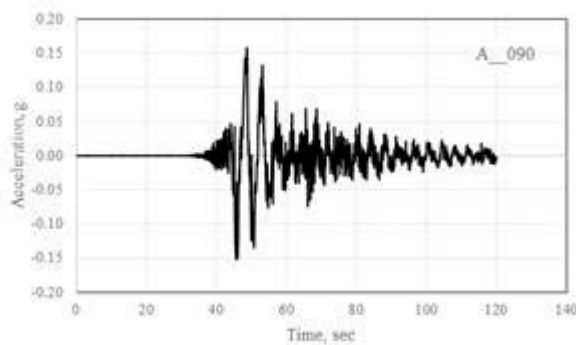
Fig. 1 Acceleration record, 90-degree component

In Katmandu, which is built in an ancient lakebed, far from the epicenter, strong motion data from the Earthquake; see Fig. 1, was available and the peak ground acceleration was approximately 0.10-0.15 g. However, site amplification resulted in large spectral acceleration at periods of 2 to 4 sec; see Fig. 2. These peaks at larger periods, in-turn excited the tall buildings with fundamental periods in this period range, resulting in significant damage to these modern concrete buildings. After almost one year of political and environmental stalemate, reconstruction is just about starting.

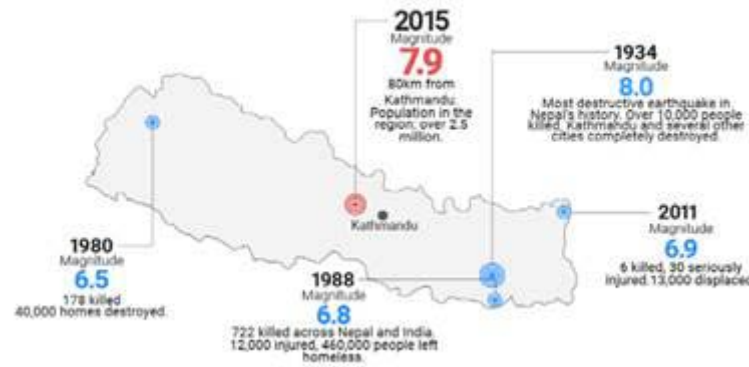
Fig. 3 Significant earthquakes affecting Nepal

Examples of significant earthquakes [1] in this densely populated region, caused by reverse slip movement include; see Fig. 3; the 1934 M8.1 Bihar, the 1905 M7.5 Kangra and the 2005 M7.6 Kashmir earthquakes. The latter two resulted in the highest death tolls for Himalaya earthquakes seen to date, together killing over 100,000 people and leaving millions homeless. The largest instrumentally recorded Himalaya earthquake occurred on 15th August 1950 in Assam, eastern India. This M8.6 right-lateral, strike-slip, earthquake was widely felt over a broad area of central Asia, causing extensive damage to villages in the epicentral region.

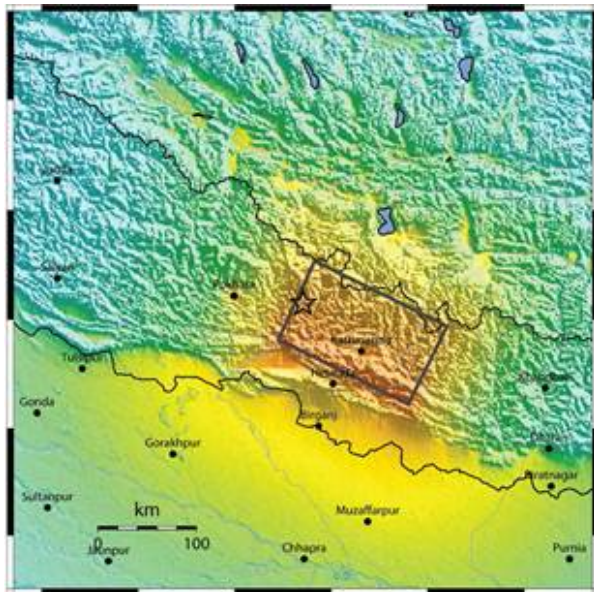
Fig. 4 USGS shakemap [1]

The Earthquake had a maximum perceived intensity of IX in the hardest hit areas of Kathmandu; see Fig. 4. From the USGS Shakemap [1], most of the epicentral region saw MMI-VII or less shaking. It is anticipated that newer buildings constructed per modern seismic codes would only suffer minor damage in MMI-VII shaking. Older buildings and structures with known vulnerabilities (unreinforced masonry, non-ductile reinforced concrete, poorly Constructed pre-cast) buildings would experience significant damage at Intensity MMI-VII. Unfortunately, in Nepal, not unlike neighboring countries in the region, unreinforced masonry and nonductile concrete building Construction are still prevalent.

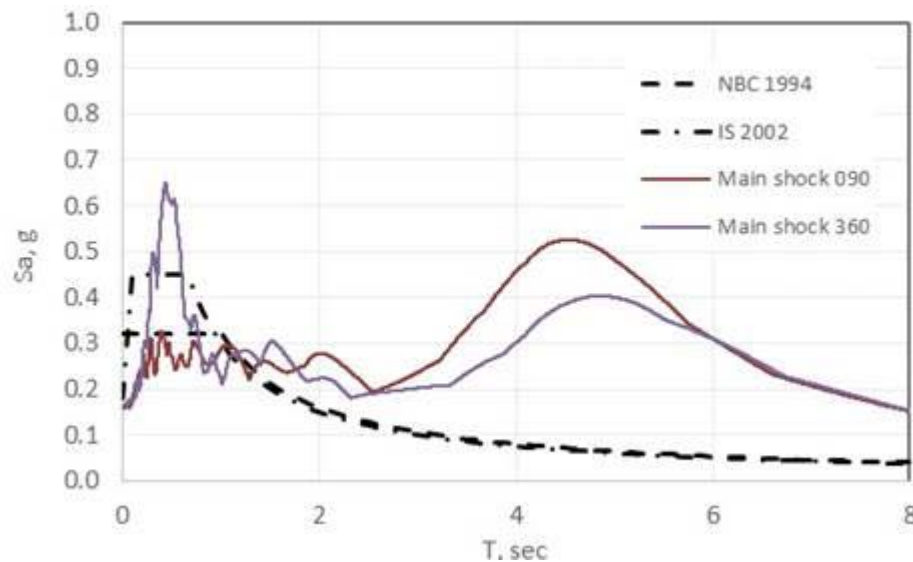
Fig. 6 Code design spectra and 2015 event spectrum

As seen in the figure, the spectral acceleration demand on buildings, in particular, for structures with periods of larger than 1 sec, is significantly larger than the spectrum used to design these structures. Accordingly, even buildings, in particular mid- and hi-rise buildings, designed per code would experience larger forces and displacements than were anticipated. For buildings with ductile detailing, the larger demand would result in plastic hinging and damage for ductile members and for buildings without ductility, severe damage and collapse can be expected.

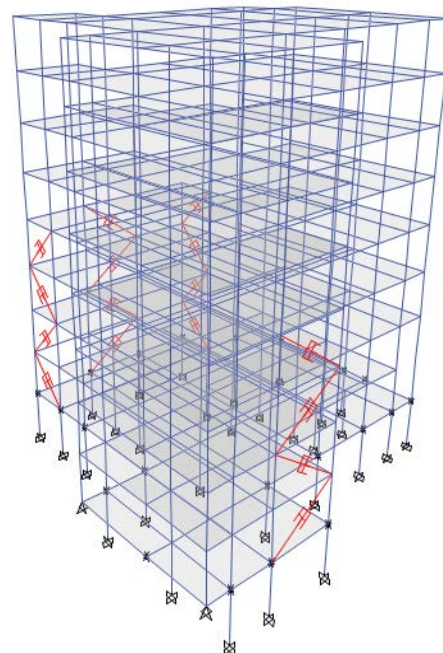
Fig. 14 Mathematical model of the tower

The application of seismic dampers to an existing building was demonstrated after damage assessment of a residential tower was completed. The 10-story 32-m tall tower is approximately square in plan measuring 18 m on side; see Fig. 13. This tower was constructed using reinforced concrete moment frame system with masonry infill. Typical columns were 600x600 mm to 800x800 mm square and rectangular beams measured 300x600 mm. The mathematical model of the building is presented in Fig. 14. In this model, the diagonal viscous dampers are also shown. The building seismic weight is approximately 47 MN.

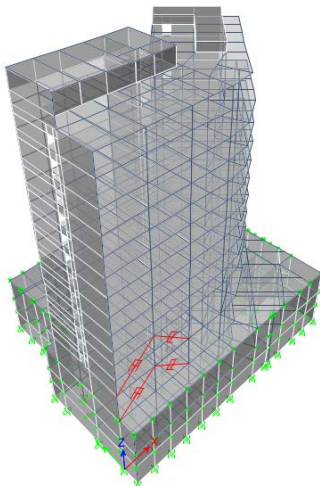
Fig. 17 -2015-earthquake analysis

The new 70-m tall hotel building has 15 stories and 3 basement levels; see Fig. 14. The dual system of reinforced concrete moment frame exterior shear walls comprises the lateral load resisting system. The structure was designed per IS 2002 [5]. Following the 2015 Earthquake, it was decided to add the additional requirement of limiting the drift ratios to approximately 1.5% for a seismic event comparable to that earthquake. As shown in Fig. 18, the building nearly met this criterion in the transverse direction. However, in the longitudinal direction, at the lower three levels, drift ratios exceeded this limit. To reduce the drift ratios, viscous dampers were added at these levels along the longitudinal direction. As shown in the figure, in the new configuration, drift ratios were limited to approximately 1.5%.
