Study on damage to cast-in-place reinforced concrete piles during the 1995 Hyogo-ken Nanbu Earthquake in Japan

This paper reports the results of investigations into the cast-in-place reinforced concrete piles of an 8-story steel reinforced concrete structure that were damaged by the 1995 Hyogo-ken Nanbu Earthquake in Japan. The damage to the piles could be observed during seismic isolation retrofit work on the building 18 years after the earthquake. Almost all the piles were damaged. Initially, pile damage was classified into four categories based on the degree of cracks in the concrete and damage to the reinforcing bar. Each category of damage was explained in detail. Subsequently, the damage was summarized and the factors behind the damage to the piles were considered.

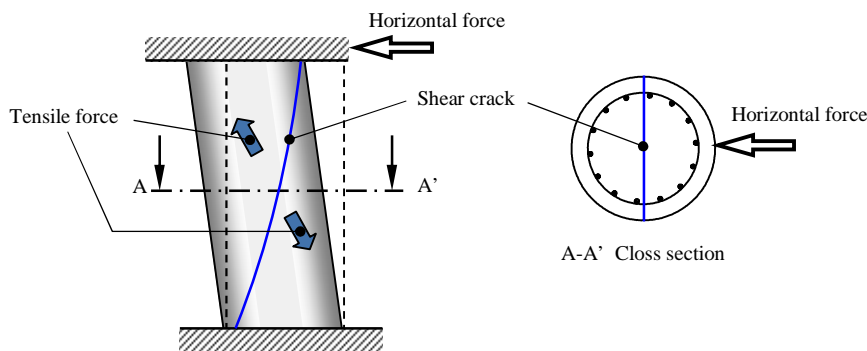
Fig. 6 – Direction of shear force

The primary direction of shear force for the piles during earthquake was estimated by considering the shear crack. Because the shear crack relates to the horizontal force as shown in See Fig. 6.

The direction of horizontal force estimated by the shear cracks are shown in Fig. 5 as arrow symbols. The dominant direction of horizontal force was north-west. It is assumed that the most common direction of shear force estimated by shear crack was N315°E although a few shear cracks of pile with different angles were also observed.

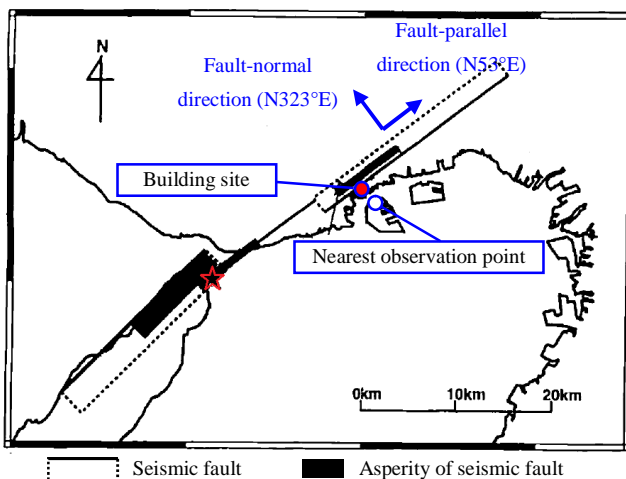
Fig. 7 – Location of the building site, the nearest observation point and the seismic fault [2]

The primary direction of ground motion at the building site was estimated from the record observed at the nearest observation point. The location of the building site, the nearest observation point and the seismic fault are shown in Fig. 7. Based on record from the nearest observation point, the primary direction of ground motion are shown in Fig. 8. The range of estimated shear force direction considering the shear cracks are also shown in Fig. 8.

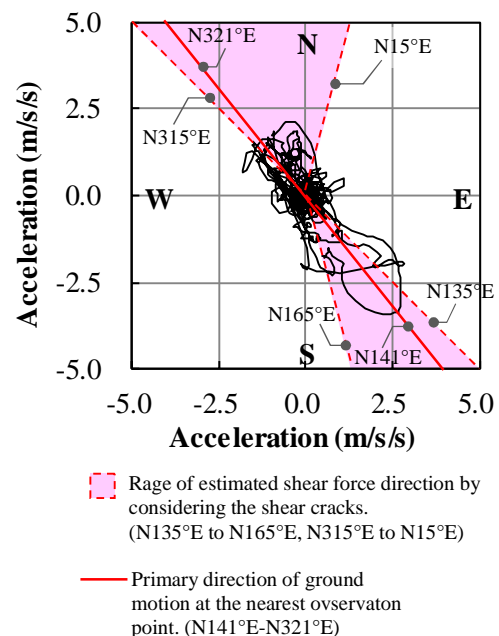
Fig. 8 – Acceleration of the nearest observation point

Referring to Fig. 8, it can be seen that the primary direction of ground motion was estimated to be N141°E-N321°E direction. This direction was nearly equal to the fault-normal direction (N323°E ; as shown in Fig. 7, direction normal to the strike direction of the seismic fault). On the other hand, the range of estimated primary shear force direction by considering the shear crack was N315°E to N345°E. The Primary direction of ground motion generally matched the direction of horizontal force estimated by the shear cracks.
