Damage analysis of a compound retaining wall collapsed during the 2014 earthquake in Northern Nagano

K. Kuribayashi⁽¹⁾, T. Hara⁽²⁾, H. Hazarika⁽³⁾, K. Takezawa⁽⁴⁾, D. Shinagawa⁽⁵⁾

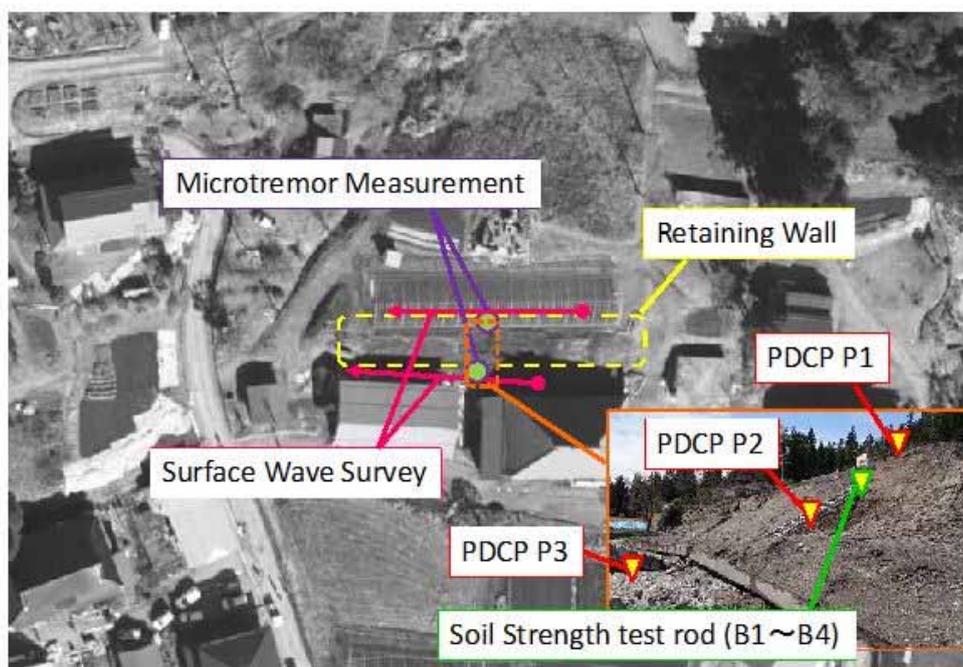
Fig. 5 – In-situ test locations

The (1) to (4) in-situ tests below were conducted to study the ground condition around the retaining wall. The locations of the in-situ tests are shown in Figure 5.

The penetration test was conducted at a total of three points - the top, middle and bottom parts of the retaining wall. A rod was inserted at a right angle to the retaining wall to find the border between the backfill soil and the foundation ground based on changes in penetration resistance for the grounds around the wall. The PDCP test was conducted according to the Japanese Geotechnical Society Standards (JGS 1433), and the number of blows (N_d) was converted into the N -value using the method of Okada et al.^[5]

The surface wave method was adopted for two measuring lines - one in the upper part of the retaining wall and the other in the lower part - to estimate the shear wave velocity (V_s) structure below the ground. The survey was conducted to estimate the velocity structure of a zone between the backfill soil behind the retaining wall and the foundation ground.

Microtremor measurements were conducted at two spots - the upper and lower parts of the retaining wall - to estimate the predominant period and identify the amplification characteristics for the backfill soil behind the retaining wall and the foundation ground.

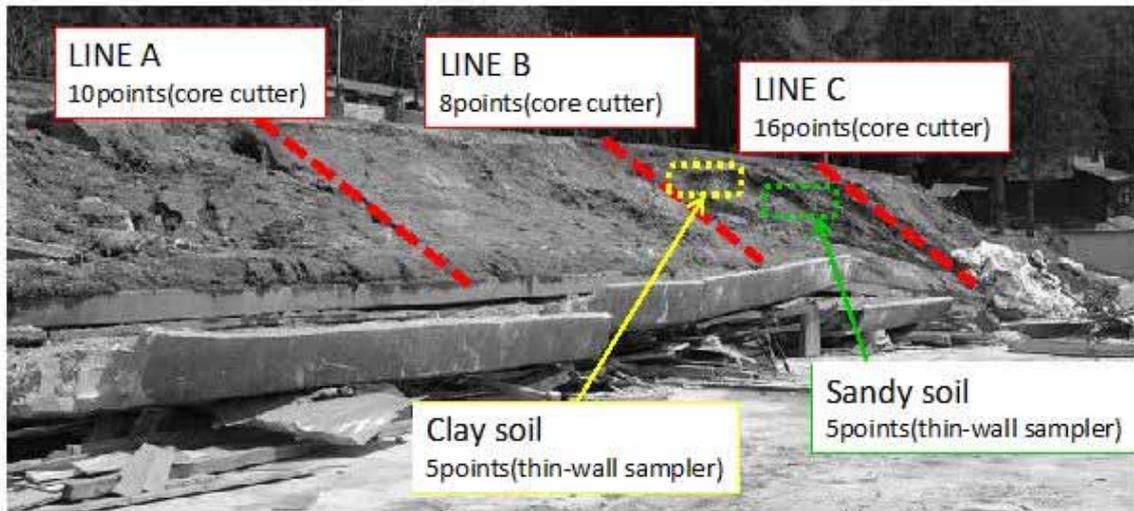
Fig. 5 – Sampling area

In addition to in-situ tests, we collected undisturbed samples with thin-wall sampler and disturbed samples with core cutter from the backfill soil behind the retaining wall surveyed in the earlier study. We performed physical laboratory test, unconfined compression test and triaxial compression test conducted by using the samples. Figure 6 show the sampling area. We collected 34 distributed samples with core cutter and 10 undistributed samples with thin-wall sampling. We collected distributed samples at 50 cm spaces on a 3 survey lines. And we collected 5 undistributed samples at each 2 points, one is a bed of silt, the other is sand.

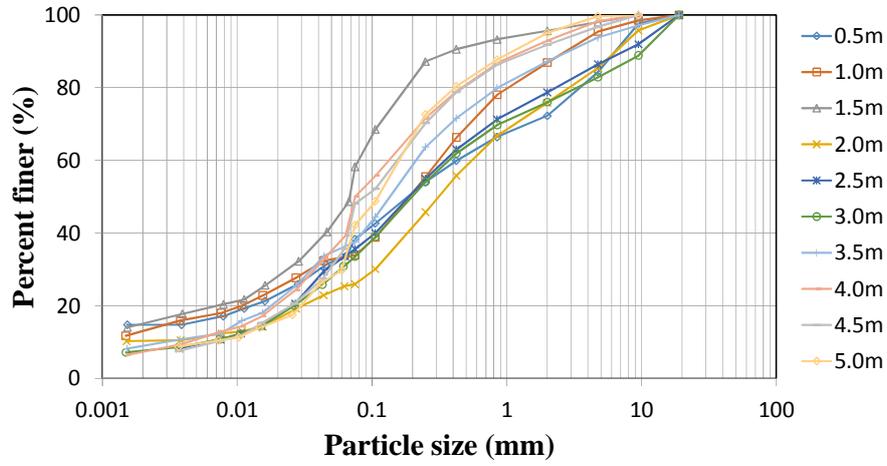
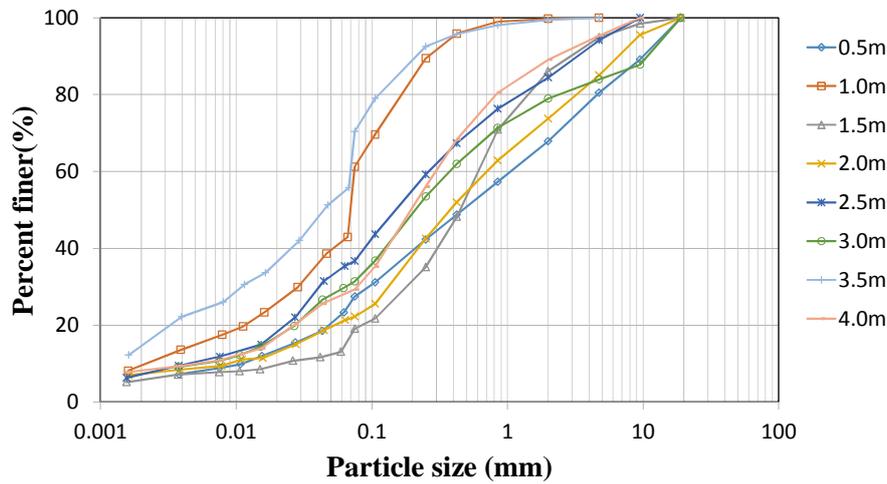
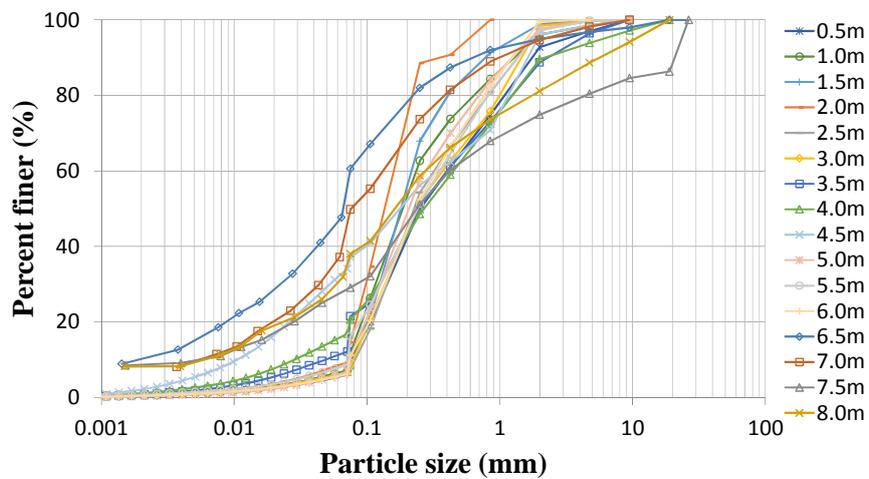
Fig. 10- Grain size accumulation curve

Figure 9 shows stratum structure of background, and Figure 10 shows the particle size distribution curve for the studied specimens which sampled with core cutter. According to the results, we found out that the background soil has a wide variety of soils, such as sandy soil, silty soil, and clay. Furthermore, these soils has formed alternating layer, as shown in Figure 9. The thickness is about 1m if divided with a point where fine fraction contents(F_c) equal 35%.
