BUILDING DAMAGE PATTERNS OF NON-ENGINEERED MASONRY AND REINFORCED CONCRETE BUILDINGS DURING APRIL 25, 2015 GORKHA EARTHQUAKE IN NEPAL

R. Guragain⁽¹⁾, S.N. Shrestha⁽²⁾, D. K. Maharjan⁽³⁾, S. Pradhan⁽⁴⁾

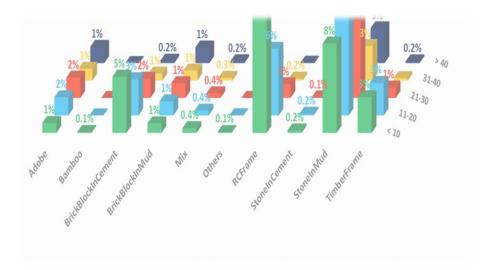
Figure 7: Building Typology vs Age Distribution

Figure 7 shows the building typology vs number of stories. The reinforced concrete buildings very clearly shows that these buildings are new and percentage distribution is more for recent buildings with age less than 10 years. However, stone in mud buildings shows almost uniform distribution among the age with less than 10 years, 10-20 years and 20-30 years. This fact also indicates that people are still constructing stone in mud buildings with very little change to other building types in overall.

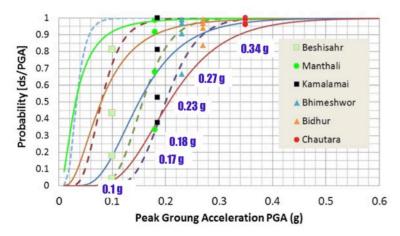
Figure 14: Estimation of Peak Ground Acceleration based on the Fragility Function

Figure 14 shows the fragility function for stone in mud buildings proposed by Guragain, R. [8] and the estimated peak ground acceleration at different locations. The stone in mud buildings are similar in configuration, construction techniques and number of stories in different geographical locations in Nepal. So it is logical to assume that the stone in mud buildings have similar level of vulnerabilities broadly. Thus, for this research purpose it is assumed that the vulnerabilities of stone in mud buildings in different location in Nepal is similar. Anyway, the numerical simulation results already covers different type of configuration and material properties. With this assumption, the comparison shows that there might have the low peak ground acceleration of about 0.1g at Besisahar municipality and high acceleration of 0.34g at Chautara municipality based on the damage ratio obtained. However, once the more reliable acceleration distribution map is obtained, the damage ratio can be compared and the proposed fragility functions may need to update accordingly.
