# THE CHURCH OF SAN FRANCISCO IN SANTIAGO, CHILE. ANALYSIS OF 400 YEARS OF EARTHQUAKE-RESISTANCE BEHAVIOUR

N. Jorquera<sup>(1)</sup>, N. Palazzi<sup>(2)</sup>, L. Rovero<sup>(3)</sup>, U. Tonietti<sup>(4)</sup>

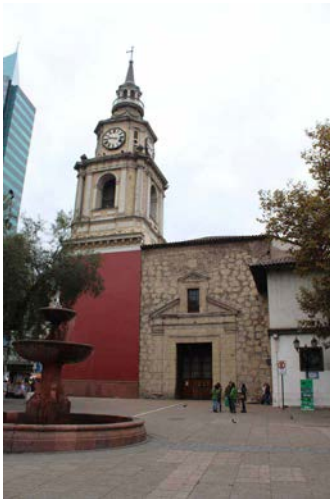
Fig. 1- View of the main façade of the church.

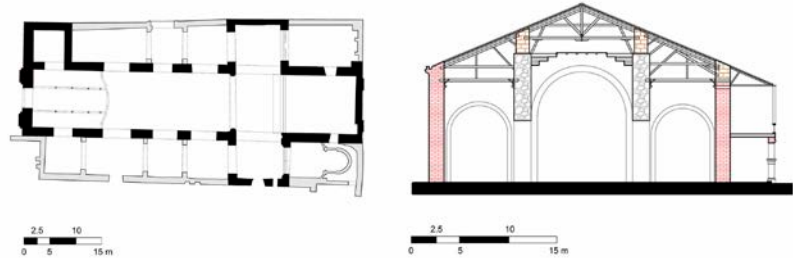
Fig. 2- Current plan and section of the church

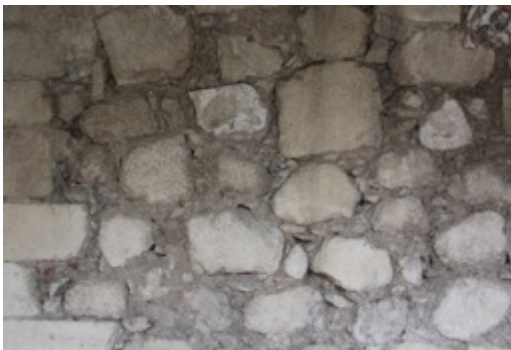
The stones that constitute the original walls of the church are large blocks of limestone of irregular shapes and variable dimensions, from 40x40cm to 90x90cm in their visible surface. They are joined with a lime mortar, which is filled with small stones (Fig.4), improving the homogeneity and the cohesion of the wall. The resistance of the stone is high (though this is not the only decisive factor in determining the final strength of the masonry); it goes from 430-580 Kg/cm<sup>2</sup>, according to Rebound test and Monotone uniaxial compression test. The fired-bricks of the lateral aisles are regular, with dimensions of 40x22x7cm and their superficial strength is about 140-180 Kg/cm<sup>2</sup>. They are also joined with a lime mortar.

Fig. 4- Stone masonry.

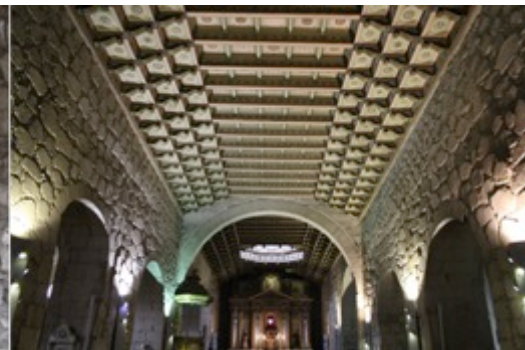
Since its origin, the church was equipped with a big horizontal diaphragm, placed on the main nave, constituted by a series of big wooden beams (30x35 cm cross section), placed very close, at an interaxis of 120 cm, and well connected to the walls (Fig.5). This original diaphragm still exists nowadays even if it was bored to create the skylight over the altar.

Fig.5. Ceiling diaphragm.

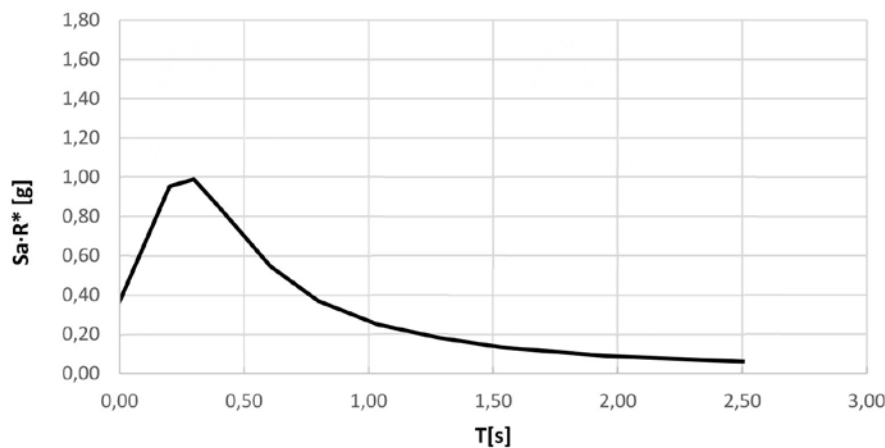
The Chilean "Earthquake Resistant Design of Buildings" [11] allows defining the effective maximum acceleration value to the ground, with respect to the seismic zone. For Santiago the acceleration coefficient (zone II) is  $A_0=0,3g$ . In [14], a probabilistic seismic hazard reassessment of central Chile is proposed considering three different seismogenesis (interplate, intermediate-depth intraplate and crustal seismogenic source). This reevaluation leads to ground accelerations of entities greater than those considered by the Chilean Code, but this study still needs to be integrated with the assessment of the amplifications produced by local conditions (site effect). A more accurate definition of the seismic hazard of Santiago will be supported from additional studies on improving seismotectonics and seismic hazard assessment along the San Ramon Fault at the eastern border of Santiago city, Chile [15]. From the mechanics soil analysis, this area is classified as very dense and stable ground ( $V_{S30} > 500$  m/s), whose soil coefficient  $S$  is 1,00. The elastic spectrum is defined by (fig.9):

Fig. 9- Elastic Spectral Acceleration (NCh433Of96 and D.S. N° 117, (V.Y U.), DE 2010)
