DAMAGE ASSESSMENT AND SEISMIC RETROFIT OF TRADITIONAL AND MODERN MIDRISE BUILDINGS IN THE AFTERMATH OF 2015 NEPAL EARTHQUAKE

H. Kit Miyamoto (1) and Amir SJ Gilani (2)

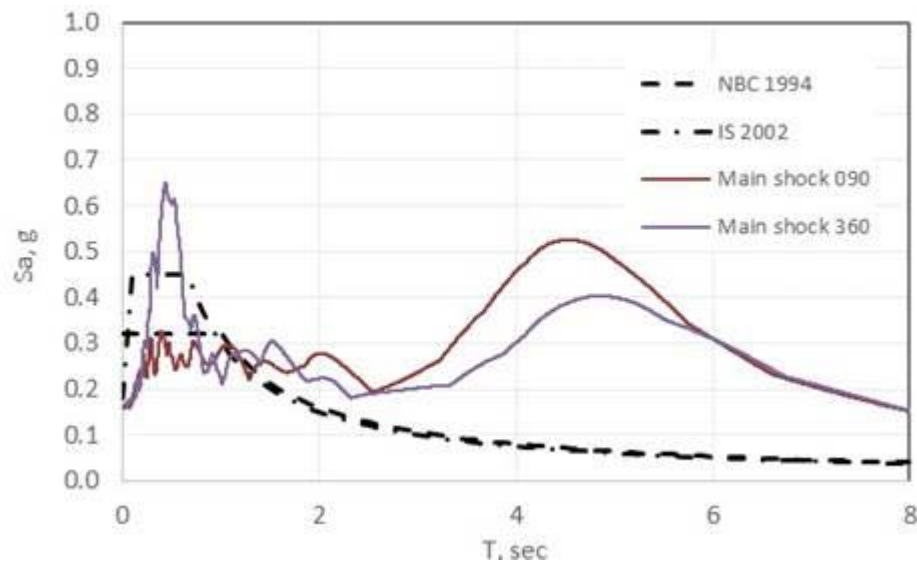
Fig. 6 Code design spectra and 2015 event spectrum

As seen in the figure, the spectral acceleration demand on buildings, in particular, for structures with periods of larger than 1 sec, is significantly larger than the spectrum used to design these structures. Accordingly, even buildings, in particular mid- and hi-rise buildings, designed per code would experience larger forces and displacements than were anticipated. The effect of such larger forces is:

- For buildings with ductile detailing, the larger demand would result in plastic hinging and damage for ductile members
- For buildings without ductility, severe damage, and collapse can be expected

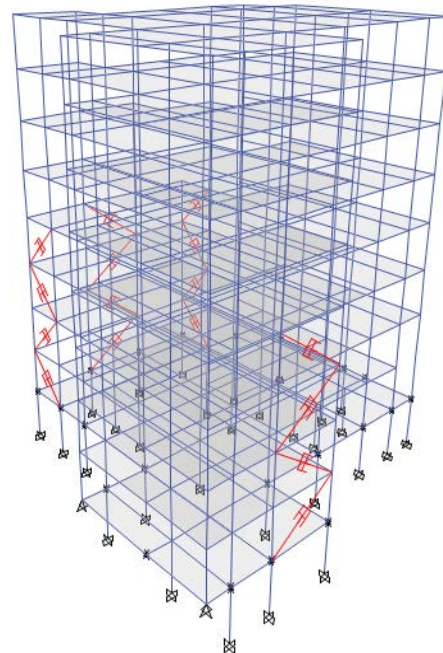
Fig. 14 Mathematical model of the tower

The application of seismic dampers to an existing building was demonstrated after damage assessment of a residential tower was completed. The 10-story 32-m tall tower is approximately square in plan measuring 18 m on side; see Fig. 13. This tower was constructed using reinforced concrete moment frame system with masonry infill. Typical columns were 600x600 mm to 800x800 mm square and rectangular beams measured 300x600 mm. The mathematical model of the building is presented in Fig. 14. In this model, the diagonal viscous dampers are also shown. The building seismic weight is approximately 47 MN.

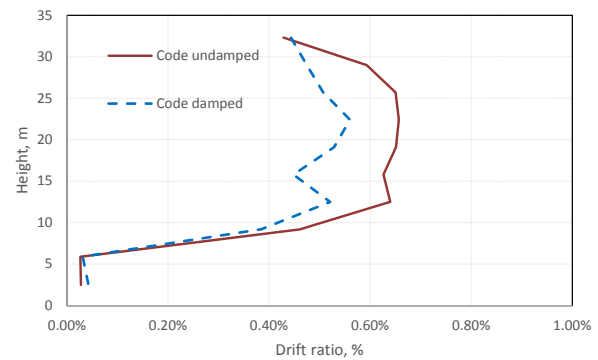
Fig. 16 Code-spectrum matched analysis

Fig. 15 and Fig. 16 present the computed drift ratios for the 2015 event and code-spectrum synthesized record analysis. It is noted that the addition of viscous dampers have significantly reduced the drift ratios and demand on the drift-sensitive reinforced concrete moment frame beams and columns.

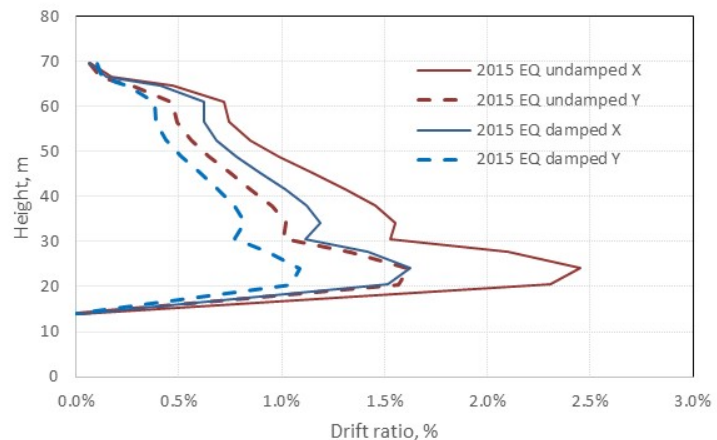
Fig. 18 2015-earthquake analysis

The new 70-m tall hotel building has 15 stories and 3 basement levels; see Fig. 14. The dual system of reinforced concrete moment frame exterior shear walls comprises the lateral load resisting system. The structure was designed per IS 2002 [5]. Following the 2015 Earthquake, it was decided to add the additional requirement of limiting the drift ratios to approximately 1.5% for a seismic event comparable to that earthquake. As shown in Fig. 18, the building nearly met this criterion in the transverse direction. However, in the longitudinal direction, at the lower three levels, drift ratios exceeded this limit. To reduce the drift ratios, viscous dampers were added at these levels along the longitudinal direction. As shown in the figure, in the new configuration, drift ratios were limited to approximately 1.5%.
