GEOTECHNICAL OBSERVATIONS FROM THE 2014 IQUIQUE EARTHQUAKE

G. Candia⁽¹⁾, C. Ledezma⁽²⁾, G. Montalva⁽³⁾, K. Rollins⁽⁴⁾

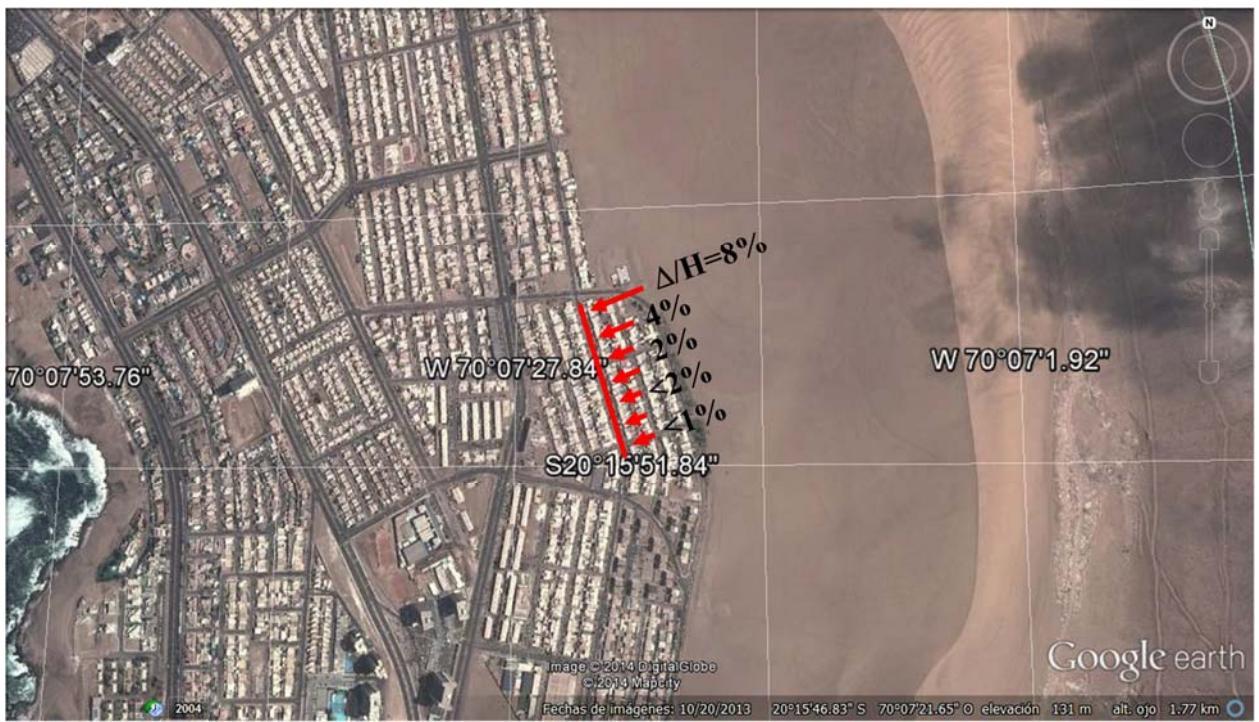
Several retaining walls in Los Algarrobos street at Cerro Dragon were damaged due to the insufficient size of the footing, the lack of restraining elements, and the low strength of the backfill. The observed failure mode was overturning, with measured tip displacement varying between $\Delta/H=8\%$ at the north end and $\Delta/H<1\%$ at the south end, as shown schematically in the Google earth photograph of Fig.7. The extent of the damage was significant considering that PGA at the site was less than 0.25g, and that retaining walls adequately designed for static loads may well resist ground shaking with PGA in the order of 0.3g [10].

Fig. 7 Google earth photograph of the housing development of Cerro Dragón

These retaining walls are made of reinforced concrete, have an average thickness of 20 cm, a height of 240 cm, and spans between 3 m and 15 m. The walls are part of a development built on the dunes of Cerro Dragon, where the terrain is made primarily of loose marine sands, poorly graded particles ($C_u=0.50$, $C_c=0.80$) of medium to small size ($d_{50}\sim0.2$ mm), and a friction angle between 30°-35°. Additionally, these soils have significant amount of calcareous sediments and soluble salts, which increases the risk of bearing capacity failures and large settlements induced by water infiltrations. The backfill soil was flat and the material was loose dune sand mixed with construction debris.
