INFLUENCE OF IRREGULAR CONFIGURATIONS IN THE DAMAGE OF RC BUILDINGS IN 2010 CHILEAN (MAULE) EARTHQUAKE

F. Yáñez⁽¹⁾, D. Silva⁽²⁾.

(1) Civil Engineer, PhD, C.E.O. IDIEM, fernando.yanez@idiem.cl
(2) Civil Engineer, Division Manager, IDIEM, david.silva@idiem.cl

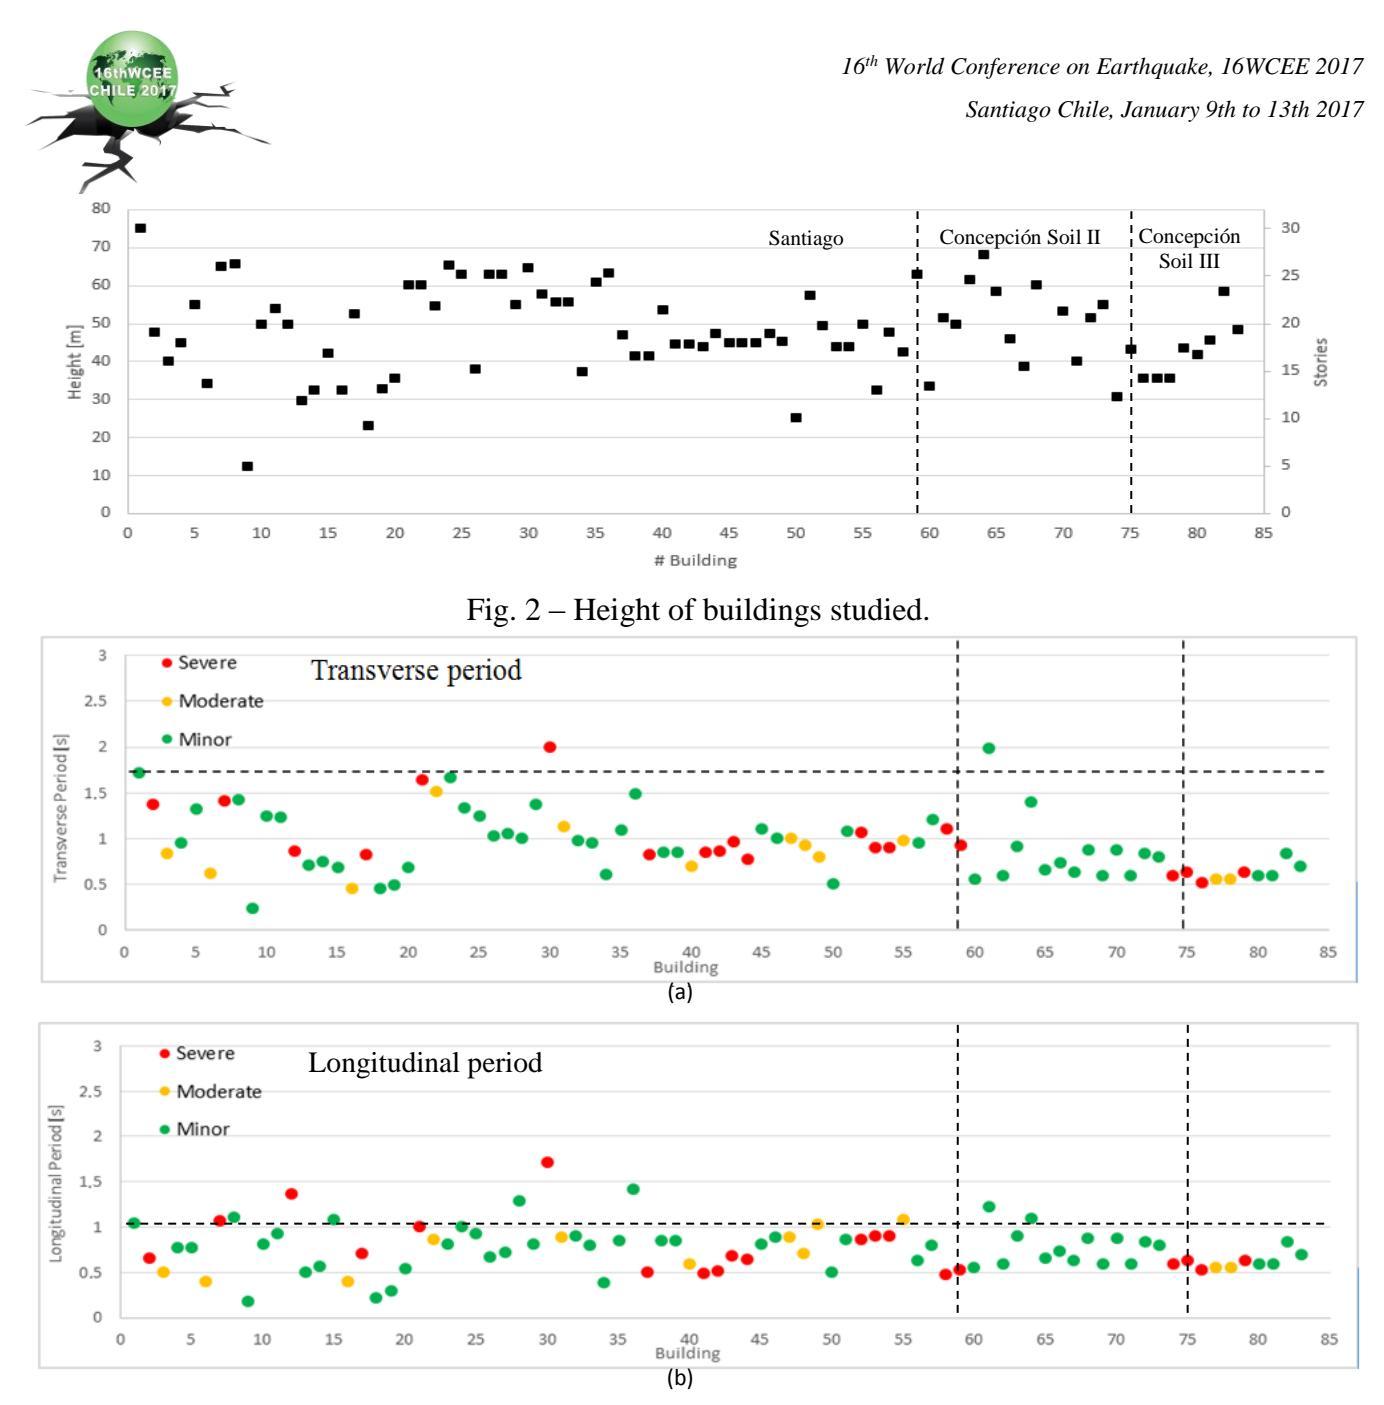
Fig. 3 – Transverse and longitudinal periods of buildings and grade of damage.

We inspected more than 150 high rise building after the earthquake in Santiago and Concepción, and got information of 83 buildings. The height of the buildings was in the range of 10 - 28 stories, as shown in Fig. 2. In this figure the buildings of Santiago are numbered from 1 to 59, and of Concepción from 60 to 83. The periods of the buildings are shown in Fig. 3.

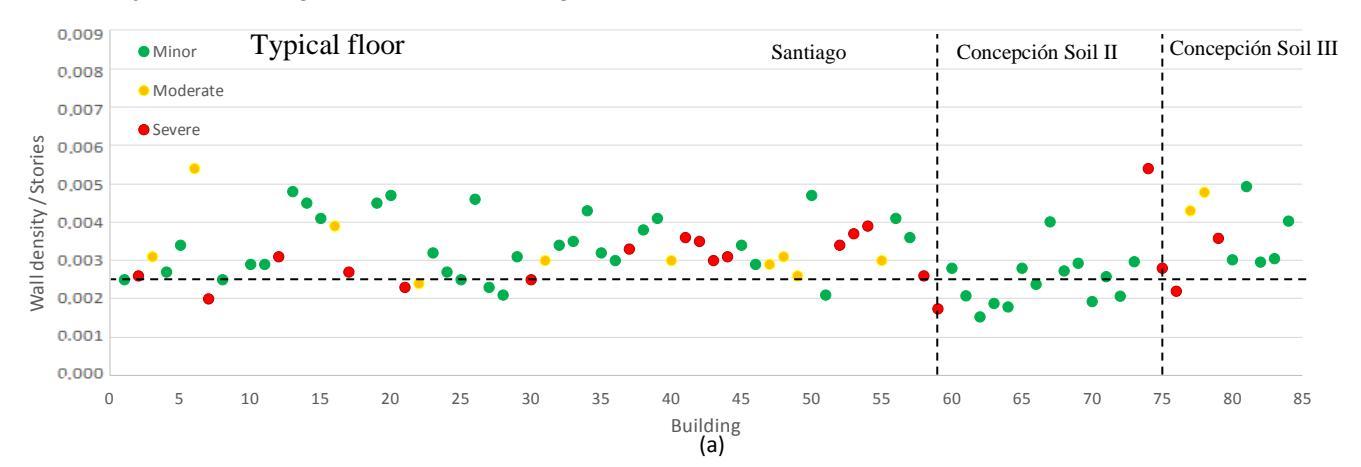
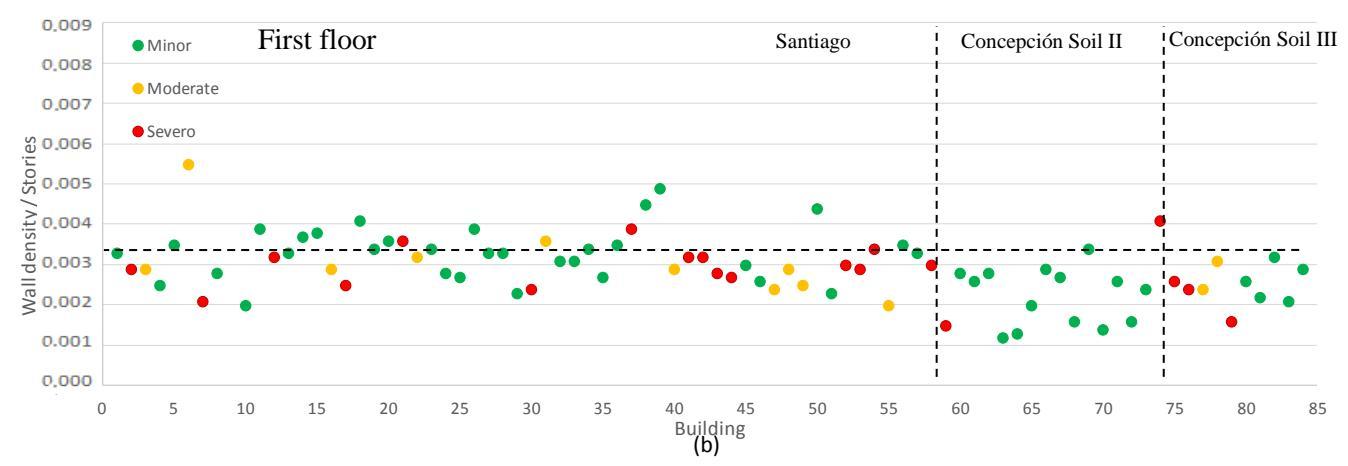
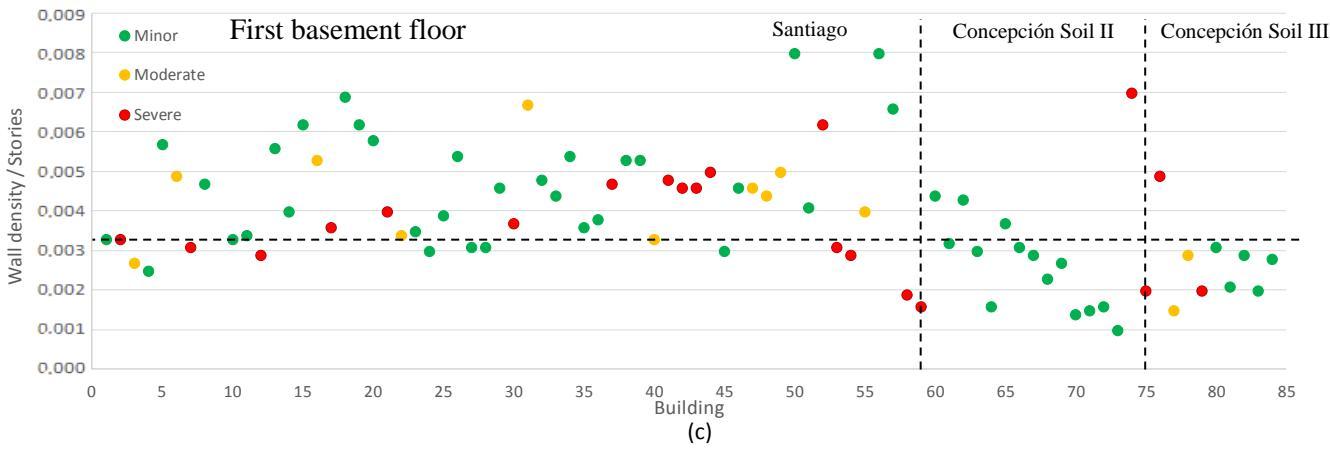
a) Almost all the buildings in Santiago with severe damage had in the first basement floor more wall density than Tajamar Building, but had less wall density in the first floor, where they typically failed, as shown in Fig. 7.

- b) Many buildings inspected in Concepción behaved quite well, having more or less wall density than the standard Tajamar Building. The buildings that failed had large irregularities or design deficiencies.
- c) O'Higgins Building (#59), Fig. 5, had less wall density than Tajamar Building in the first floor and the basement; however it failed in upper stories due to large irregularities.
- d) Alto Rio Building (#74) had more wall density in the first floor and the first basement floor than the Tajamar Building, but collapsed.
- e) Centro Mayor Building (#75) had less wall density in the first floor and first basement floor than the Tajamar Building, and mechanical irregularities (see Section 6). It was demolished.

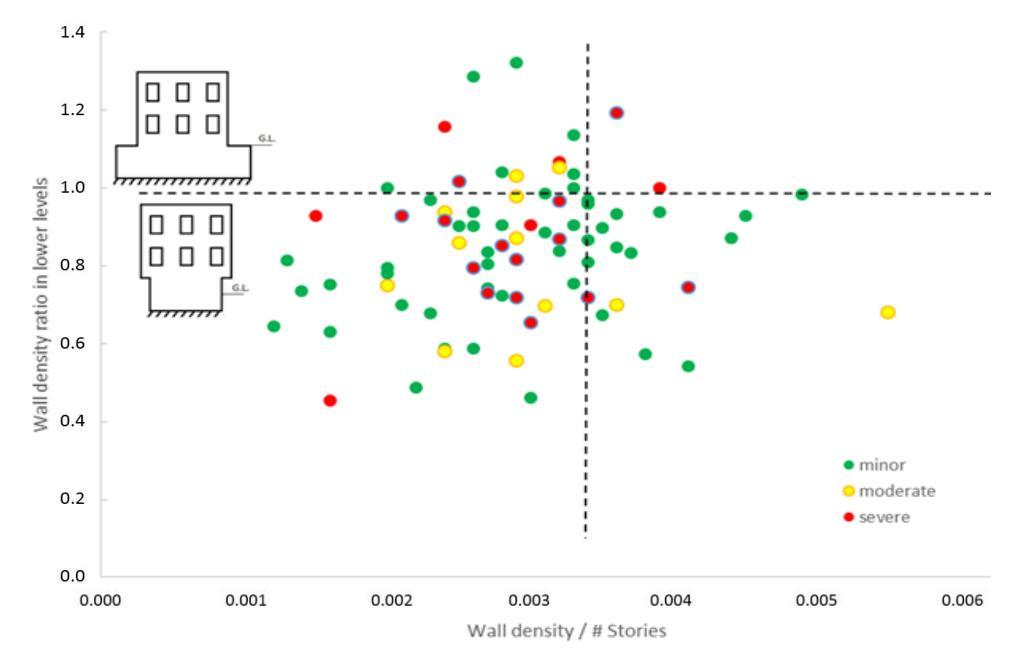
Fig. 8 – Effect of density of walls and wall density changes between lower floors in building behavior.

In Fig. 8 the wall density ratios in the lower stories are plotted against the index [wall density/stories]. It indicates that almost all the building of this sample that had severe damage had less wall density than the standard Tajamar Building, and had a set back in the first floor.

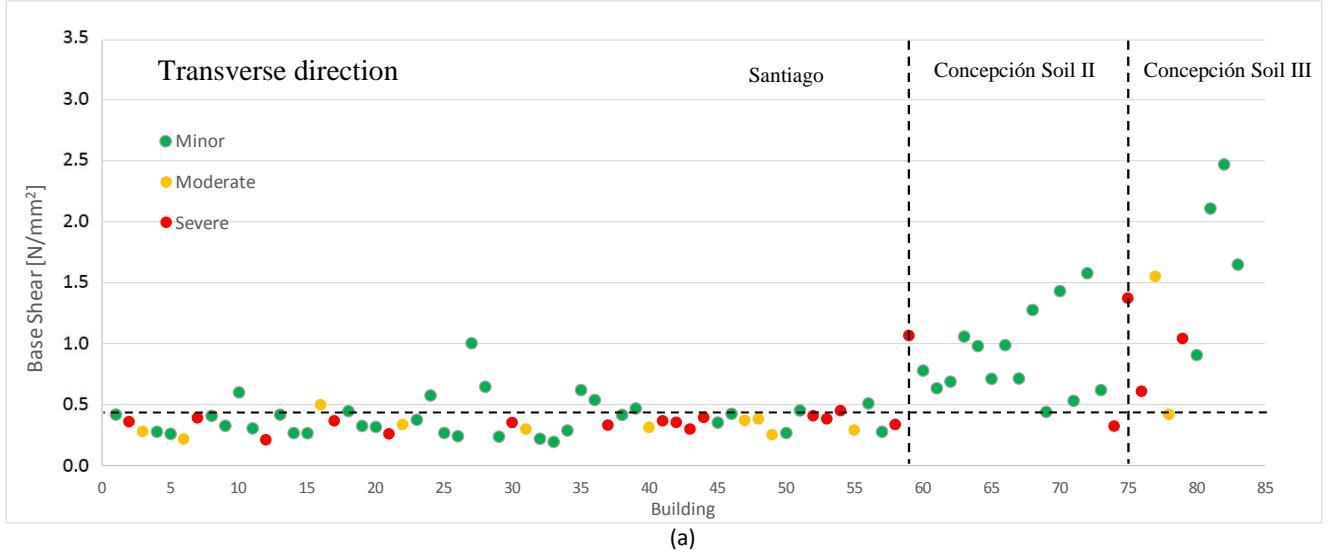
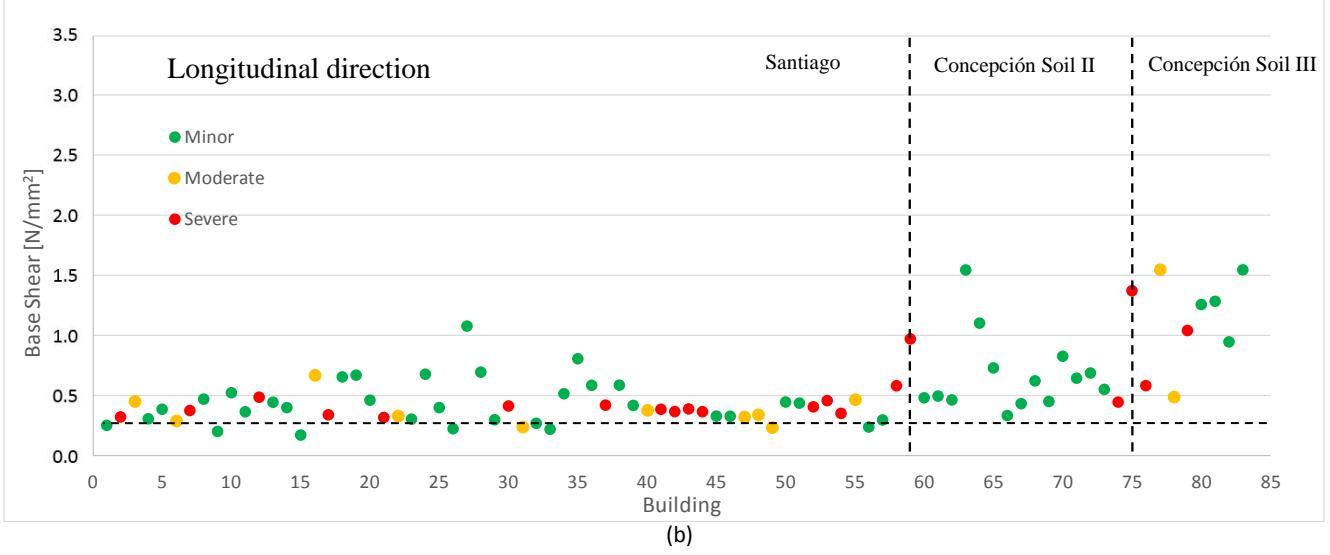
Fig. 9 – Base Shear index (The horizontal dotted line corresponds to the Tajamar Building (#1)).

Fig. 9 shows that all building with severe damage in Santiago had a mean base shear (based on the design base shear of the Chilean standard NCh 433) less than 0,5 [N/mm²]. As a reference, the concrete contribution to shear strength is

These values indicate that the Chilean buildings have large reserve of shear capacity, and confirm what occurred in the field, where no shear failure was observed.
