APPLICATIONS OF MODERN TECHNOLOGIES FOR THE SEISMIC ASSESSMENT OF HERITAGE CONSTRUCTIONS IN PERU

R. Aguilar⁽¹⁾

Abstract

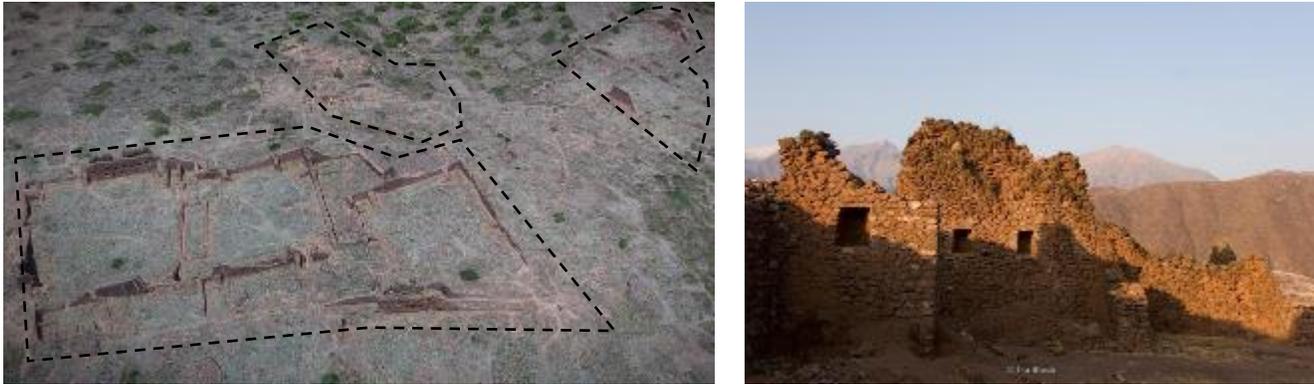
The archaeological site of Chokepukio is located 30 km from the city of Cusco, Peru. This site corresponds to a vestige of the Lucre culture (beginning of the Inca Empire) and its construction took place between 900 AD and 1300 AD. Chokepukio, as shown in Fig.2, presents a special architecture with walls forming enclosures around open spaces. The perimeter walls were of around 12 m high and had trapezoidal and rectangular niches at different heights. The masonry found in Chokepukio was made of semi rounded stones with irregular joints of mud and straw mortar that range between 25 and 100 mm [2]. Unfortunately, this complex is severely damaged due to past earthquakes and the lack of suitable maintenance activities. The damage constitutes the partial or total destruction of most of the complex, the loss of supporting elements and the presence of vegetation.

Fig. 2– Aerial photography and architectural details of the archaeological complex of Chokepukio

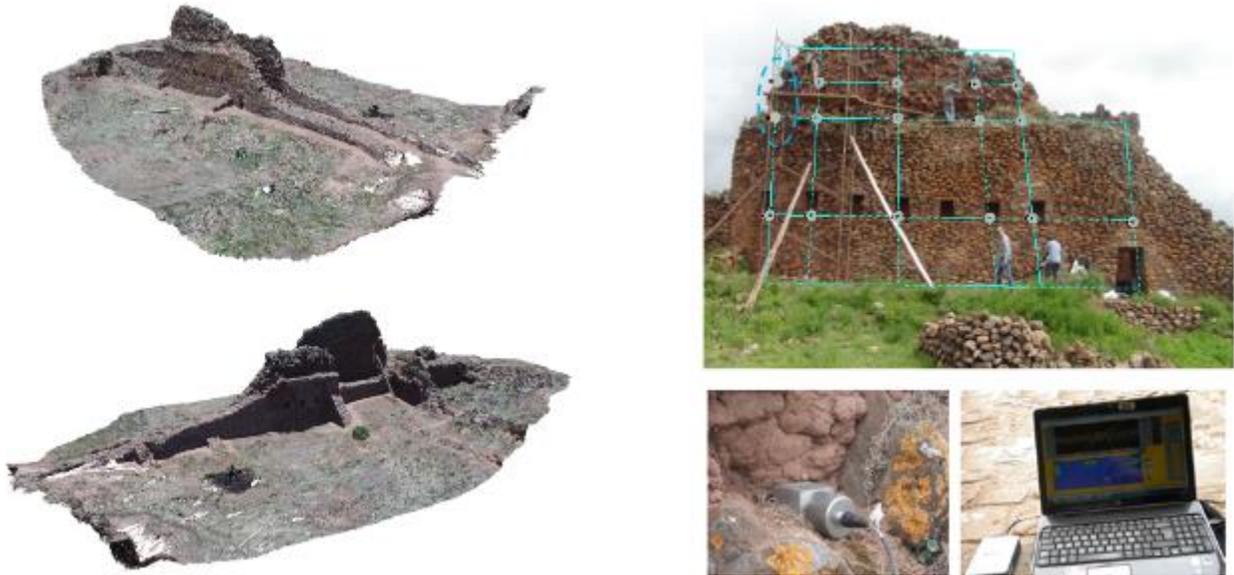
As shown in Fig 4, OMA tests were carried out through the instrumentation of the wall with high sensitivity (10 V/g) accelerometers and high resolution (24 bits) data acquisition equipment. The experimental program allowed the determination of the first seven natural frequencies and vibration modes that ranged among 1.9 Hz and 9.2 Hz (see more details in [10]).

Fig. 4—Studied area and experimental setup during the Operational Modal Analysis tests

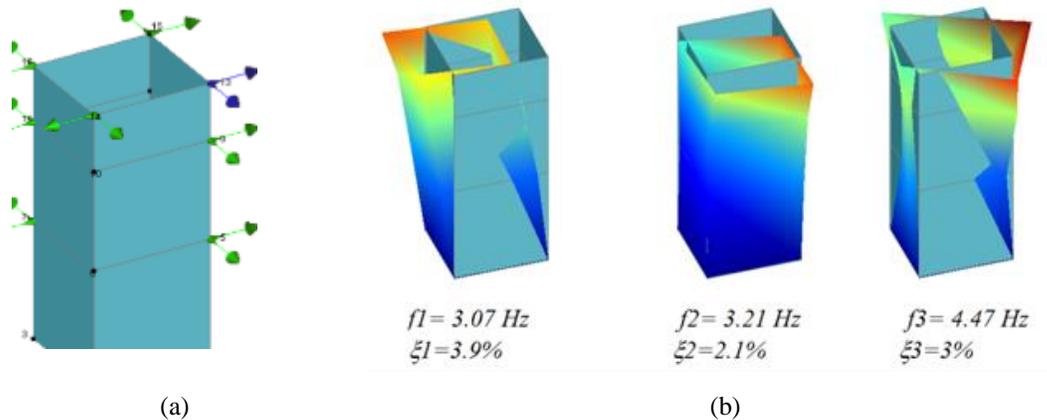
As part of a preliminary study carried out on 2013, OMA tests were performed in the bell tower of the church to estimate its dynamic properties. Eight measuring points according to a biaxial configuration were established in seven setups, considering two fixed and two rowing sensors. The transducers used were four piezoelectric accelerometers with a sensitivity of 10 V/g and a dynamic range of ± 0.5 g together with an USB-powered 24 bits resolution data acquisition module. The data processing was carried out using the stochastic subspace identification method (SSI) implemented in the Artemis Software [18]. The results in terms of the identified first three mode shapes are displayed in Fig. 10 (more details can be found in [19]).

Fig. 10–Modal identification tests in the bell tower: (a) general test setup and (b) first three mode shapes (adapted from [19])
