16th World Conference on Earthquake, 16WCEE 2017 Santiago Chile, January 9th to 13th 2017 Paper N° 2466 (Abstract ID) Registration Code: S-K1464748820

Assessment of Seismic Vulnerability of Historic Buildings Based on their Current Condition Captured by Laser Scans and Retrofit Strategies

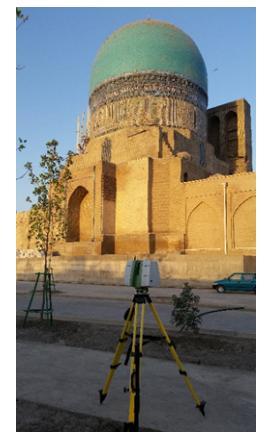
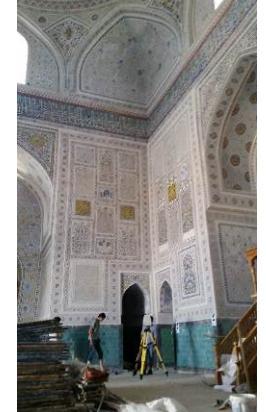
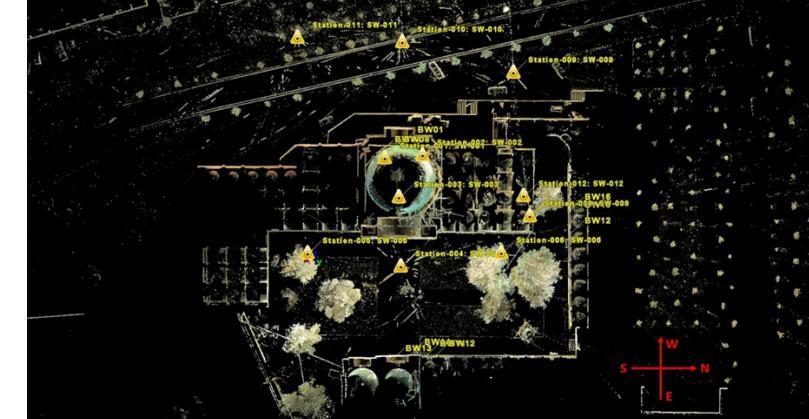
station c) Final registration of laser scans in TruSpace (coordinate system is presented in red) Fig. 2 – Locations of scanning stations

The monument was scanned from outside, inside of the main hall, and inside of a stairway with a large crack between the portal and the main structure. Some of scan stations are shown in Fig. 2a and Fig. 2b. A resultant point cloud of the mosque stitched from the scans captured from the thirteen scanner locations is presented in Fig. 3.

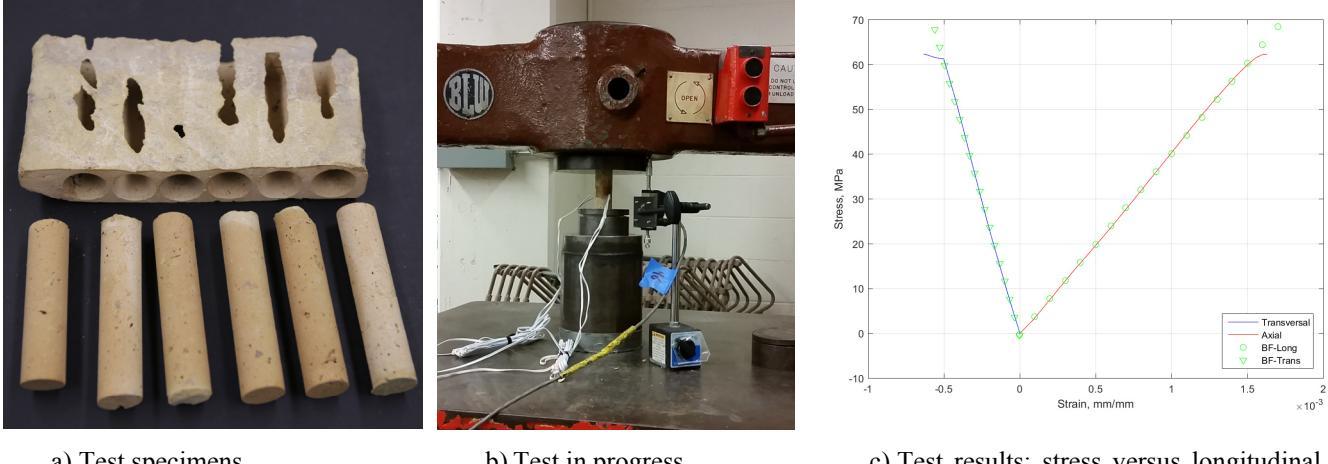
Fig. 11 – Bricks' material tests

The material properties of the bricks from similar historic monuments were estimated earlier [1] by material tests. Test specimens were bored out from a brick as presented in Fig. 11a and tested in an Universal Test Machine under compression load (shown in Fig. 11b). The compression tests show that the stress versus strain curves for both longitudinal and transversal strains are quite linear all the way till failure of the test specimen as presented in Fig. 11c. In addition to the compression tests, a number of split tests were also conducted on the specimens extracted from the brick.
