PERFORMANCE OF MASONRY WALL RETROFITTED USING CFRP SHEETS AND ANCHORS

G. Huaco Cardenas Ph.D.⁽¹⁾, J. Jirsa Ph.D.⁽²⁾

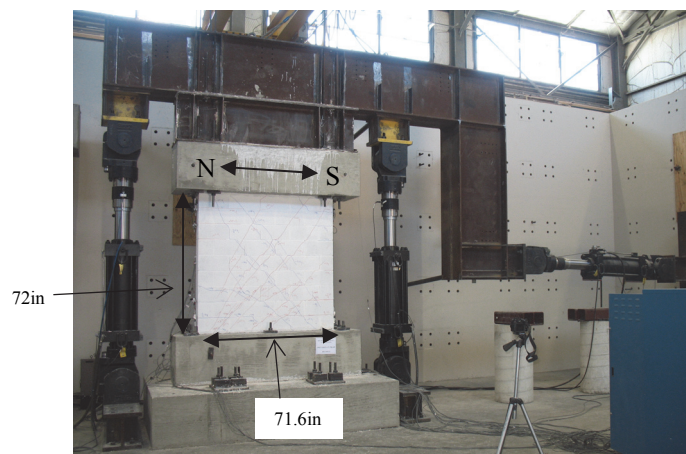
The wall called RMW was tested under constant axial load and cycle lateral forces using a test setup which restrain the specimen to rotate at top and bottom resulting in double curvature deformation as shown in Fig.1. The test setup consisted at three hydraulic actuators, L-steel frame formed by welded ASCE structural beam shapes. An extra steel shape and one concrete bed spacers were installed in other to fit the wall on the test setup. Details for the test setup and instruments are in Leborgn[2] and Huaco[3]

Fig. 1 – Test setup for the fix bottom – top rotation restrained masonry wall RWM [3]

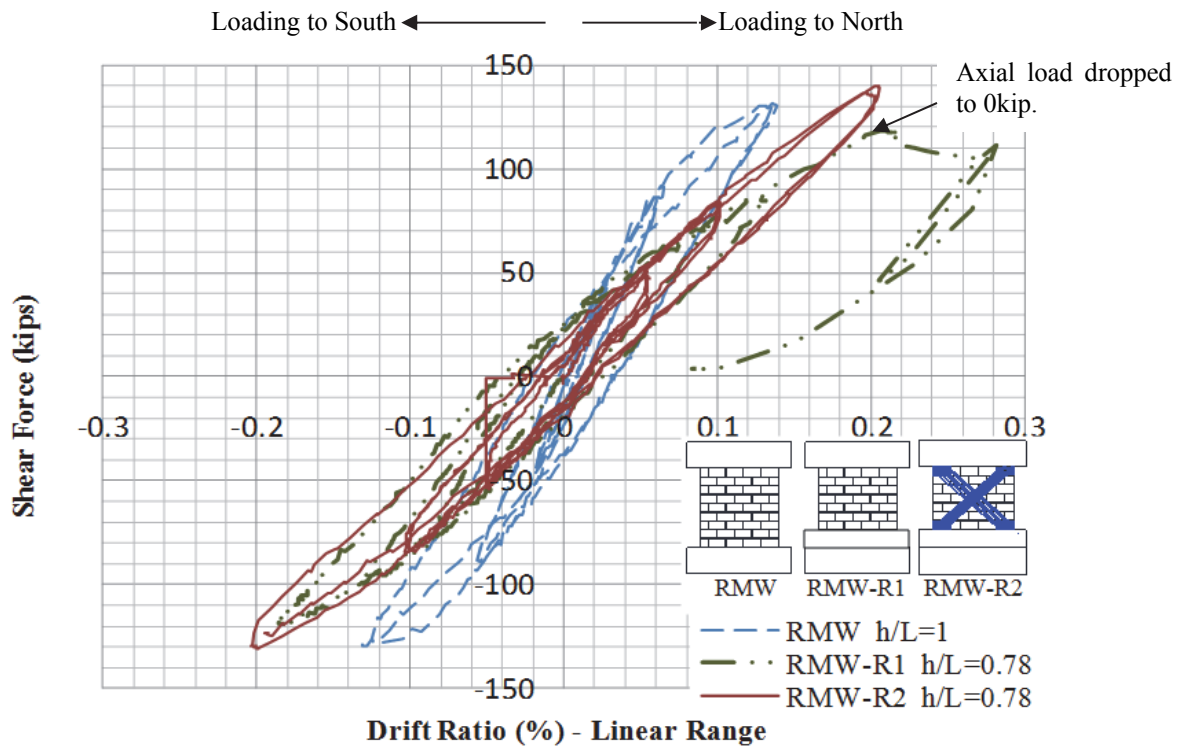
Fig.9 shows the comparisons of shear force vs. drift ratio responses for specimens RMW, RMW-R1 and RMW-R2 at linear range where the 1st Phase of retrofit was tested, seeing that reduced stiffness for both retrofitted phases. Fig.10 shows the responses for RMW and RMW-R2 including the behavior due sliding showing the increasing of shear force capacity and the comparable lateral deformation.

Fig. 9 – Shear force vs. drift ratio on linear range of RMW, RMW-R1 and RMW-2

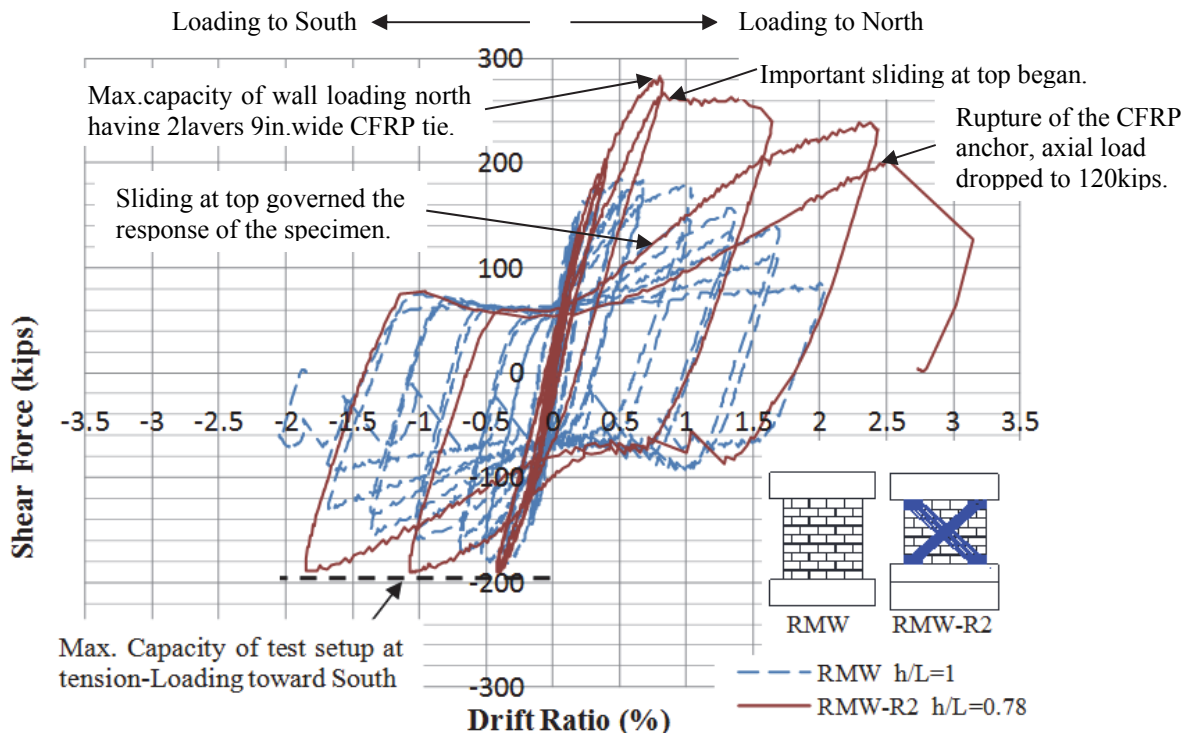
Fig. 10 – Shear force vs. drift ratio of RMW and RMW-R2.

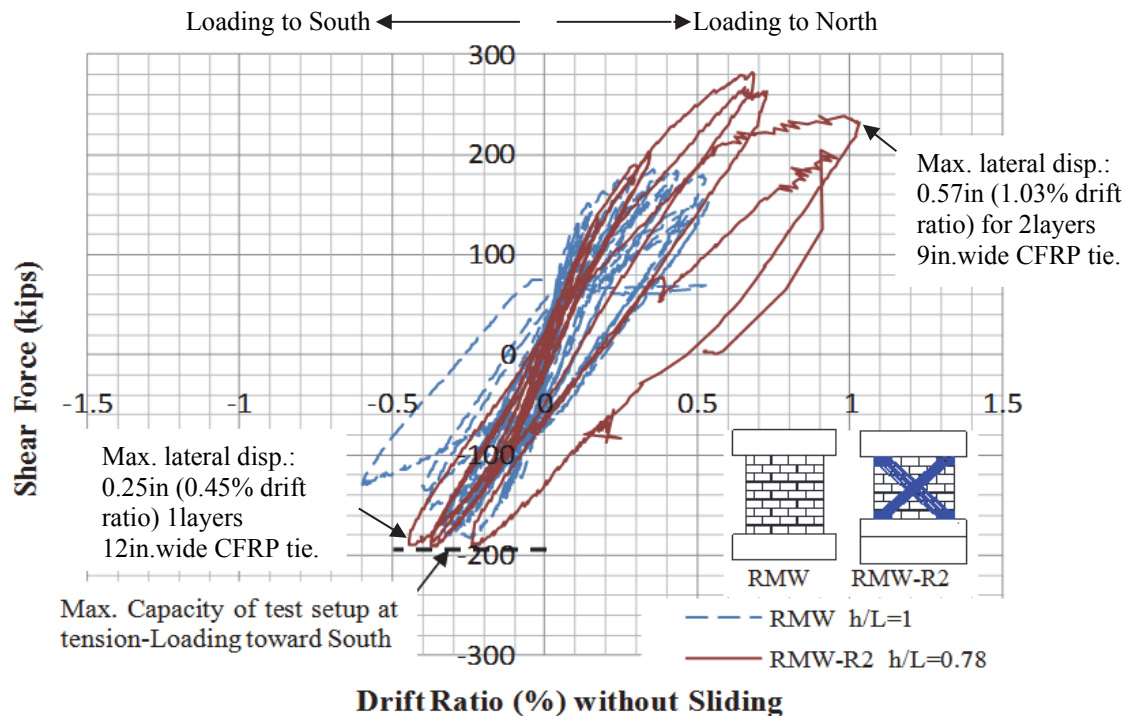
Fig.13 shows the response of the specimen without sliding at bottom and top of the masonry wall. The overall nonlinear response of the specimen was governed primarily by sliding at the top. Considerable sliding displacement occurred at the top of the strengthened wall. Sliding at top was about 50% of the total lateral displacement. Sliding at bottom of the wall was not significant. The maximum shear capacity prior to sliding was 284kips at 0.8% drift. Failure occurred due to rupture of the CFRP anchors installed at the top of the masonry wall at a lateral load 128kips and the maximum drift ratio was 3.1%.

Fig. 13 – Shear force vs. drift (without sliding) of RMW and RMW-R2.
