## PERFORMANCE OF THREE DIFFERENT PILE FOUNDATIONS IN URAYASU CITY DURING 2011 TOHOKU EARTHQUAKE

K. Tokimatsu<sup>(1)</sup>, H. Suzuki<sup>(2)</sup>, A. Abe<sup>(3)</sup>

### Abstract

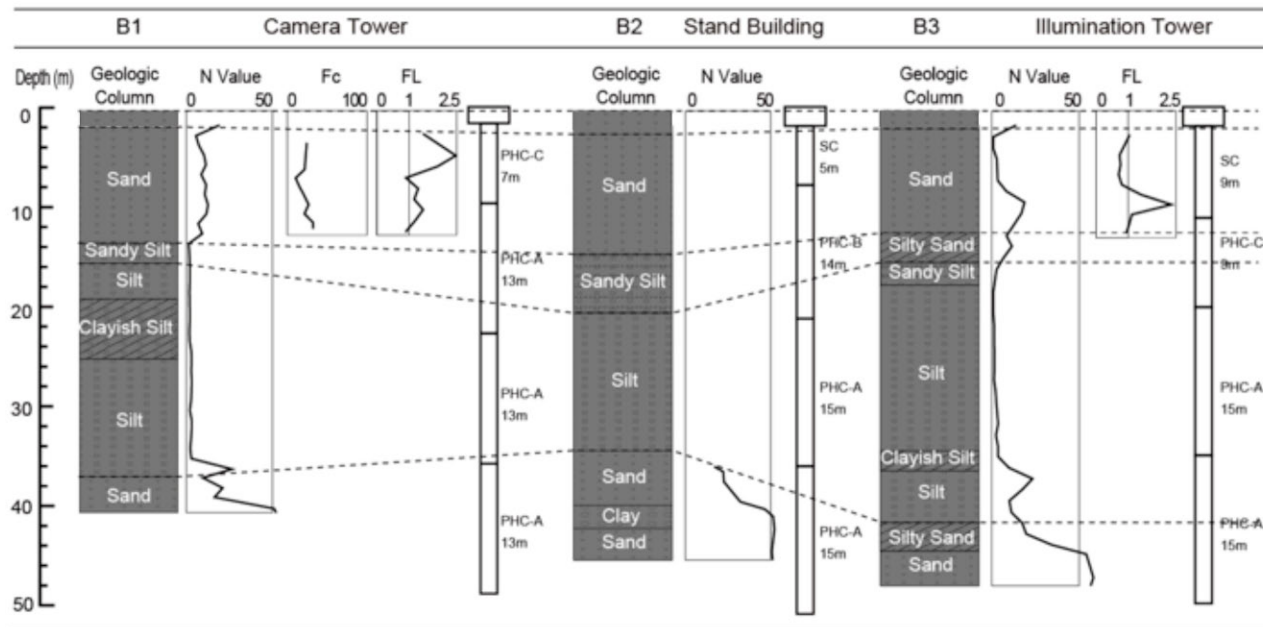
Fig. 3 - Boring logs and pile types used for three structures in Urayasu Sports Park [2, 4]

Fig. 3 shows three boring logs obtained before the quake at B1-B3 (Fig. 2) in the site [2, 4]. The groundwater table was located at a depth of 1.4 m. The surface layer to a depth of about 10 m is a reclaimed fill consisting of loose sandy soils, which is underlain by layers of thick silty soil and dense sandy gravel at a depth of about 40 m.

All the piles used for the three structures were follower piles with a diameter of 600 mm, each of which consisted of four different precast piles along the length of about 48 m, as shown in Fig. 3. Stand Building was supported on 44 piles 49 m long, each of which consisted of an upper steel reinforced concrete (SC) pile 5 m long, one Prestressed High-strength Concrete (PHC Type B) piles 14 m long and two PHC Type A piles 15 m long each. Camera Tower was founded on 4 piles 48 m long, each comprising an upper PHC Type C pile 7 m long, and three PHC Type A piles 13 m long each. Each Illumination Tower was supported on one follower pile, comprising an upper SC pile, one PHC Type C pile 9m long and two PHC Type A piles 15 m long each. Type A, B and C piles had an effective prestress of 4, 8 and 10 N/mm<sup>2</sup>, respectively.

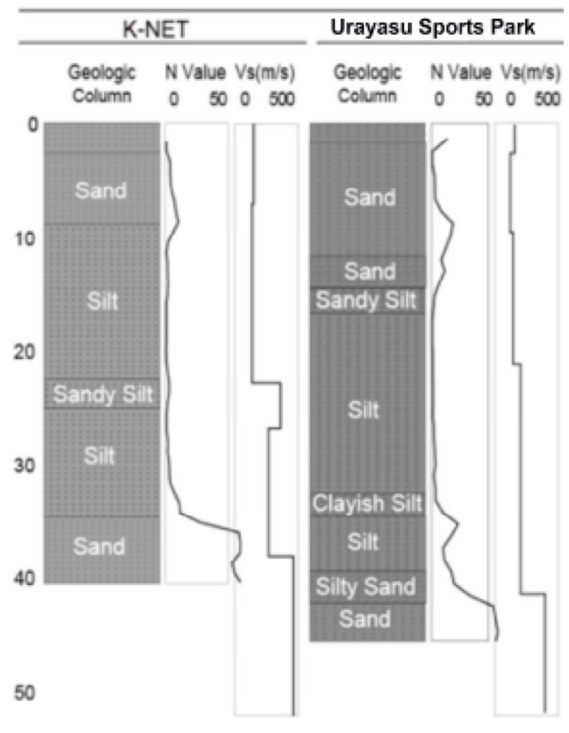
Fig. 9 - Boring and shear wave velocity logs at K-NET Urayasu and Urayasu Sports park

Fig. 9 shows the geologic and geophysical logs at K-NET Urayasu and Urayasu Sports Park. The very dense sand layers with  $V_s$  greater than 400 m/s that occur at depths about 40 m were considered as the common bedrock for the dynamic analyses. The details of a similar analysis made for various sites in Urayasu has been described elsewhere [4, 6]. The estimated peak ground acceleration (PGA) and maximum ground surface displacement with respect to the bottom of the liquefiable layer were 1.57 m/s<sup>2</sup> and 0.11 m in the X direction and 1.45 m/s<sup>2</sup> and 0.08 m in the Y direction.

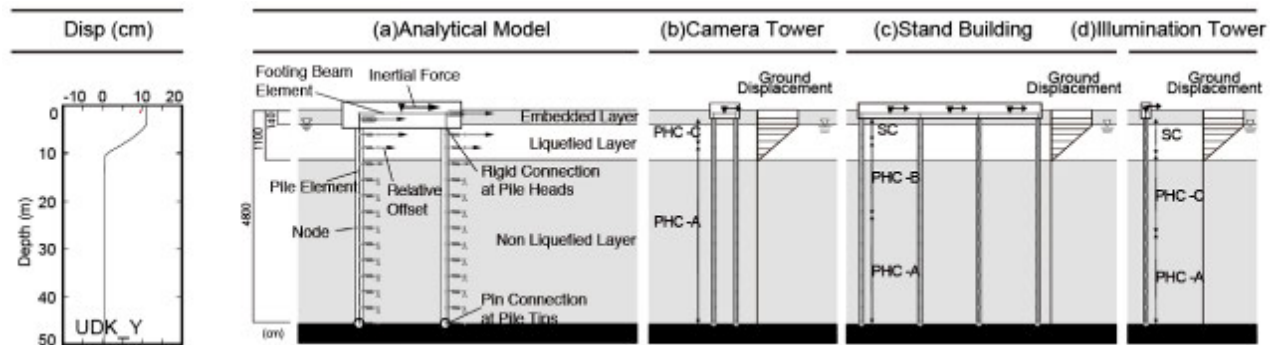
Fig. 10 - Soil-pile-foundation models used for pushover analysis

Fig. 10 schematically illustrates soil-pile-structure modes in the unsafe direction of the three structures. In the analytical mode, the inertial force is applied to the gravitational center of the foundation and the cyclic ground displacement to the pile through p-y springs and they were stepwise increased in the same direction simultaneously from zero to the maximum values estimated in the effective stress analysis. The change in axial pile force supporting foundation without a superstructure was very small and thus neglected.
